Preliminary Information

PIT5985C Diagnostic Tip: No Start/ Ignition Will Not Turn ON/ No Power Due To A CAN bus 2 Issue/Lightning Strike/ Failed Over The Air Update

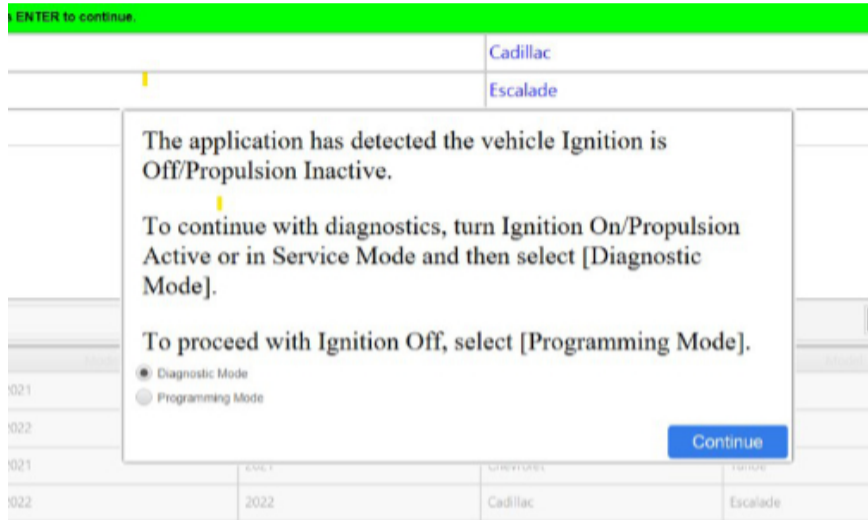
1) Dealership technicians will notice that they are unable to access GDS data to review DTC's or check the network communication status. They may experience the following pop up box, shown below, and will be unable to get past this screen. You will need to keep hitting the continue button 5-6 times and then it will allow you to get past this screen and then it will be possible to go into vehicle diagnostics to check DTC's and CAN bus status.

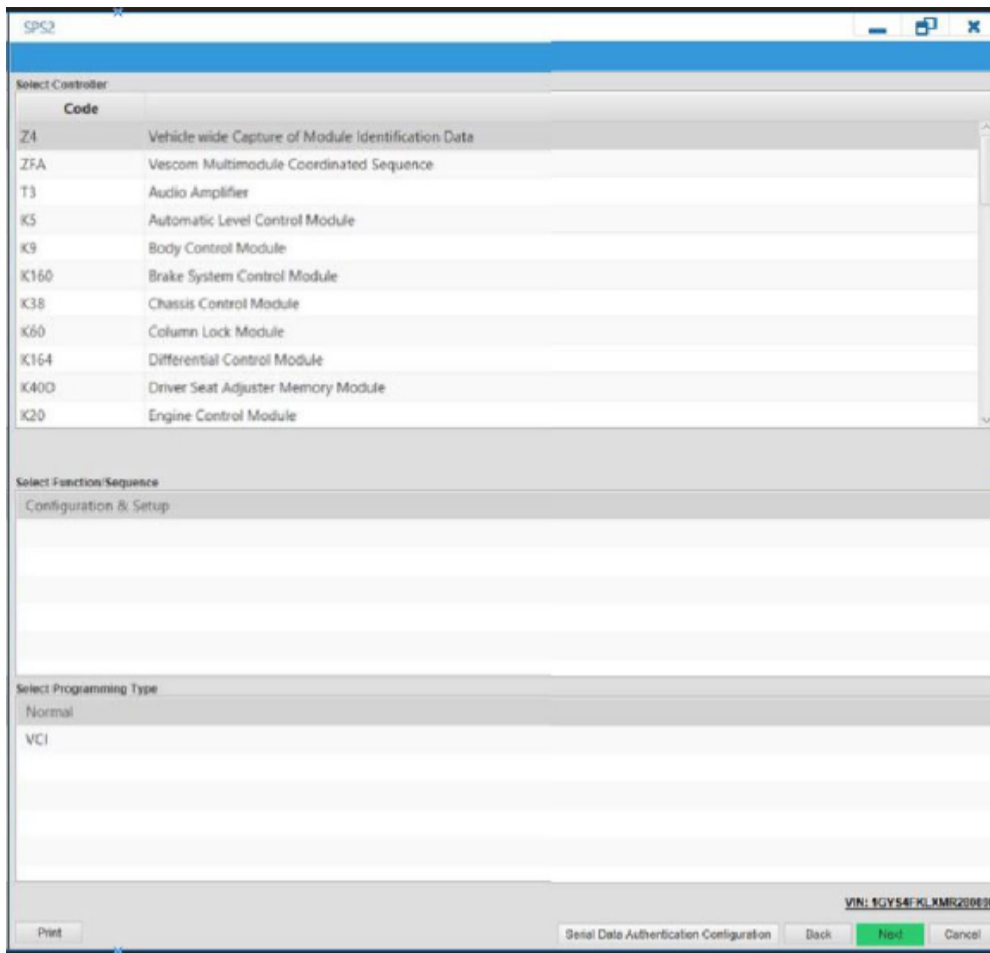
3) If after all modules are communicating and you continue to have issues or current DTC: U1962, then perform a Serial Data Authentication Configuration (SDAC), which is located on the SPS controller screen in the SPS, shown below. This will have to be completed so each module recognizes each other on their respective data buses.

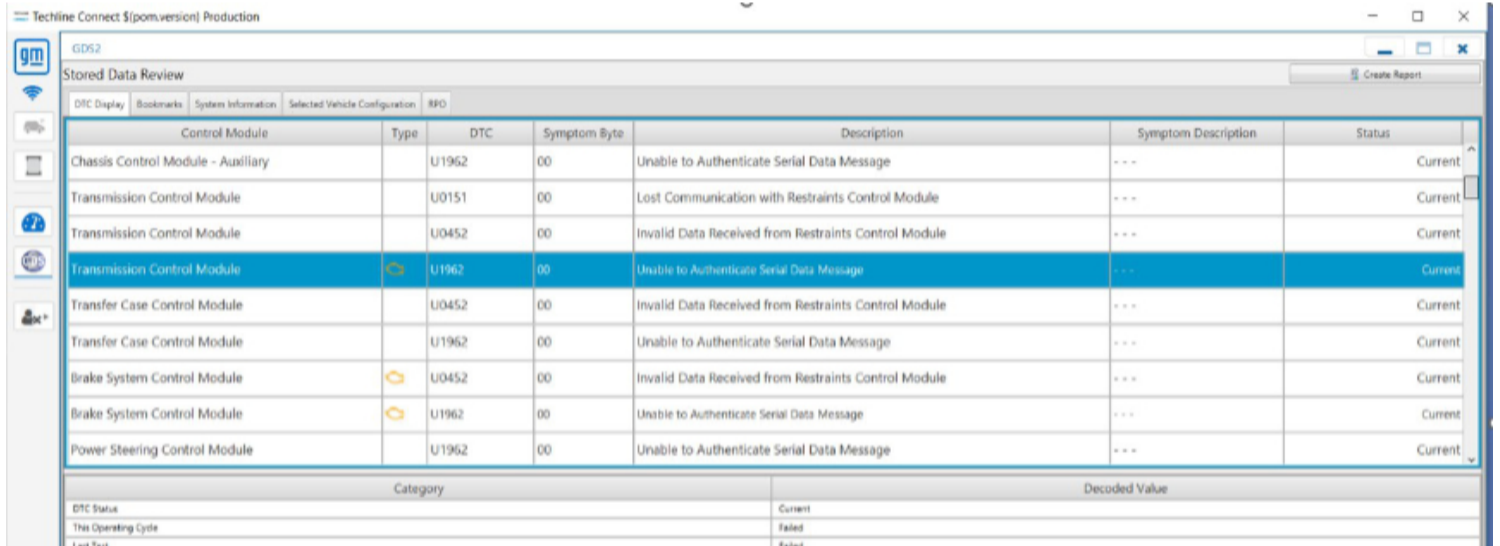
5) If the SDAC passes and a labor code is generated, make sure to clear all the U codes that are current or the vehicle still may not start.
