STAR ONLINE PUBLICATION

Case Number: S2308000122

Symptom/Vehicle Issue: Vehicle is a no crank/no start with the following DTCs, as well as a no crank/no start condition: U0164, U0140, U0151, U0155

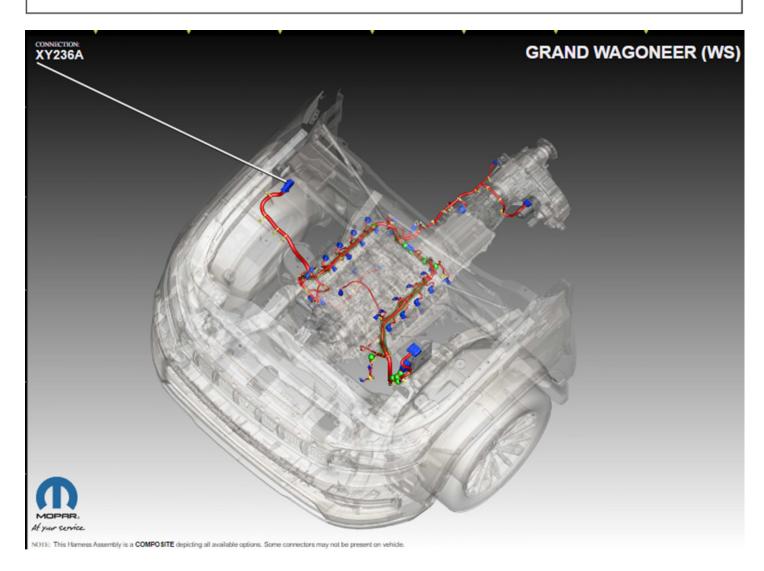
Discussion: Use the available BUS wiring diagrams in Service Library (SL) to trace the involved BUS harness circuits for the module that has set the DTC. Inspect the component and circuit inline connectors visually for any signs of loose, spread or pushed-out terminals for the involved BUS. Locate the inline XY236A, which is on the passenger side underneath the radiator reservoir. Inspect for fully seated and locked conditions. Verify the bail is fully seated to the connector.

If a loose connection is found, repair it by fully seating the connector.
