Service Bulletin

Bulletin No.: 21-NA-149

Subject: Engine Wire Harness Chafing / IPC Gauges Sweep / IPC Warning Message / SES/Check Engine/MIL / No Start / No Crank / Runs Rough / Stalls / Reduced Engine Power / Various DTCs

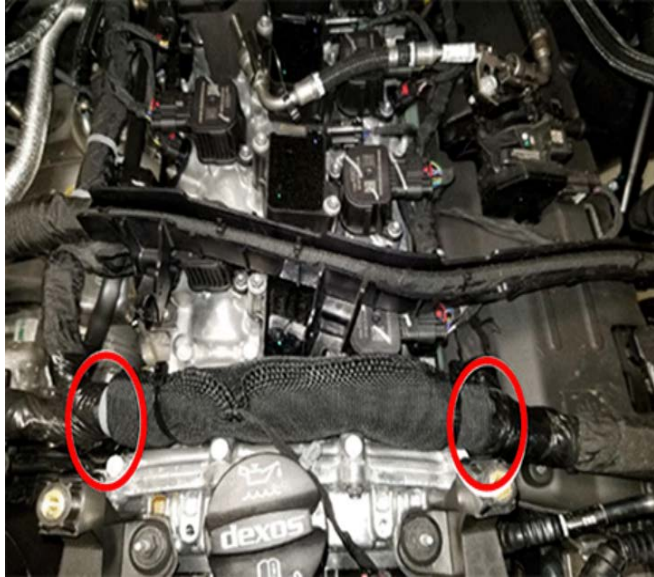
<p>5394681</p>

<p>Cause 1</p>	<p>This Cause pertains to vehicles equipped with engine 2.7L, L3B only.</p> <p>These concerns may be caused by engine harness contact with under hood components.</p> <p>Caution: This Document Only Applies To VINs NOT Covered by Customer Satisfaction Program N192219370 Please Verify In VIS Before Proceeding</p> <p>Shown below are areas that should be inspected for this concern.</p> <p>Inspect the engine harness as it crosses over top of the Camshaft Carrier Cover.</p> <p>Harness damage can occur at any point across the Camshaft Carrier Cover.</p> <p>Typical inspection locations shown below.</p>

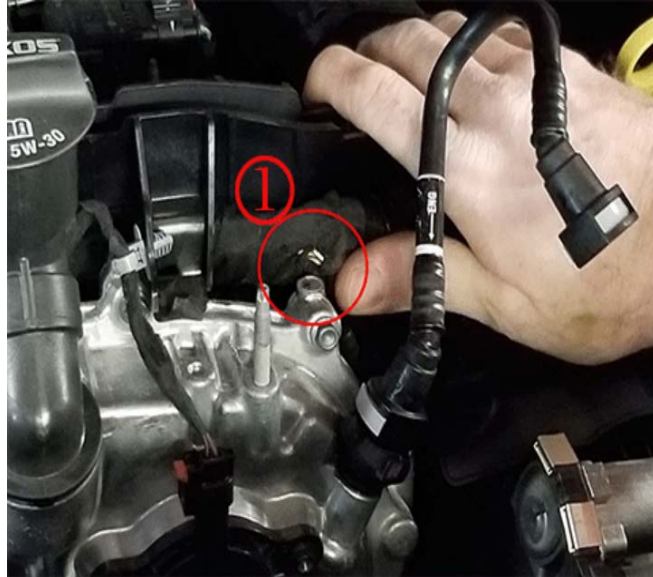
5324748

Example of engine wiring harness damage at Camshaft Carrier Cover shown below.

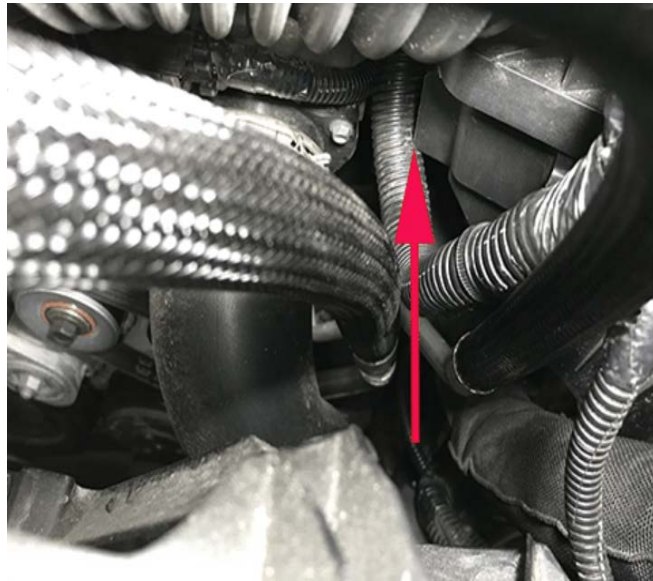
5394683

Inspect the engine harness at the Lower Air Cleaner Housing as shown below.

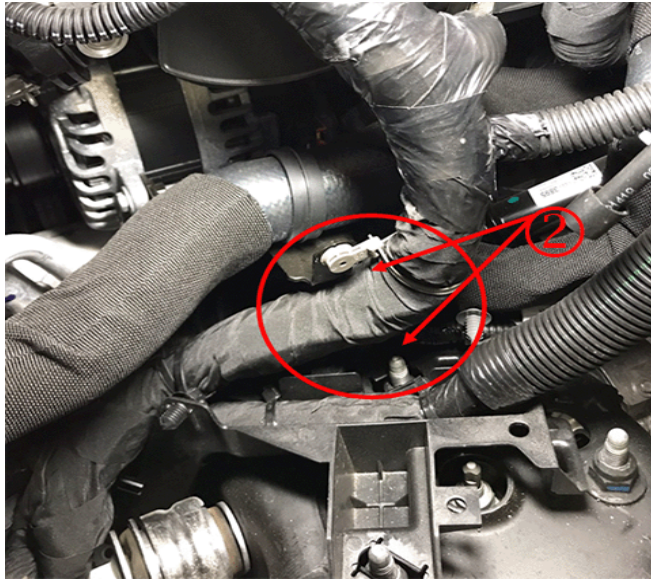
5324752

Inspect the engine harness at the Generator Bracket and Left Front Coil Spring stud as shown below.

Note: Under normal driving conditions, the engine will rock back and forth in its mounts.

This may result in harness contact with this bracket that may not be present during engine off inspections.

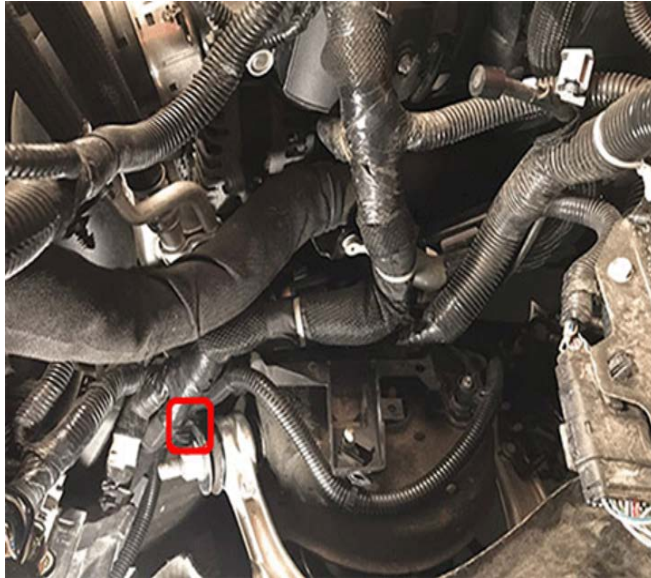
5394677

Inspect the engine harness at the Left Front Upper Control Arm Bushing as shown below.

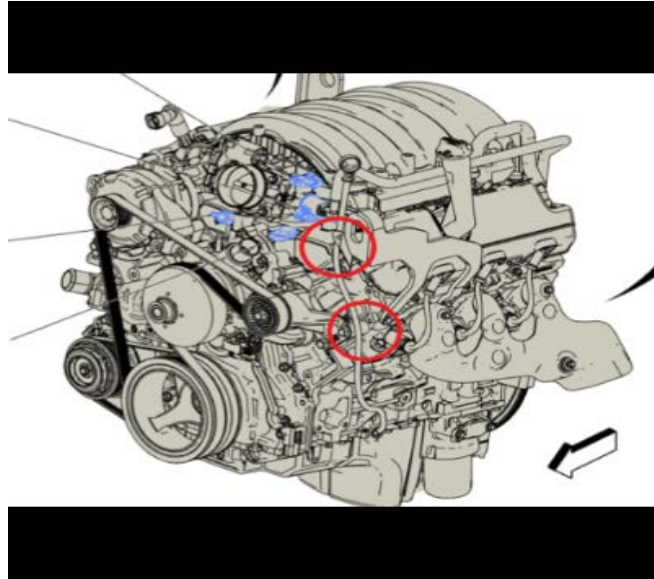
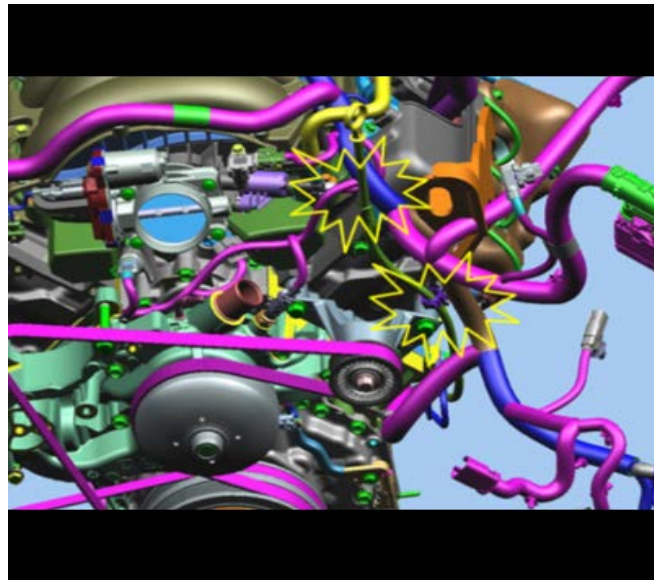
These concerns could be caused by engine wiring harness chafe on underhood components at various locations such as: Front corner of the left hand cylinder head, drive belt idler pulley bracket, or oil dipstick bracket; noted by the circled and starred areas in the graphics above. This harness chaffing could cause shorting of any number of circuits to ground. Due to the number of circuits in the harness, there is a wide variety of different symptoms that could occur depending on which circuit(s) are damaged.

To correct this concern, repair the damaged wiring following the SI wire-to-wire repair procedures. Once repaired, protect and reposition the engine wiring harness to prevent future harness damage.

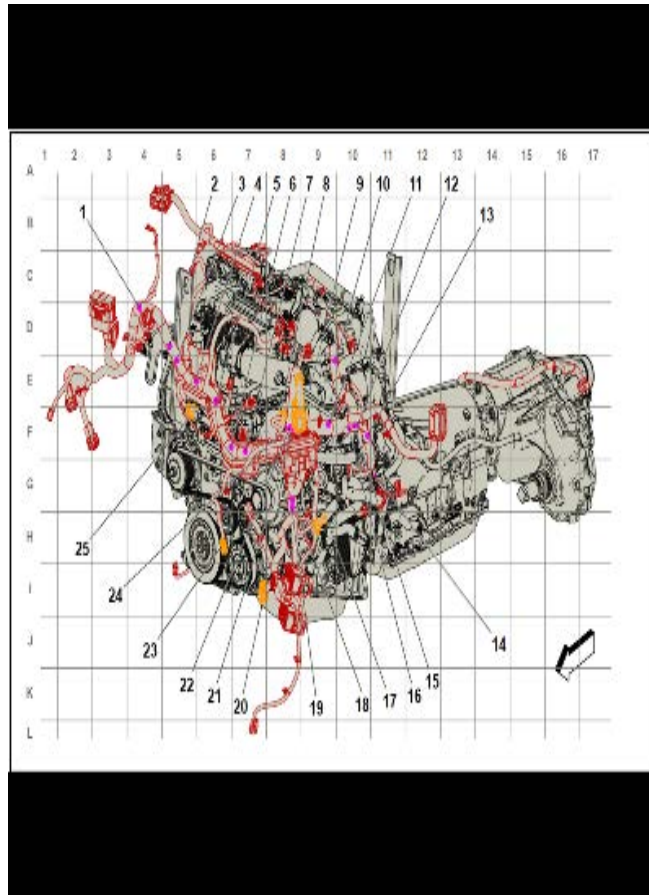
6163833

1. The engine harness pinched/shorted/chaffed at grid coordinates G-8, as shown above. This location is approximately 18 inches from the ECM connectors (1) and on top of the generator (2), as shown below. Due to the number of circuits in the harness, there is a wide variety of different symptoms that could occur, depending on which circuit(s) are damaged.

2. The engine harness shorted/chaffed at grid coordinates C-9, as shown above. The engine harness could be shorted out on the PVC hose clamp at the crankcase pressure regulator, as shown below (6). This is located approximately 4 inches from the crankcase sensor connector pigtail harness breakout.

This Correction pertains to vehicles equipped with engine 3.0L, LM2 only.
Inspect areas designated by the graphics and call-outs in Cause # 3.
In many cases, the ECM has been unnecessarily replaced for these concerns. Please thoroughly inspect the areas shown above and follow published SI diagnostics before any parts are replaced. If any concerns are found, then follow SI Wiring and Connector repair instructions to correct the concern.

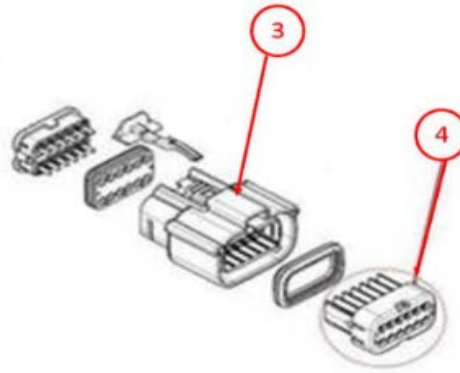
5643650

1. Inspect for poor terminal tension at connector X160, shown in the grid above, as callout 25. While inspecting X160 make sure the terminal locking feature (4), shown below, is not missing.

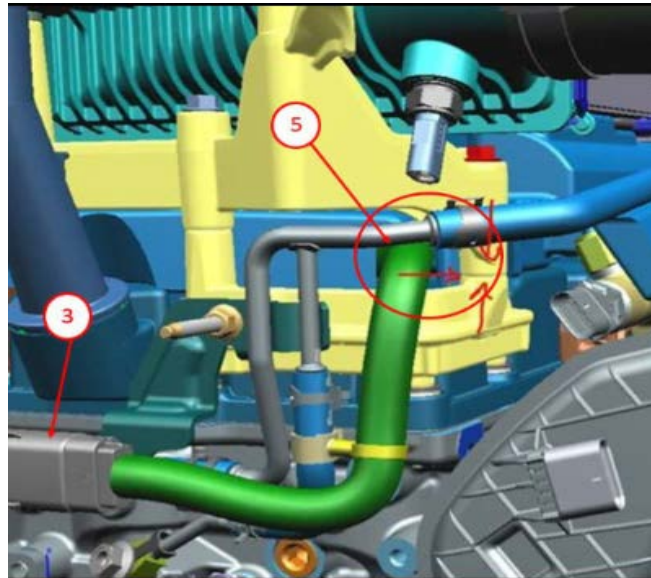
5643651

2. Inspect the fuel injector connectors to make sure they are fully connected/seated.
3. Inspect the fuel injector wiring harness near the X160 connector (3) for being pinched/shorted/chaffed, as shown below (5).

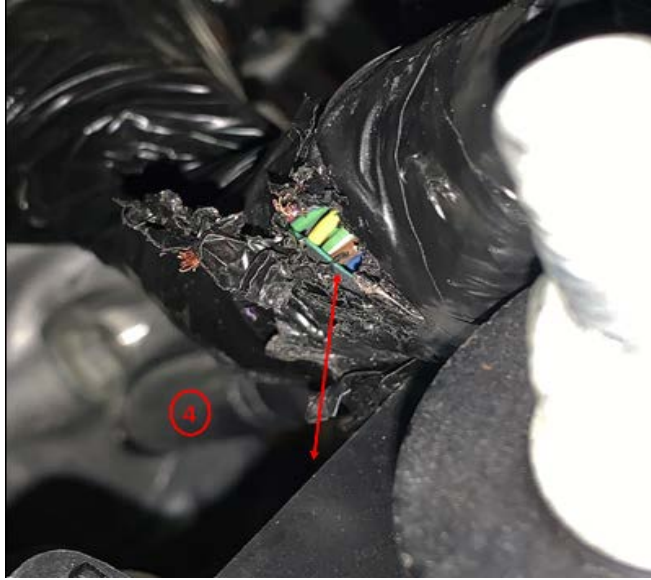
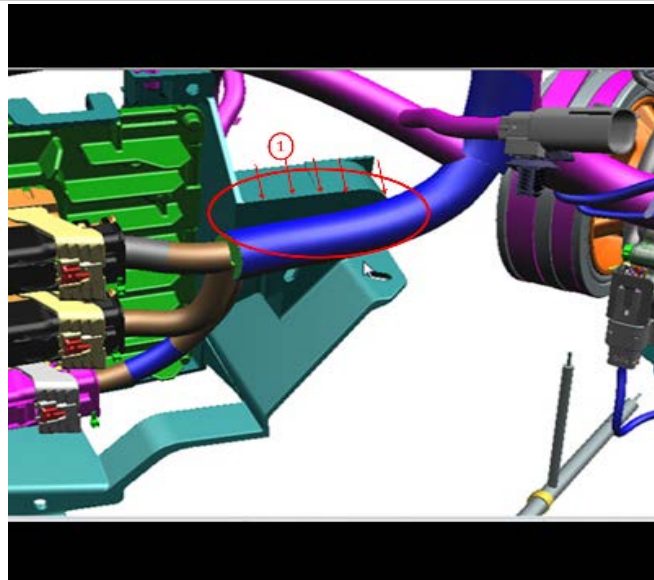
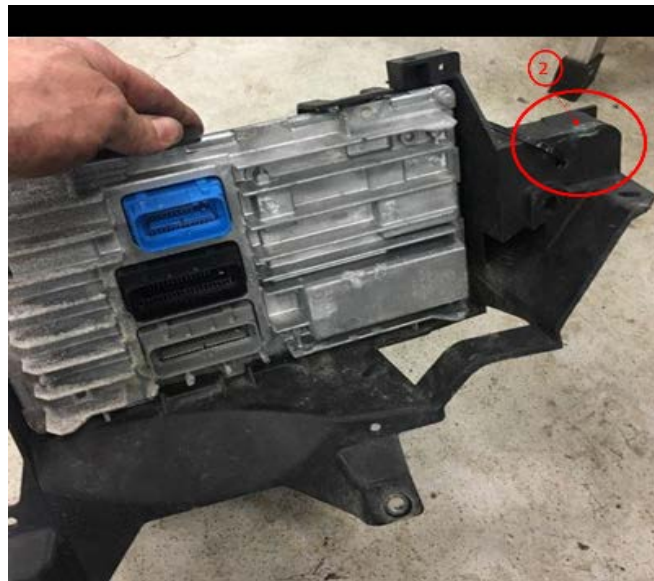
The cause of the condition may be an engine wire harness clip was removed during production due to ergonomic issues (hand clearance and branch stiffness). This led to an uncontrolled branch that came into contact with a sharp edge (1) & (2) on the ECM/TCM bracket, driver side upper control arm, and/or shock tower and caused chaffing during engine vibration and roll.

Utilizing Engine Harness sleeves, anti-abrasion tape, and zip-ties to secure the harness away from one or more of the chaffing points. Follow the Service Procedure steps below.

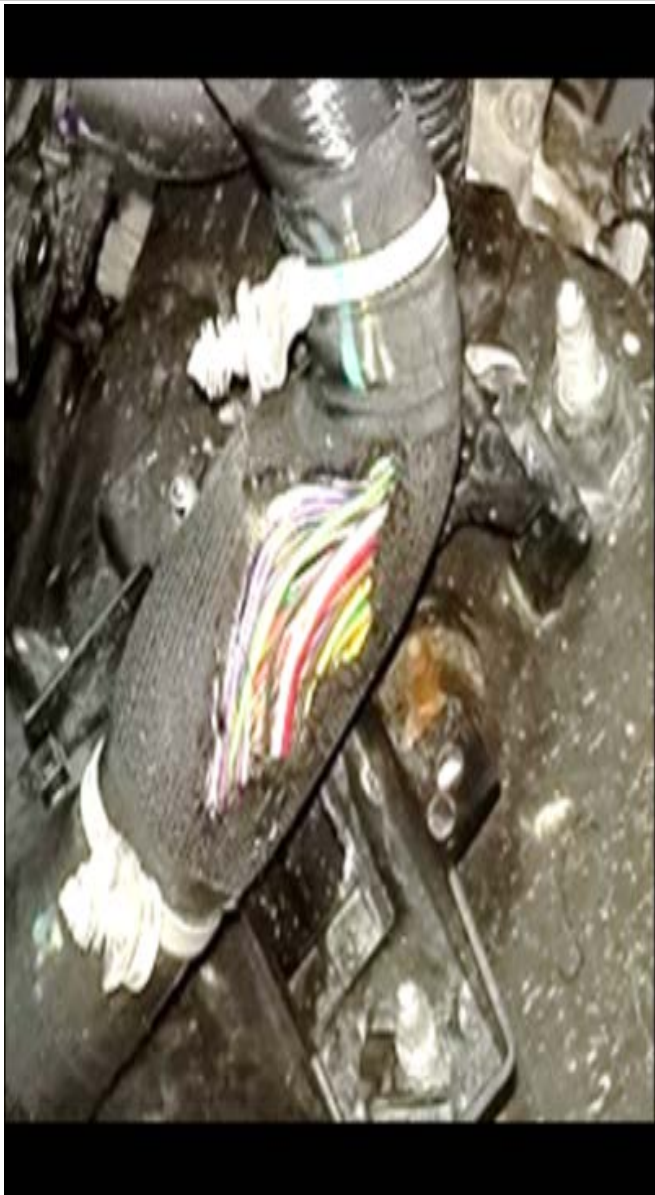
5868347

Examples of extreme wire chaffing.

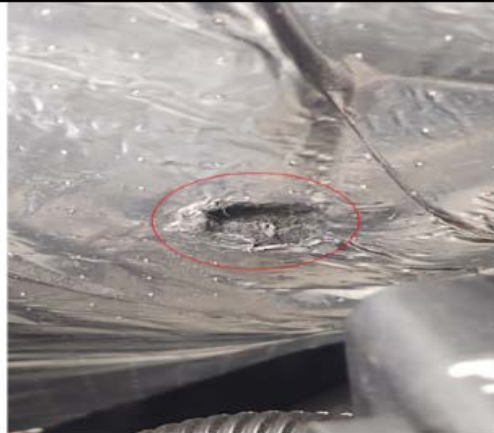
5949751

An example of firewall insulator chaffing

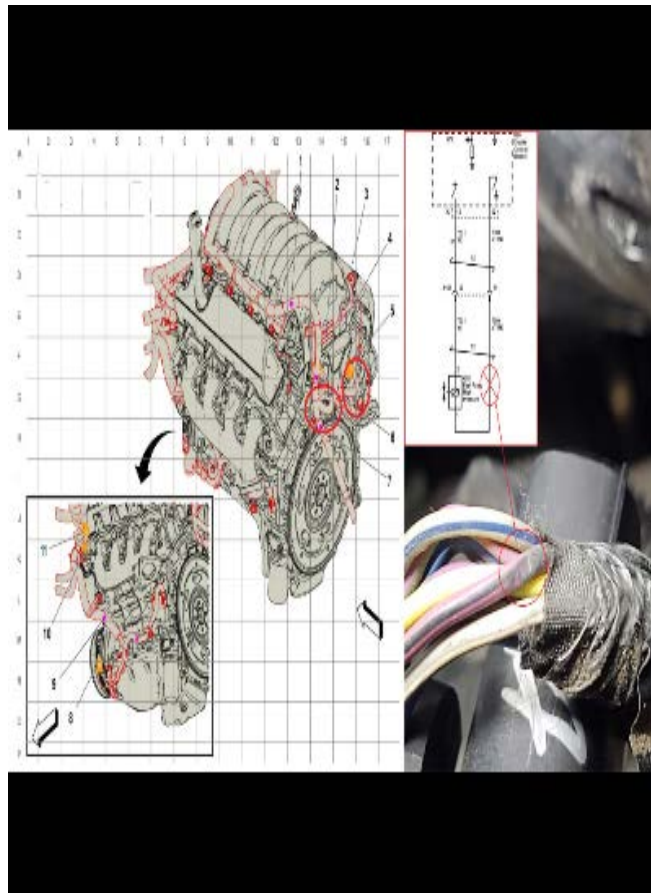
5949755

Other areas of concern.

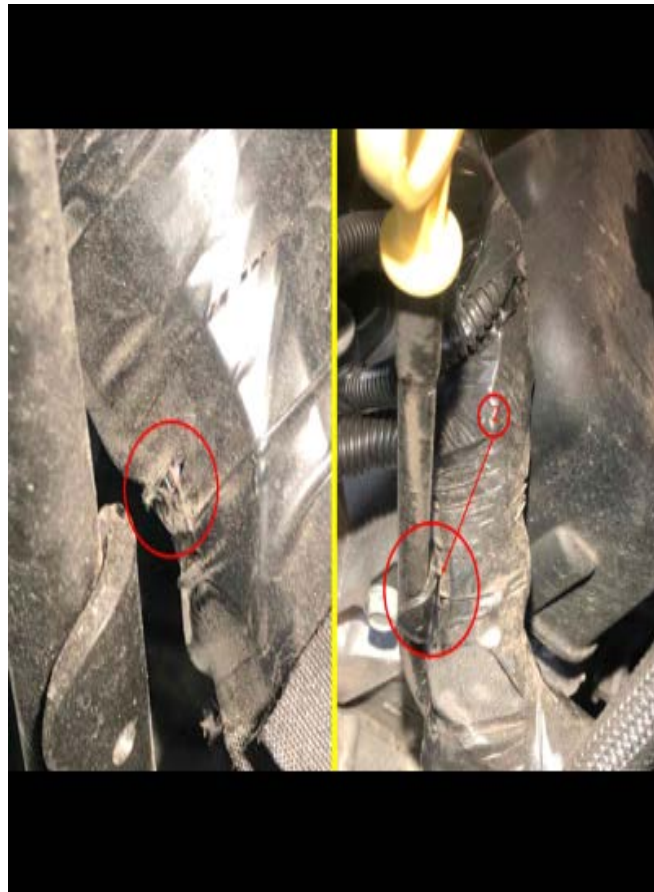
5911722

Note: The first graphic below is a before, and after (2), repair example of harness chaffing at the Oil Dipstick bracket.

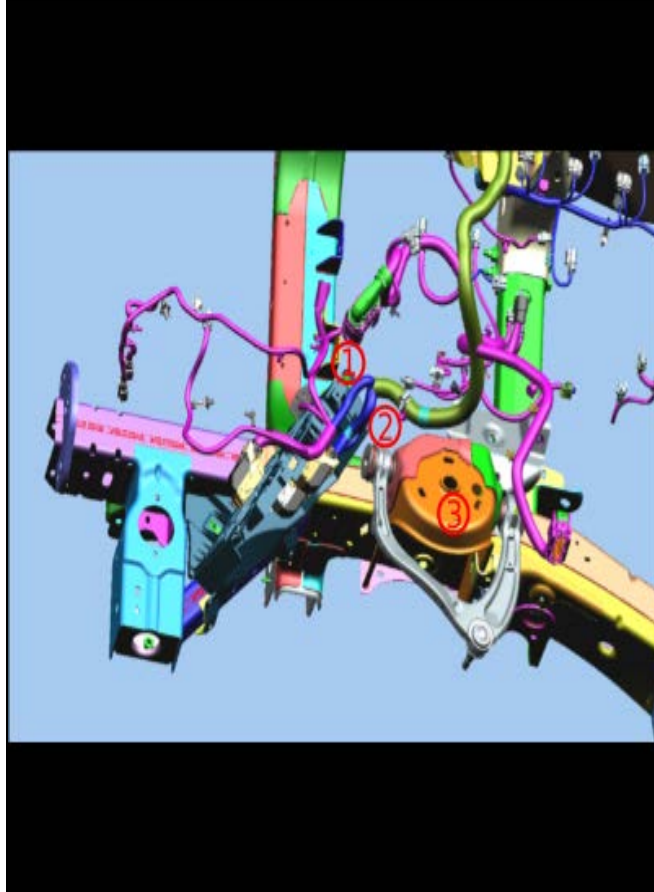
5868341

3. Locate the three contact points where the wire harness is chaffing, the ECM/TCM black bracket (1), the upper control arm (2), and the shock tower bolt (3).

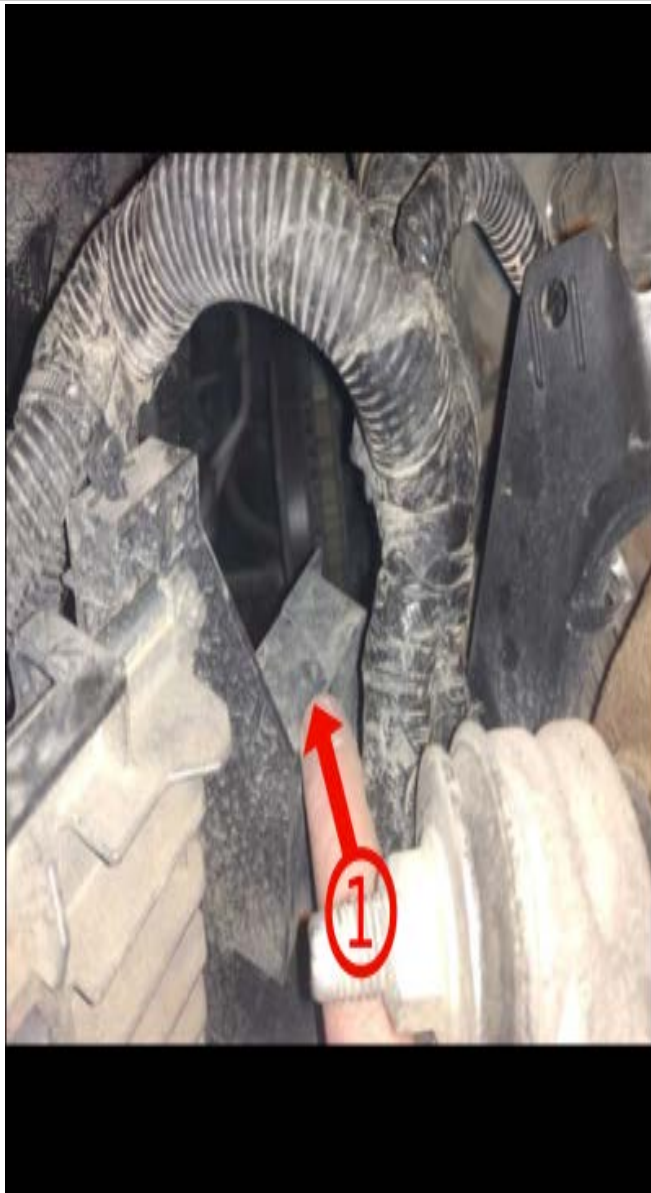
5868349

4. At the ECM/TCM bracket, locate the wire harness laying against the ledge (1).
