48-23-02 - Steering wheel / airbag: grinding/creaking/clacking noises when steering (cornering/parking/maneuvering)

Release date: 12/11/2023

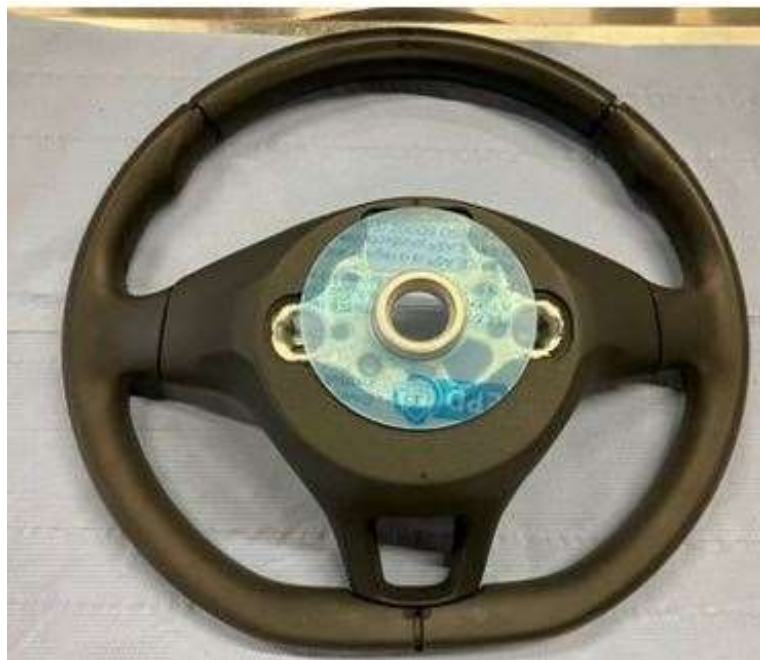
Figure 3.

3. Supplied template positioned on the back of the steering wheel.

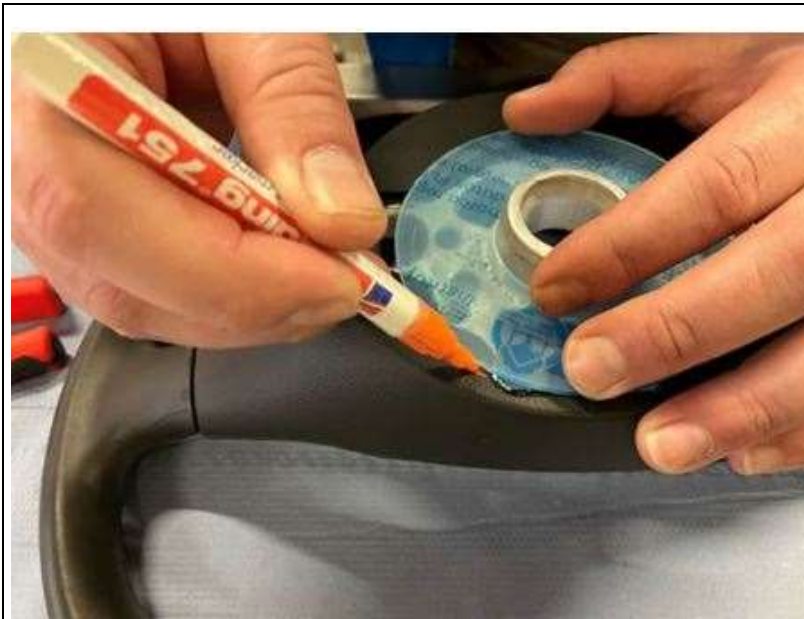
Figure 5.

5. Example: Mark the area on the steering wheel with a pen

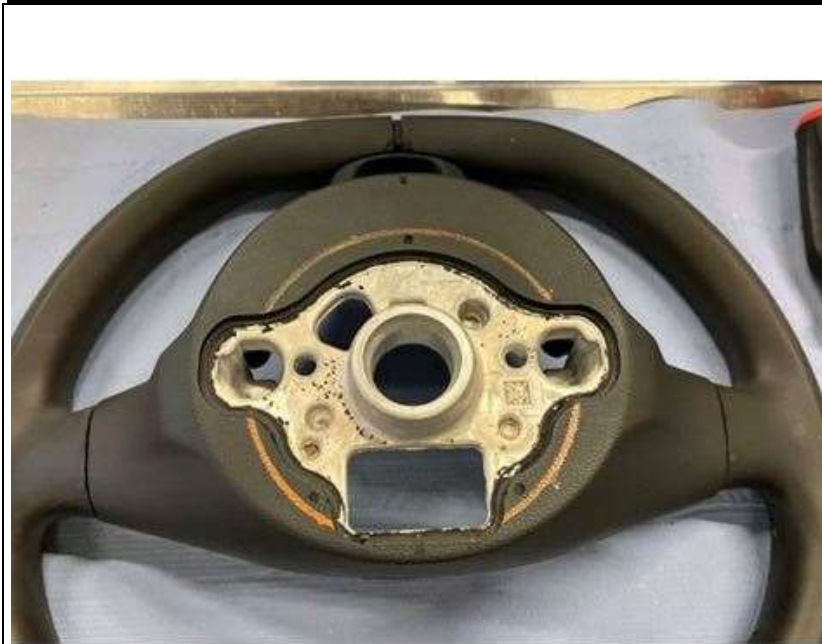
Figure 6.

6. Example: Marked area on the steering wheel foam (template removed).

Put the template back on the steering wheel.

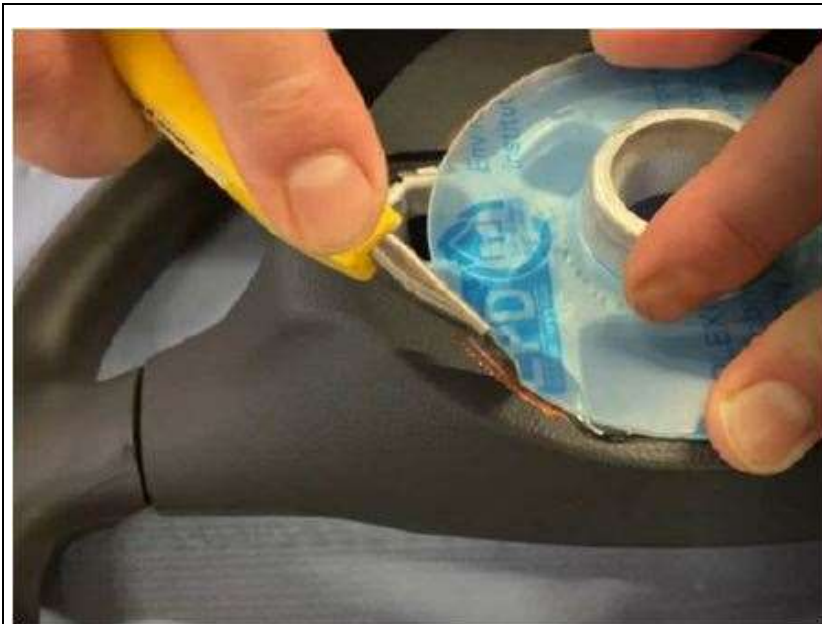
7. Example: Cutting foam on the steering wheel.

Using a suitable cutting knife, carefully cut the foam along the template. See Figure 7.

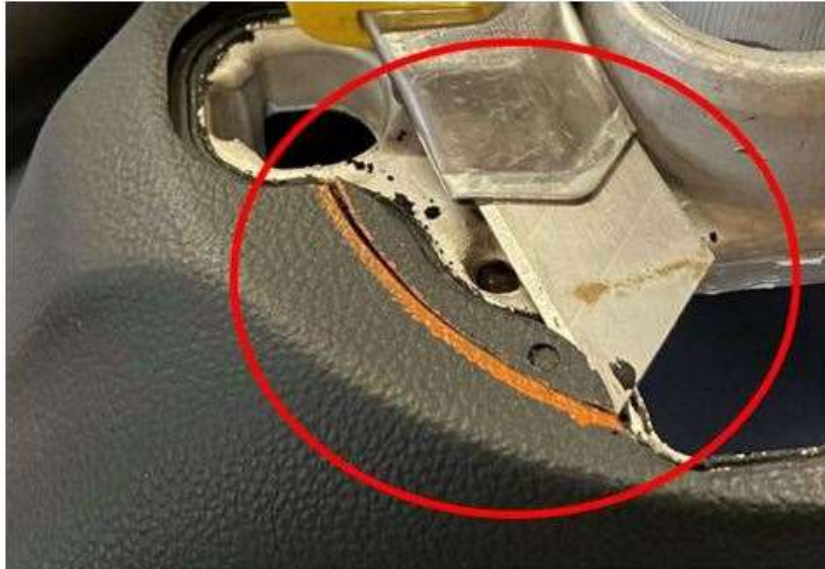
Figure 8.

8. Example: Remove the cross-section /excess foam along the marking in the foam of the steering wheel.

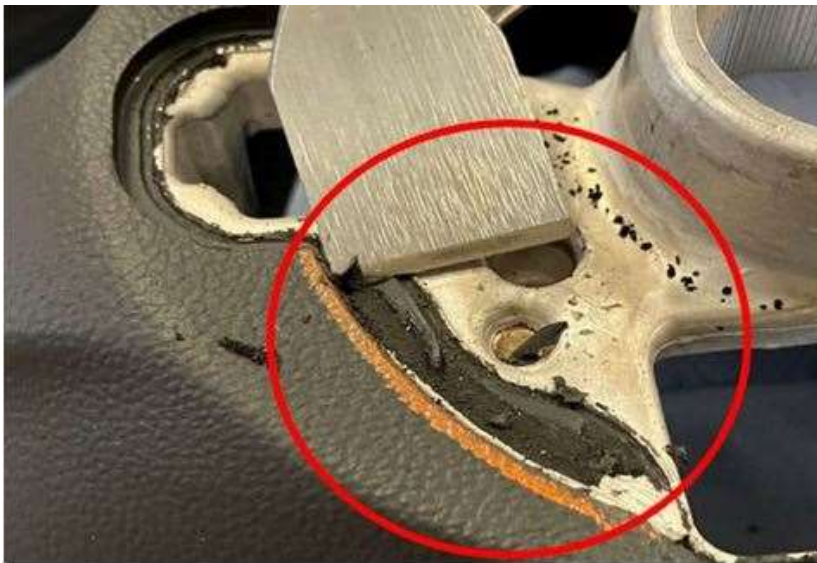
Figure 9.

9. Example: Removing the excess foam of the steering wheel.

Using a cutting knife and scrapper (Figure 9, red ellipse) carefully remove the access foam until the aluminum is clearly visible for the steering wheel body.

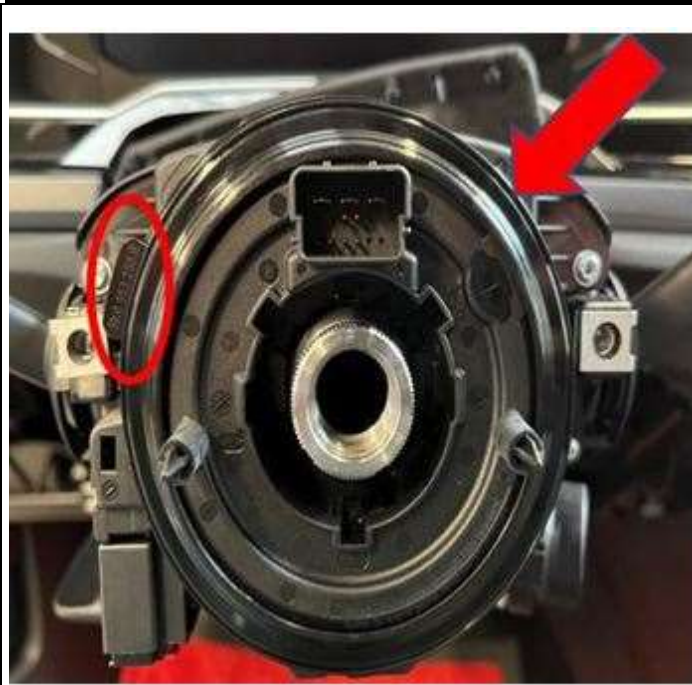
Figure 12.

12. Place the steering wheel on the steering column (pay attention to the previously applied marking).

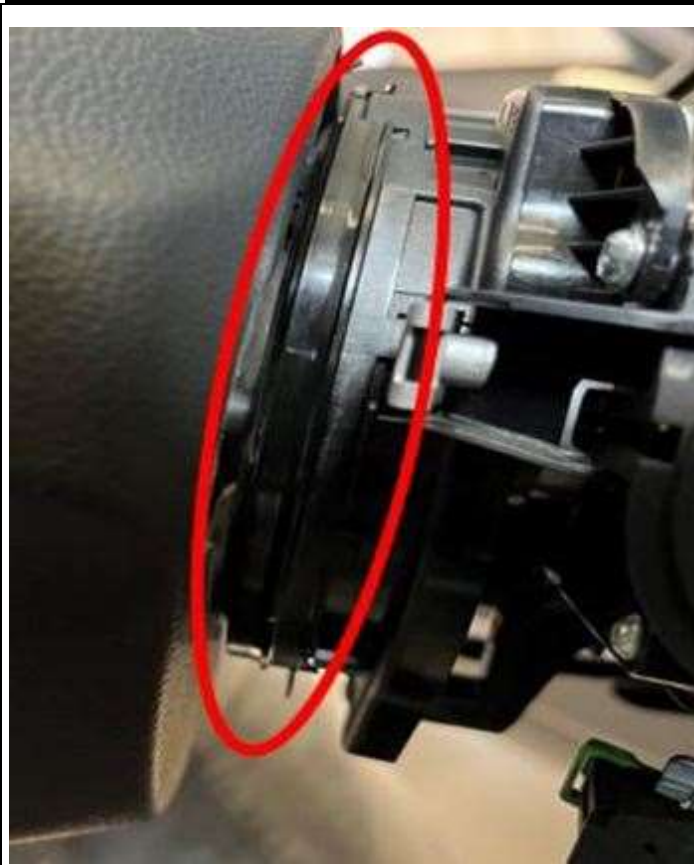
Figure 13.

Before finally tightening the steering wheel, check whether there is sufficient space and play (see Figure 13, red ellipse) and that no grinding or contact noises are audible.

Install the steering wheel/airbag, See repair group 48 in Elsa.
