Service Bulletin

Bulletin No.: 23-NA-127

Subject: Second Row Seat Loose and/or Clicking

Brand:	Model:	Model Year:		VIN:		Engine:	Transmission:
		from	to	from	to		
Cadillac	Escalade Models	2021	2023				
Chevrolet	Suburban Tahoe Models						
GMC	Yukon Models

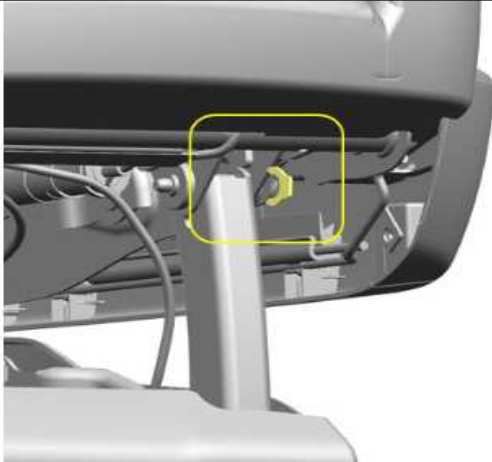
6388127

1. Verify 2nd row seat frame at front pivot shows looseness.
2. Insert a 2 mm shim between the outside surface of the effected front leg / the inside surface of the U-bracket like illustrated above.
