Service Bulletin

Bulletin No.: 23-NA-205

Subject: Audio Boom or Drone Noise Caused by Active Noise Cancellation with RPO UQS

| Brand: | Model: | Model Year: | | VIN: | | Engine: | Transmission: |
|---|---|---|---|---|---|---|---|
| Chevrolet | Corvette Stingray | 2024 | 2024 | — | — | 6.2L (LT2) | — |

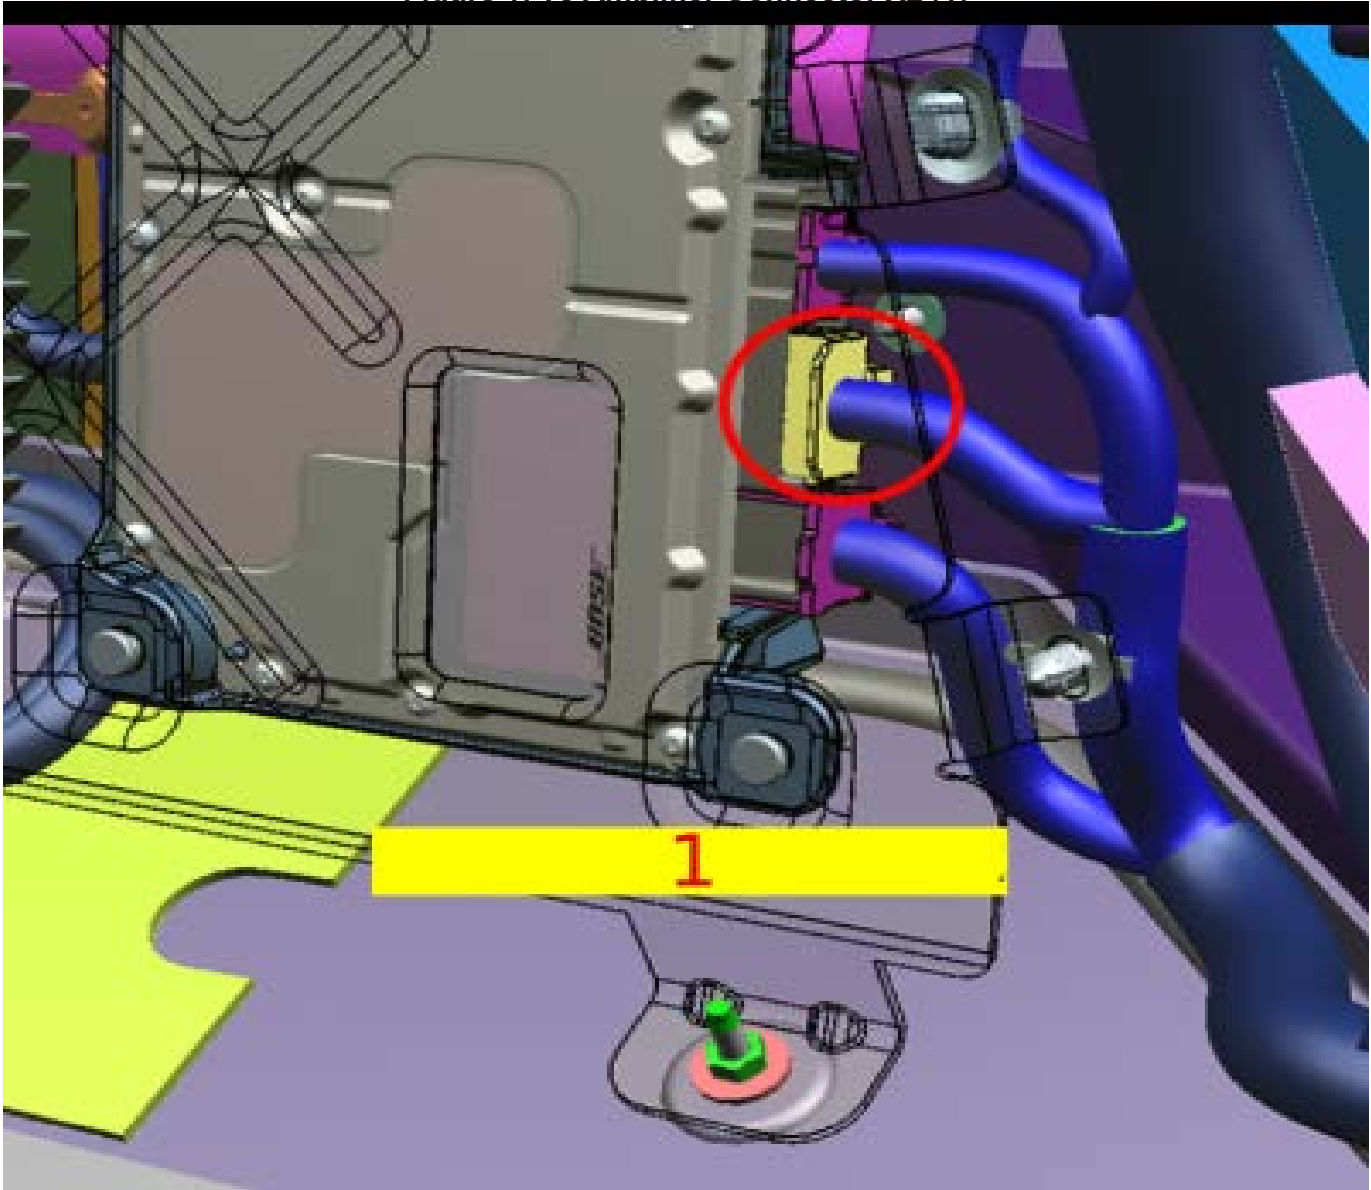
Figure 1: T3 Amplifier Connector X2 (1)

| Cause | The cause of the condition may be that the wiring harness may have a different polarity than the amplifier for the right front midrange speaker. |

1. Follow SI for *Vehicle Performance Data Recorder Bracket Replacement* (Doc ID 5388184) to remove the bracket covering the T3 radio speaker amplifier in the passenger footwell.
2. Remove connector X2; location shown in Figure 1.

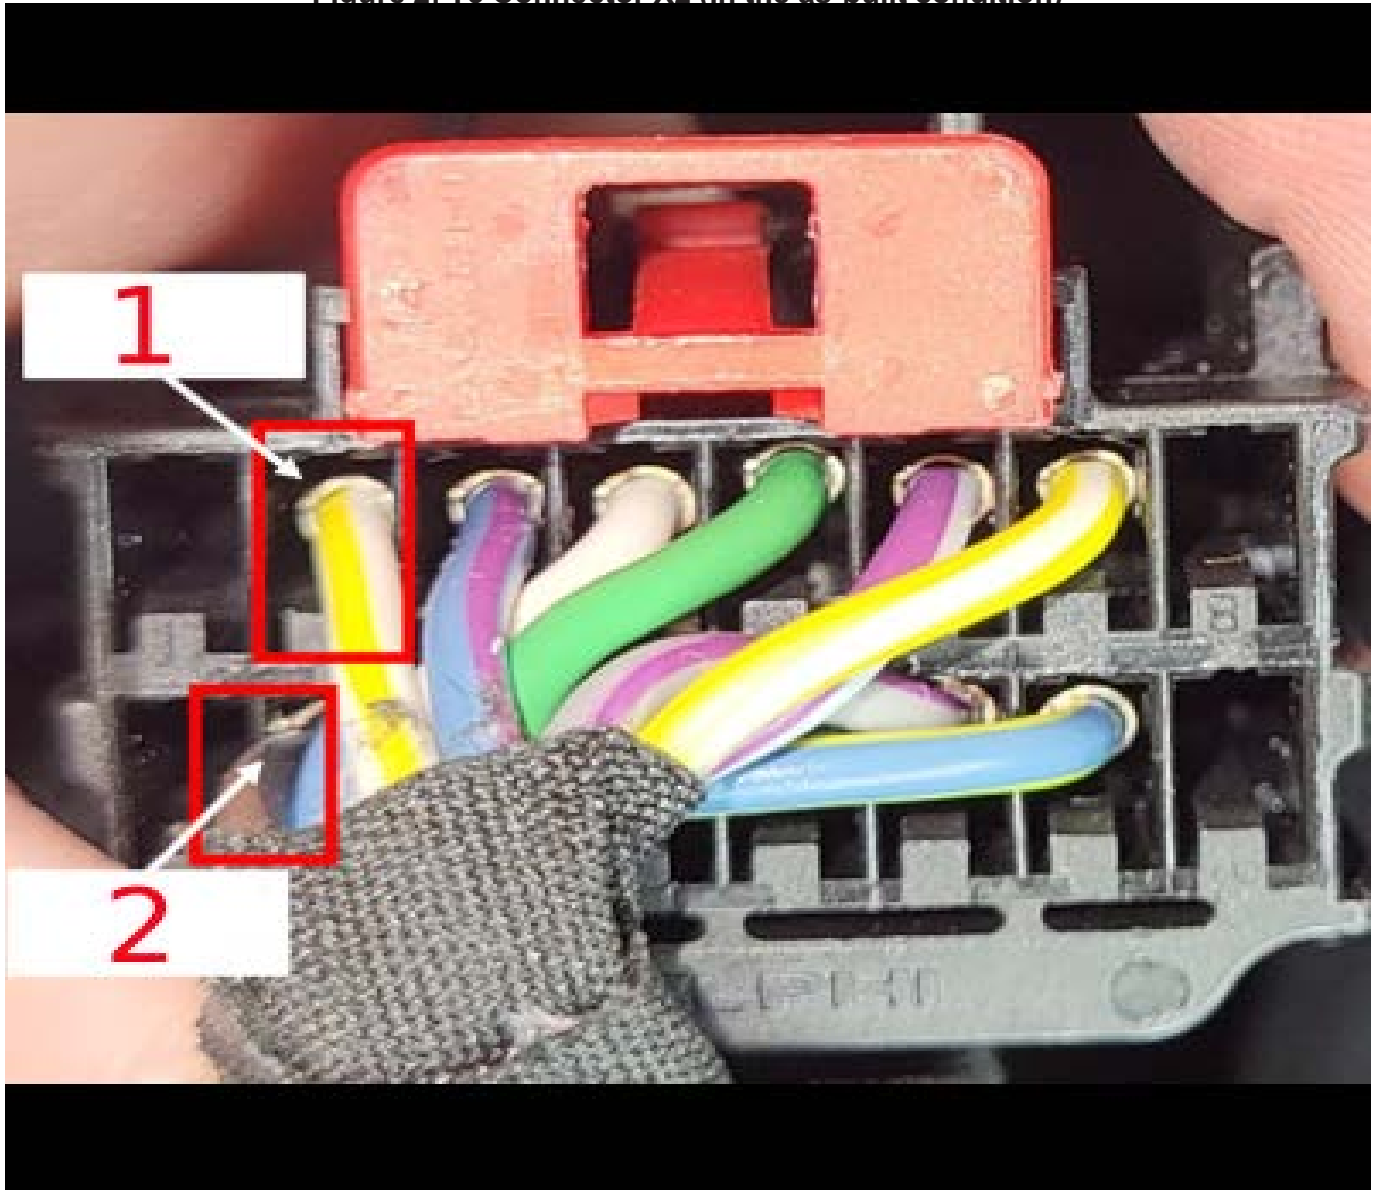
Figure 2: T3 Connector X2 (in the as-built condition)

3. Locate terminals two (1) and ten (2) in the X2 connector, as shown in Figure 2.

4. Use terminal removal tool J-38125-215A to swap terminals 2 and 10 such that the brown with black stripe wire will be in the upper cavity 2, and the white with yellow stripe wire will be in the lower cavity 10. Use SI Doc ID 6422077 if needed for connector reference information.
