SIB 61 32 23

DELIVERY STOP: ENGINE COMPARTMENT SOUNDPROOFING

E-Series	Model Description	Production Date
G70	i7 Sedan Battery Electric Vehicle	July 4, 2022 – April 24, 2023

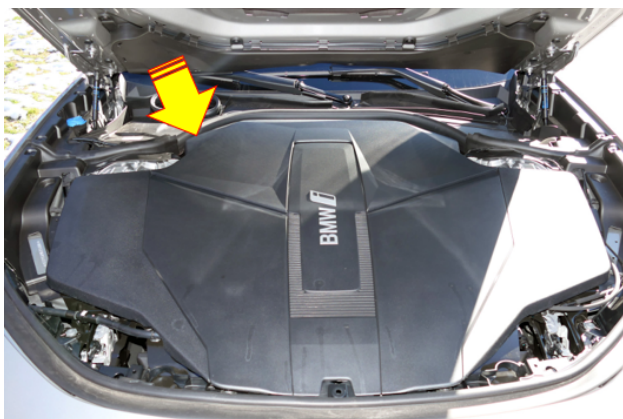
A small flap of sound insulation material may come into contact with some of the 12 V B+ cables at the remote B+ charging point terminal (general location at arrow) along the engine compartment's passenger side inner fenderwell.

If the sound insulation becomes damp and is in contact with the mounting point of the possible cable terminal or the positive battery cable, in very rare cases corrosion may occur over time.

Remove the engine compartment sound insulation on the passenger side; and, if necessary, rework the connections of the positive battery cables at the terminal.

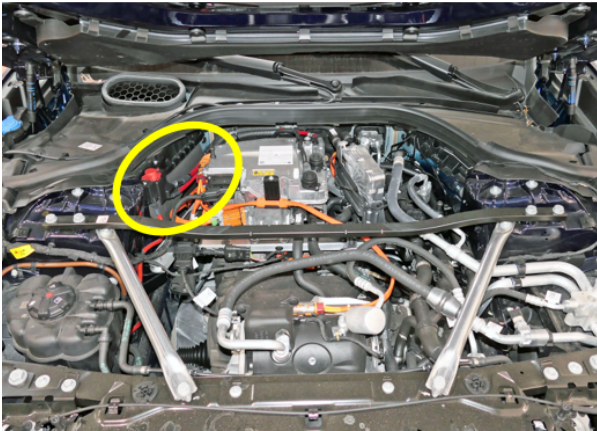
The inspection/rework area is circled.

Remove the acoustic cover from the engine.

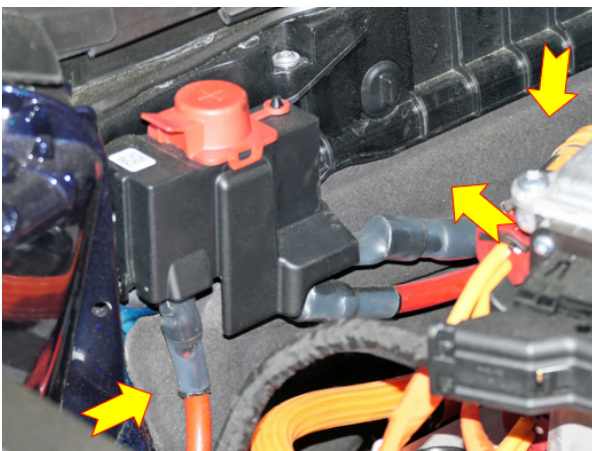
The arrows indicate the sound insulation to be removed.

Remove the B+ 12 V junction point cover.

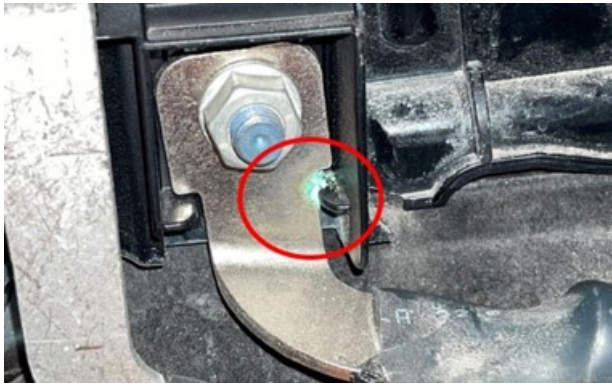
Inspect the exposed cables for any corrosion.

If there is no corrosion, reinstall the junction point cover and the engine acoustic cover to finish the repair.

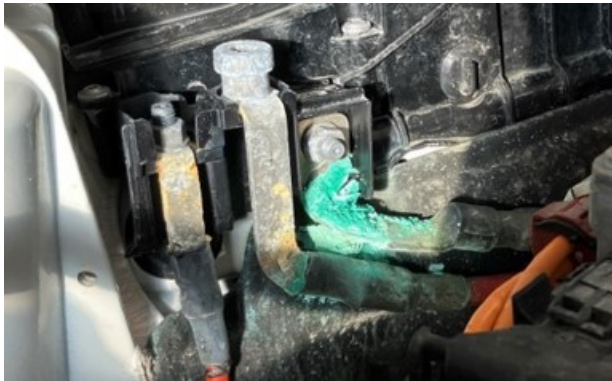
If there is corrosion, proceed to the next step.

- Disconnect the 12 V battery per repair instructions 61 20 900 “Disconnecting and connecting battery ground lead.”
- Disconnect the corroded cable(s) and use a brass-bristle wire brush to remove the corrosion. Do not use a metal-bristle brush, which can remove the cable terminals’ protective plating. Brass bristles are softer and do not abrade the plating.
- Apply electrical contact grease KF1 to the exposed cable terminals.
- Reconnect the cable(s) and nut(s). Refer to 6114 “Overview of tightening torques” for the correct tightening torque.
- Reconnect the 12 V battery per repair instructions 61 20 900 “Disconnecting and connecting battery ground lead.”
