HYUNDAI Technical Service Bulletin	GROUP CAMPAIGN	NUMBER 23-01-089H
	DATE NOVEMBER 2023	MODEL(S) SONATA (YFA)
SUBJECT: REAR COMBINATION LAMP INSPECTION & REPLACEMENT (WARRANTY EXTENSION TXXT)

Description: Some 2011-14MY Sonata (YF) vehicles may exhibit inoperative brake lights that may be caused by melting/deformation of the rear combination housing lamps.

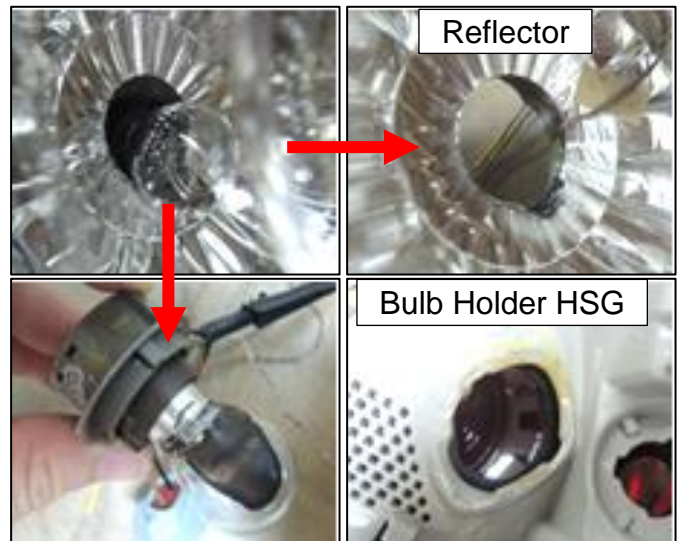
3. Remove the stop lamp socket from the LH and RH housing and inspect for any signs of heat deformation.

Heat deformation around the bulb housing opening may vary. The discoloration of the bulb socket alone does not necessarily indicate this condition.

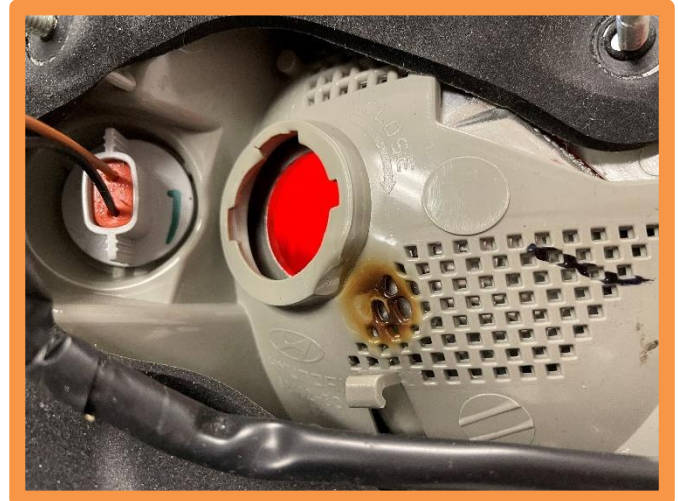
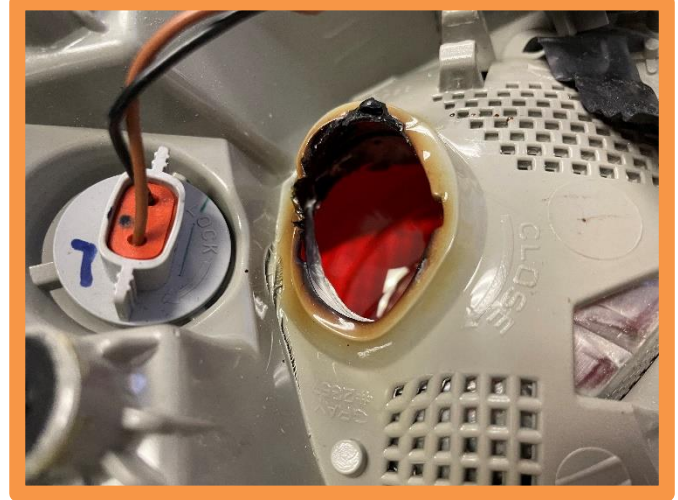
Examples of heat deformation shown in photos on the right.

6. **If heat deformation is present on either lamp**, replace both the LH and RH combination lamps.
