# Service Bulletin

Bulletin No.: PIT5182

**Subject:** Radio Button Backlighting Inoperative (Inspect X212 Connector)

**Models:** 2007 - 2013 Chevrolet Avalanche, Silverado, Suburban, Tahoe  
2007 - 2013 GMC Sierra, Yukon, Yukon XL  
Without Y91 or STZ

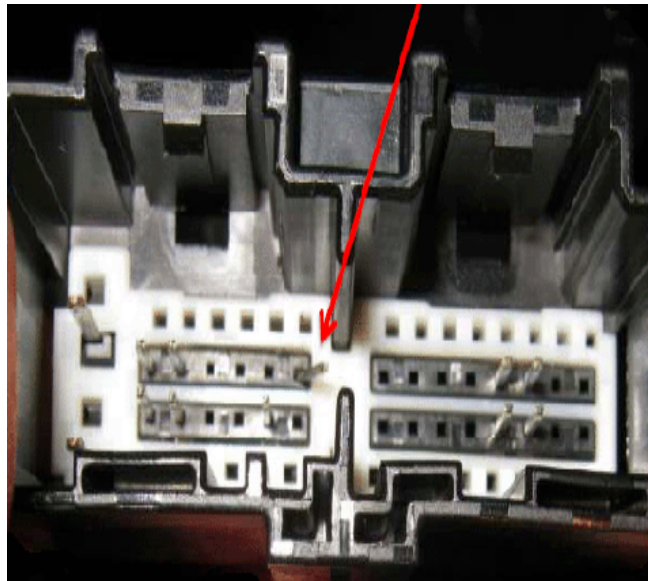
2910867

Some owners may comment that the backlighting for the radio buttons is inoperative. The radio display will work properly and dim up and down with the panel dimmer switch. This could be caused by an open/high resistance in the LED Dimming circuit 6817 to the radio.

If after performing normal diagnostics and the concern is not found, inspect for a bent or backed out terminal at connector X212 pin B7 (see picture below). Repair as necessary.
