Preliminary Information

PIT5823A Possible Crank No Start or Extended Crank with DTC P12A6

Brand:	Model:	Model Years:	VIN:		Engine:	Transmissions:
			from	to		
Chevrolet	Equinox	2018 - 2022	All	All	All	All
GMC	Terrain	2018 - 2022	All	All	All	All

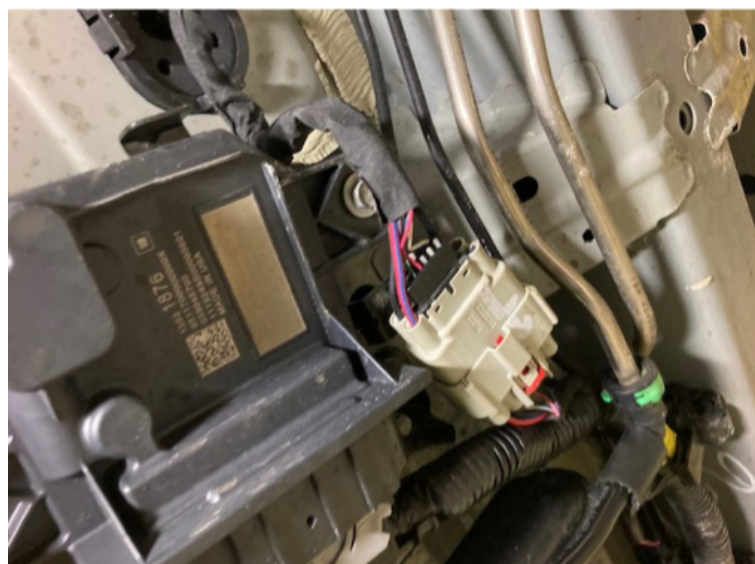
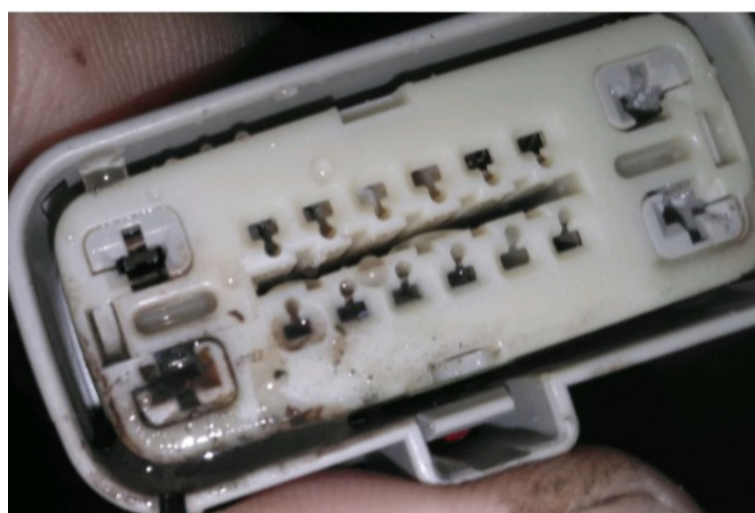
Example of corrosion which can cause a poor connection resulting in no-start. The water intrusion can also short terminals together, which can keep the fuel pump running after key off, draining the battery.

Inspect the right tail lamp for signs of a water leak. If there is standing water, or the tail lamp is cracked and there are signs of water in the bulb socket(s), replace the tail lamp and blow out the water from the socket(s) with compressed air, then check ground G304 for signs of water on the ground wire strands, and dry then blow off the water with compressed air. Inspect connector X350 for signs of damage, missing cavity plugs, signs of water intrusion or corrosion. If there are issues, make repairs by replacing the connector with terminated leads on the body harness side, or by replacing the fuel tank harness, or both repairs if both sides show water intrusion, corrosion and/or damage.

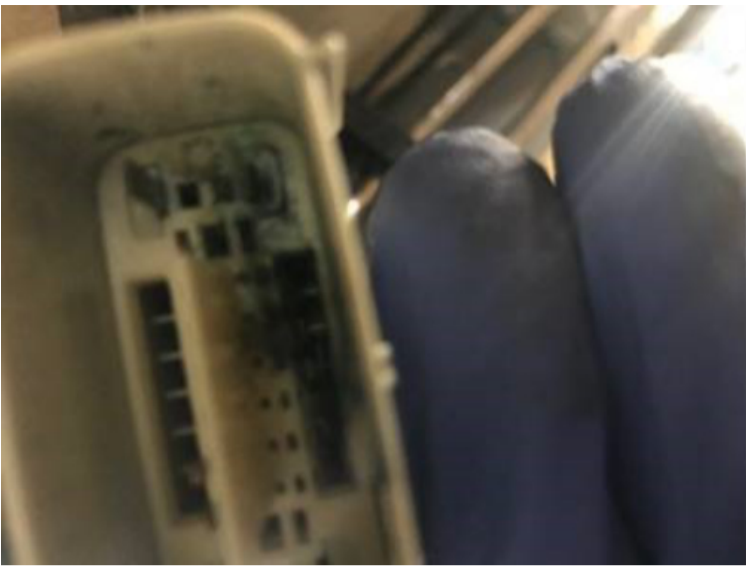
Example of damaged connector at plugged cavity, which may displace the cavity plug, allowing water to enter.

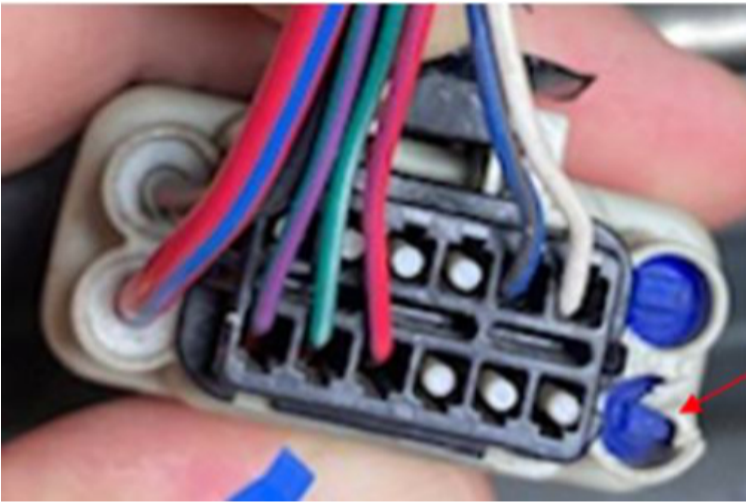
Example of missing cavity plug
