Preliminary Information

PIC6378C Diagnosing Various Concerns On A Power Folding Top Models

Brand:	Model:	Model Years:	VIN:		Engine:	Transmissions:
			from	to		
Buick	Cascada	2016 - 2019	All	All	All	All
Cadillac	XLR	2004 - 2009	All	All	All	All
Chevrolet	Camaro	2016 - 2024	All	All	All	All
Chevrolet	Corvette	2005 - 2024	All	All	All	All
Pontiac	G6	2006 - 2010	All	All	All	All

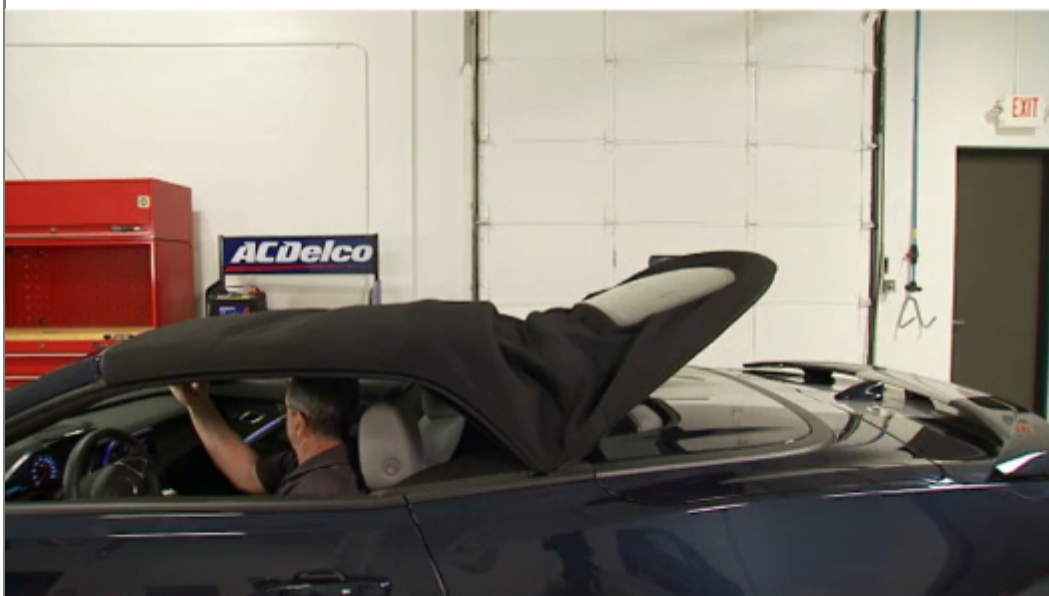
Example Case: Let's take a 2018 Chevrolet Camaro for instance, with a basic folding top concern. The customer states that the top will open fine, but it will not close all the way. A preliminary check will indicate that there is a "Top Not Secure" message in the DIC, but no DTCs are set. The tech is able to duplicate the concern each and every time. When closing, the top will lift up out of the stowage compartment, latch tightly to the windshield header, and the tension bow will lift up to a 45° angle. The Rear Stowage Compartment Lid will lower and lock into position, but the tension bow will not lower. It simply remains suspended in the air as seen in the photo below. The folding top pump quits working and the top stops moving at that point.

On a correctly working car, the stowage compartment lid must close completely before the tension bow is commanded down. Because the steps or phases must be completed in order, the technician
