MAS003715\_A RU 23-64

# Rapid Update 585 MC20 – Rear axle shaft replacement

**DATE:** NOVEMBER 14 2023

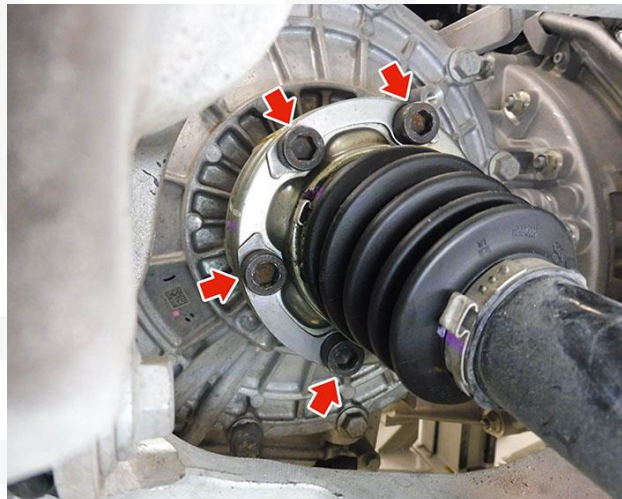
**NOTE:** Please visually inspect the inner shaft boot at the differential joint and its caps for any presence of grease and or torn boot. Be sure to clean all cap holes and surfaces from any residual grease.

**NOTE:** during the disassembly procedure, if **broken screws** are found or the **threads** on the gearbox flange are **damaged** open a BOL report as "Support Request" for assistance.

Remember to **always replace removed screws** with new ones per the workshop manual.

4. **Use a Torque Wrench: Follow the workshop manual instructions!** Tighten/torque ALL screws following the sequence:

Tightening torque of the axle shaft screws - 03.10.145	
<b>1. TIGHTENING TORQUE</b>	30N ·m (22.1 ft-lb)
<b>2. ANGLE</b>	90° (1.57 rads)
<b>3. CONTROL TORQUE</b>	45N ·m (33.2 ft-lb)
