WARRANTY BULLETIN

NO: D-23-04

SUBJECT: 2018 - 2023 (Current) Jeep
Wrangler (JL) and 2020 - 2023 (Current)
Jeep Gladiator (JT) - Corrosion Warranty
Claim Simplification

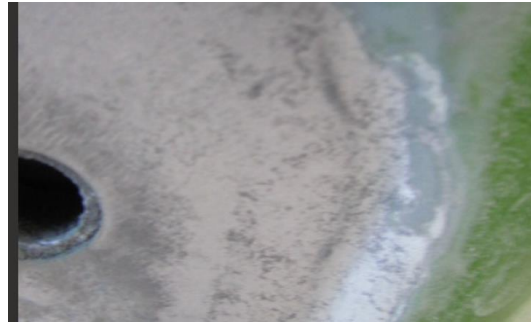
1. Pitting found after sanding the affected area (Fig. 1)

Pitting Found After Sanding Example (Fig. 1)

Note: If pitting is found during the sanding process, please use LOP 23-75-XX-XX for up to 0.5 hours in conjunction with the 23-85 replacement LOP.

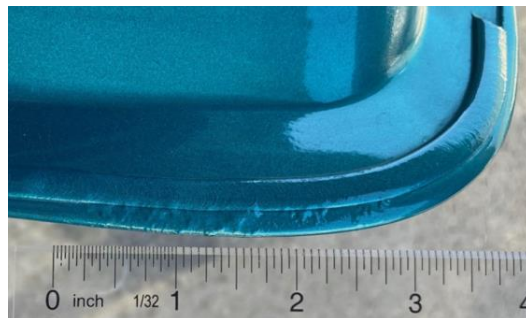
2. Corrosion found on the seam of the panel (Fig. 2)

Seam Panel Area Examples (Fig. 2)

Note: If corrosion is found on the seam of the panel, the door shell will be replaced. No additional sanding in the hinge or seam area is supported.

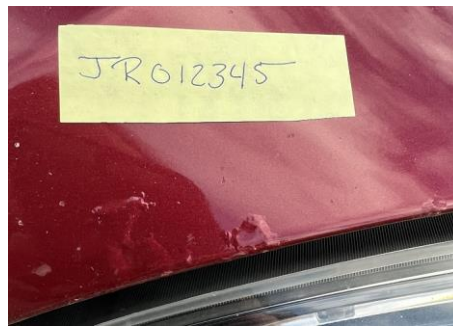
VIN Example (Fig. 3)

Dealers will need to take photos of the affected areas identified during the inspection to support the repair. A clear photo of the corrosion is needed and **MUST** include the VIN. The VIN can be included on a sticky note, written with a grease pen, a copy of the RO in the photo, masking tape, etc. (Figure 3)
