# INTERNATIONAL WARRANTY BULLETIN

**NO:** ID-23-03

**SUBJECT:** 2018 - 2023 (Current) Jeep  
Wrangler (JL) and 2020 - 2023 (Current)  
Jeep Gladiator (JT) - Corrosion Warranty  
Claim Simplification (Rev. A)

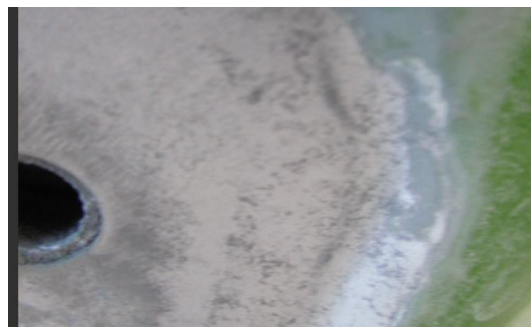
**Pitting Found After Sanding Example (Fig. 1)**

1. Pitting found after sanding the affected area (Fig. 1)

Note: If pitting is found during the sanding process, please use LOP 23-75-XX-XX for up to 0.5 hours in conjunction with the 23-85 replacement LOP.

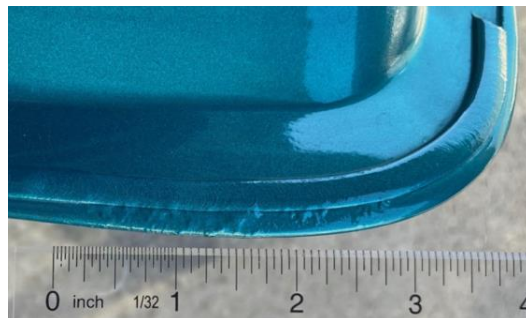
**Seam Panel Area Examples (Fig. 2)**

2. Corrosion found on the seam of the panel (Fig. 2)

Note: If corrosion is found on the seam of the panel, the door shell will be replaced. No additional sanding in the hinge or seam area is supported.
