**ID #** CBR-2320

11L Engine - Air Conditioner (A/C) Line Damaged At Bracket - Model Year 2007 to Present

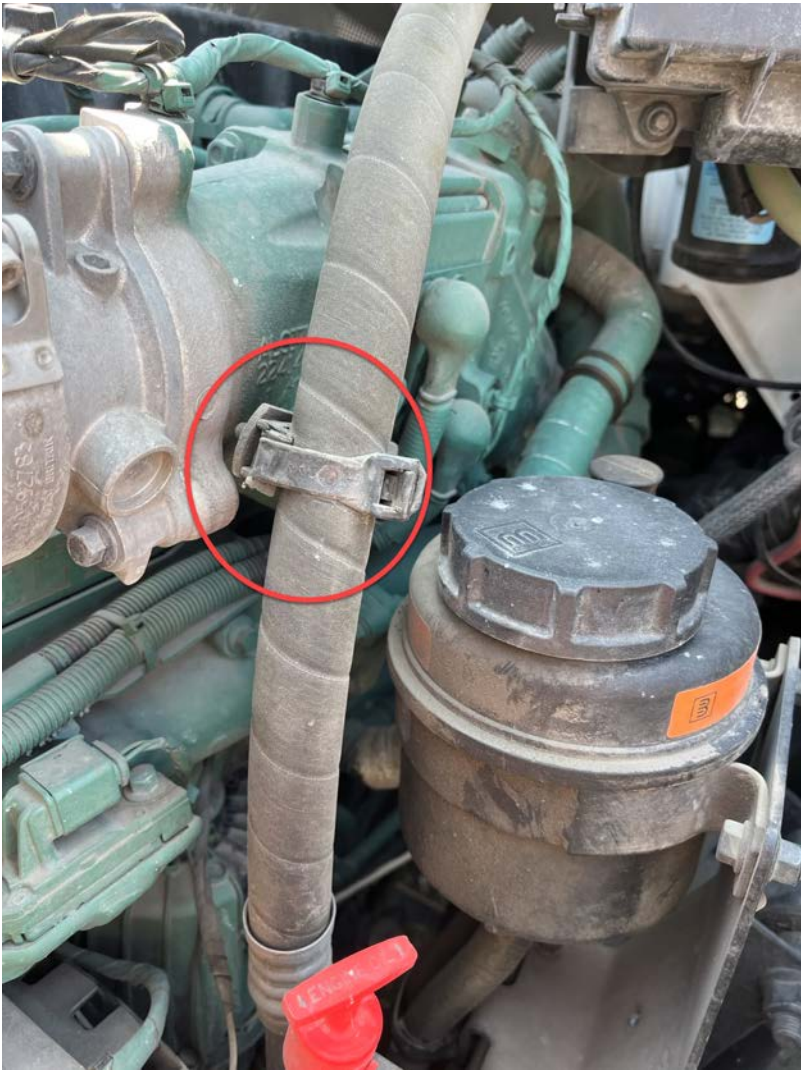
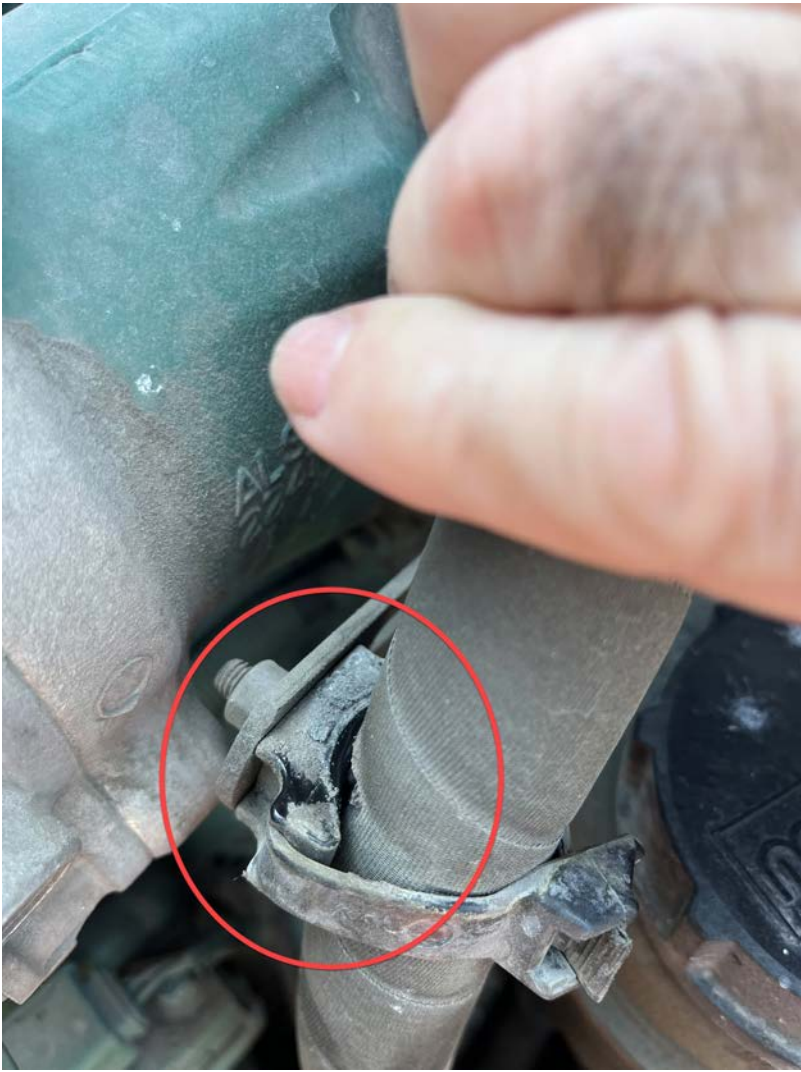
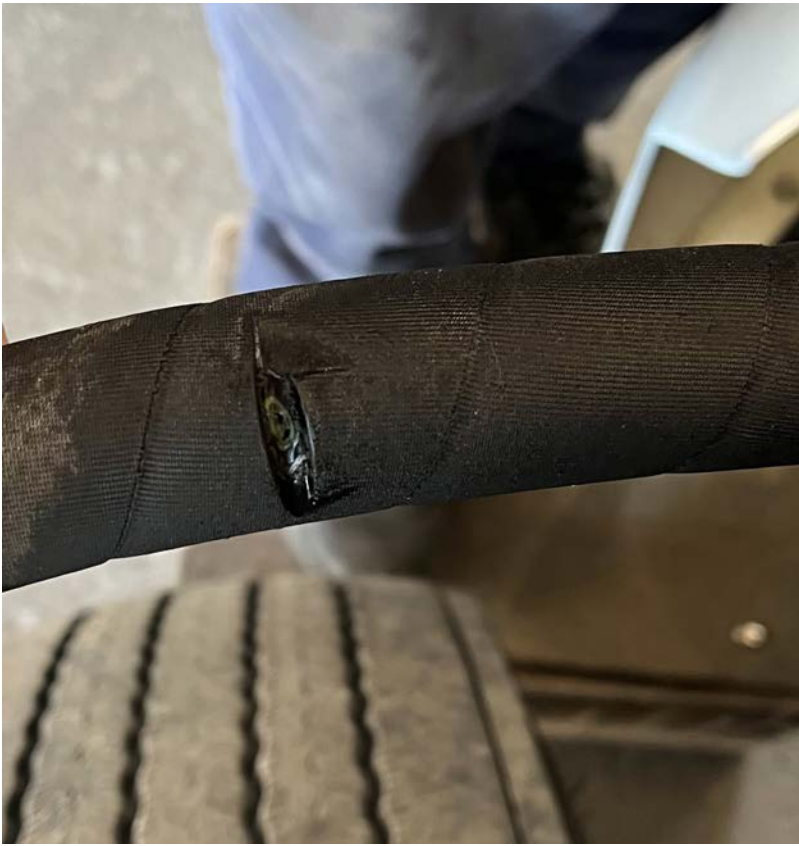
For vehicles equipped with an 11L engine, the plastic saddle bracket holding the a/c line on the left side of the engine may move excessively and rub the area where it secures the line. This may result in damage to the line as shown in the images below.

1. Replace the damaged hose.
2. Remove the hard plastic saddle and tie.
3. Replace the hard plastic saddle and tie with a 32mm ID P-Clamp P/N 952640. Use the pre-existing hardware from the plastic saddle to install the P-clamp.
