SIB 52 20 23

RATTLE NOISE FROM SECOND SEAT ROW ARMREST

2023-12-29

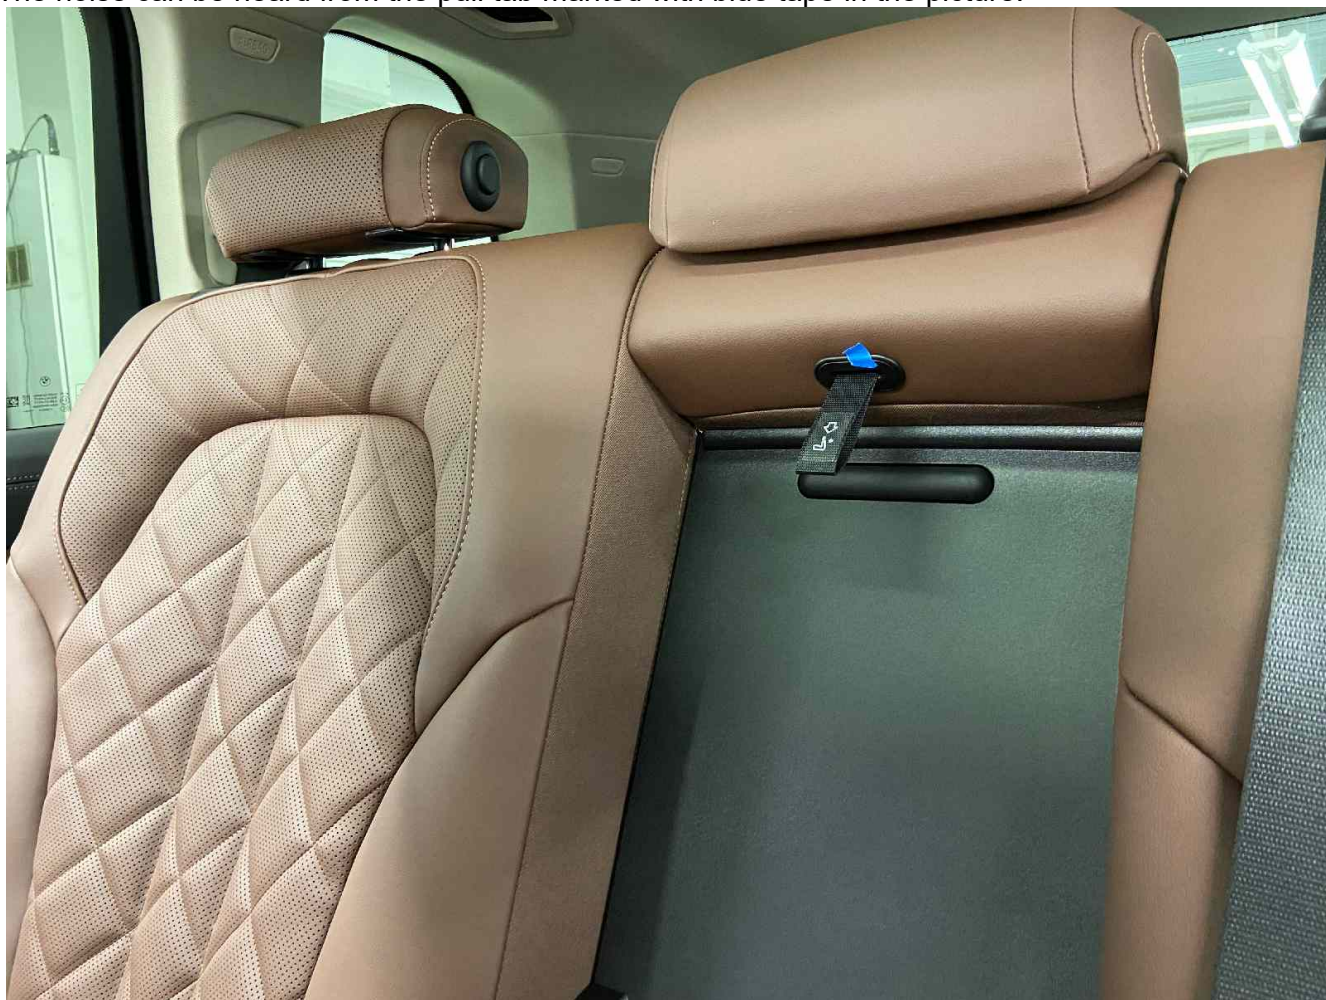
When the center armrest of the second seat row is lowered but the center section of the seat is in its upright position, a rattle noise may be heard when the vehicle goes over a cobblestone/rough road.

The noise can be heard from the pull tab marked with blue tape in the picture.

An application of felt tape applied to the latch housing will stop the noise.

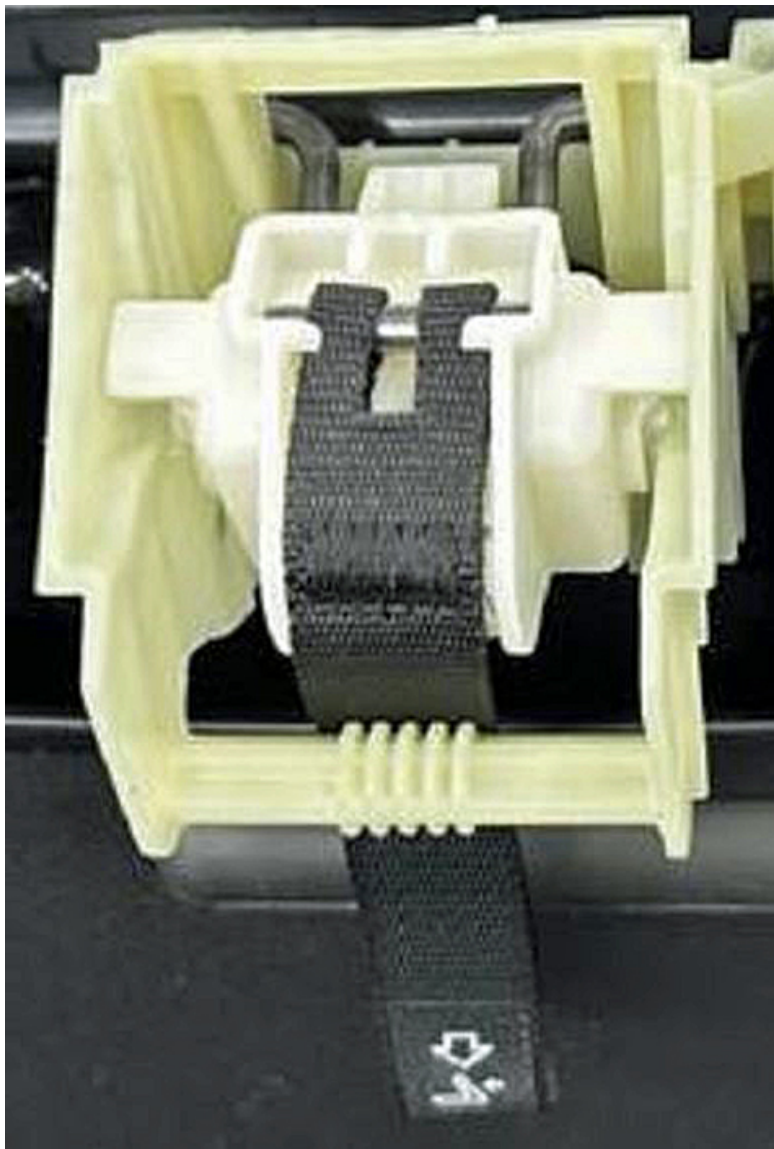
The metal pin that retains the pull tab may move within the plastic housing if manufacturing tolerances are too great.
