Technical product information

Bentayga Series

New Continental GT/C and New Flying Spur

Driver / Passenger door(s) creak on close - All models (front and/or rear)

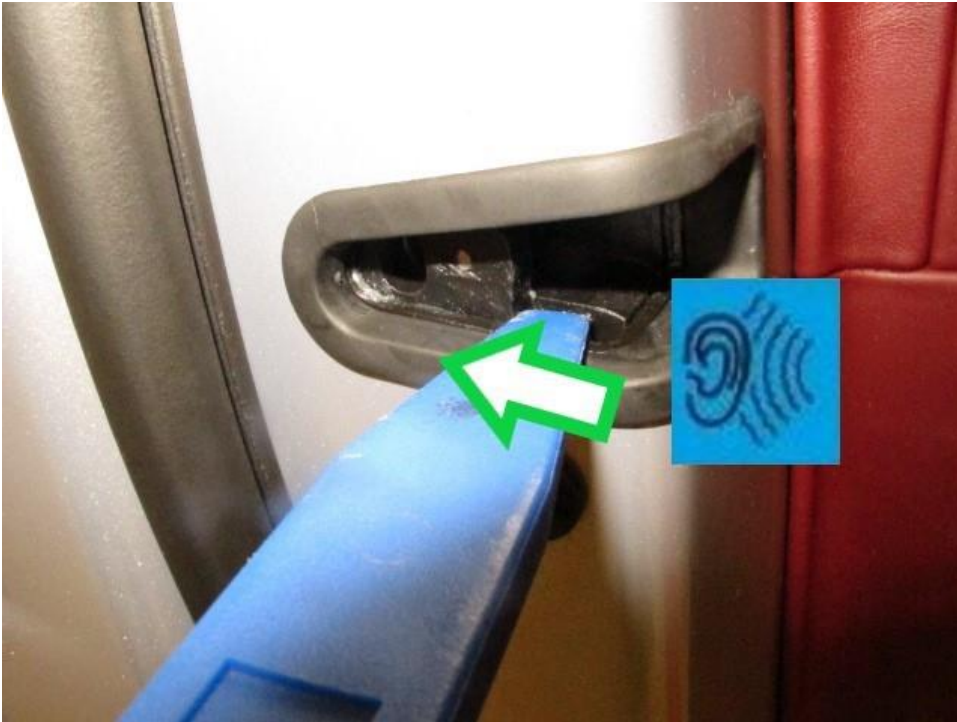
2) Referring to Figure 1 - With the door open - Use a suitable non metallic tool - Close the latch

Hint: Whilst closing the latch the operative must listen for the creaking noise

With the door open - Does the latch creak during the latch close operation?

YES - Record a clear video of the noise with the door open when closing the latch using a non metallic tool - Go to Step 3

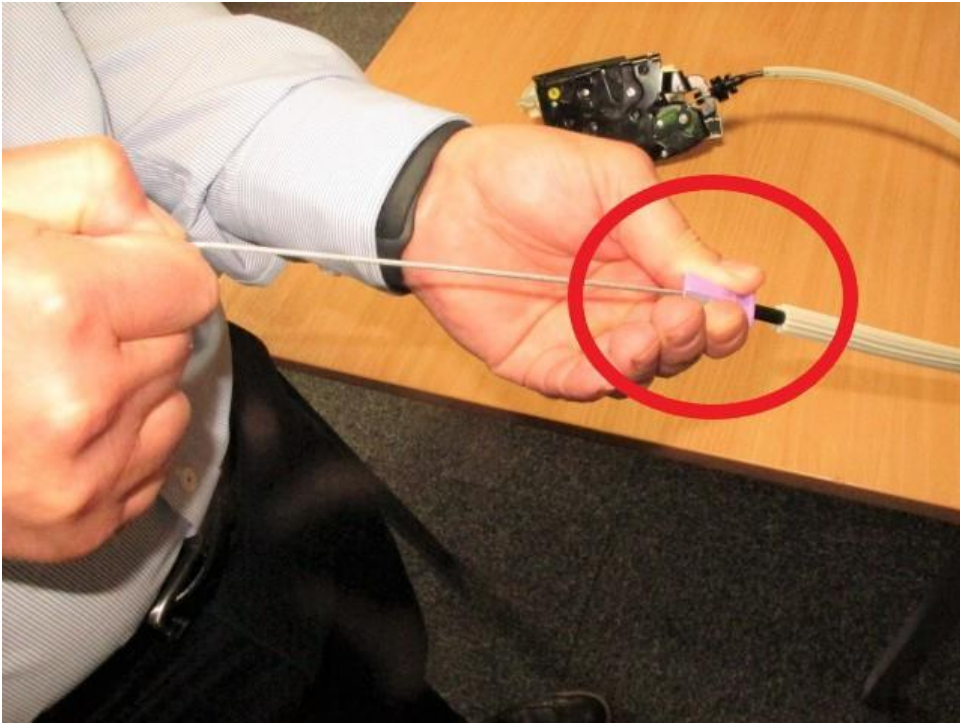
4) Referring to Figure 2 (Circle) - Hold the cable at the location shown (end fitting)

IMPORTANT: Do not hold the cable at any other point than the end fitting

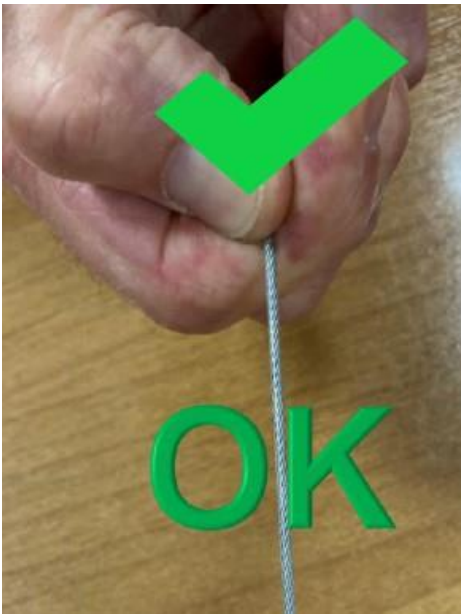
5) Referring to Figure 3 – Grip / hold the cable end as shown

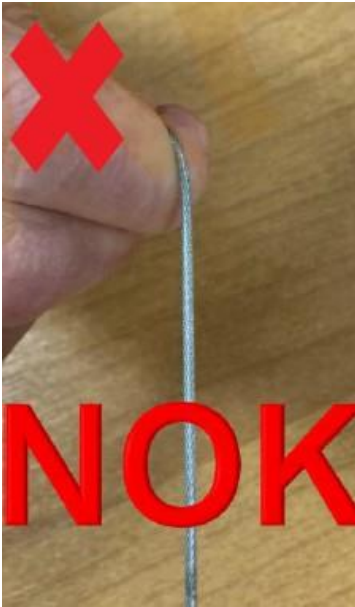
⚠ CAUTION
Do not grip / hold the cable as shown in Figure 4 as the cable can be easily damaged/bent (this is imperative when fitting the new replacement cable)

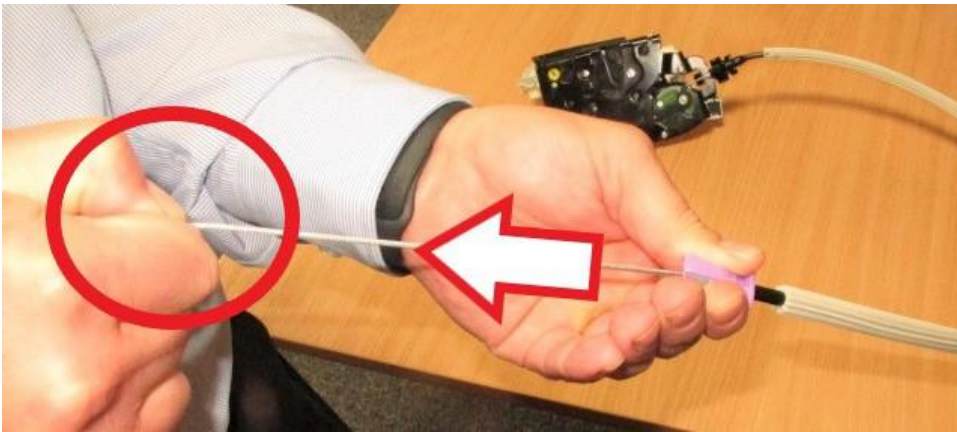
Figure 5

6) Pull the cable outwards (Figure 5) until the spool reaches the end stop (Figure 6)

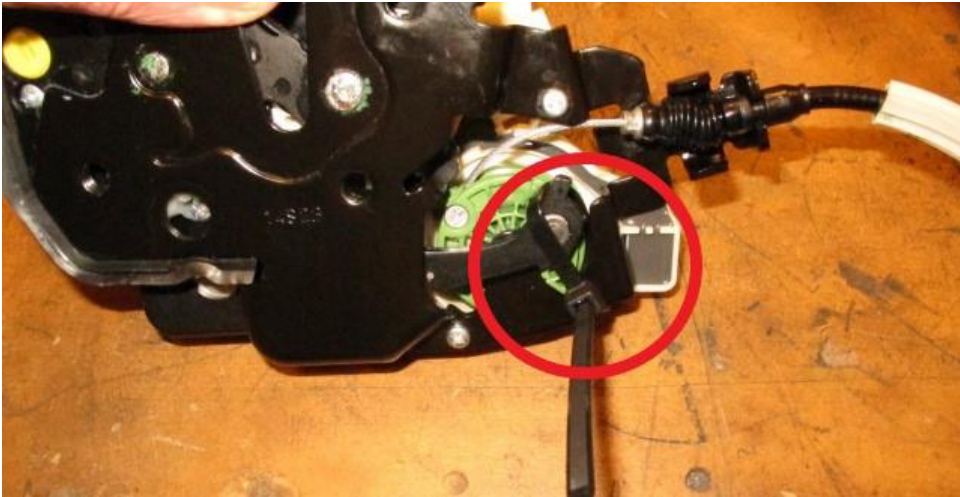
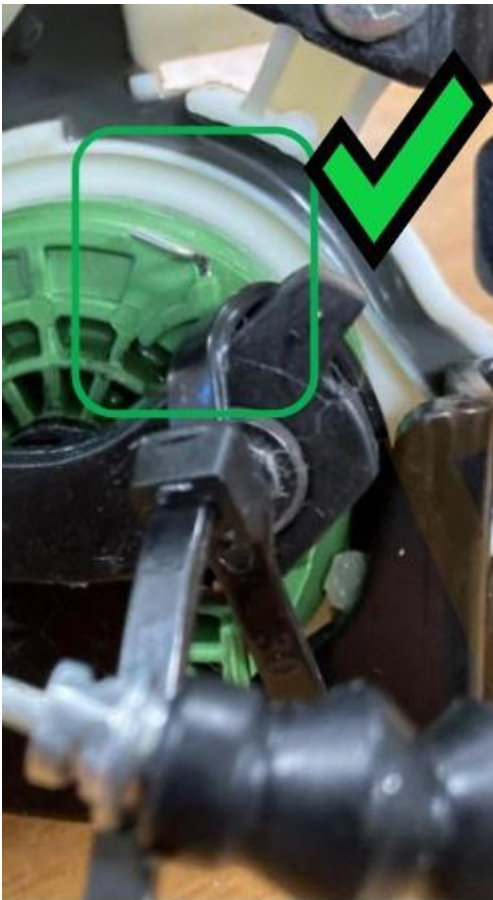
7) Once the spool reaches the end stop, a second operative is required to lock the spool in position using a cable tie (4.8mm x 200mm) at the location shown in Figures 7 and 8

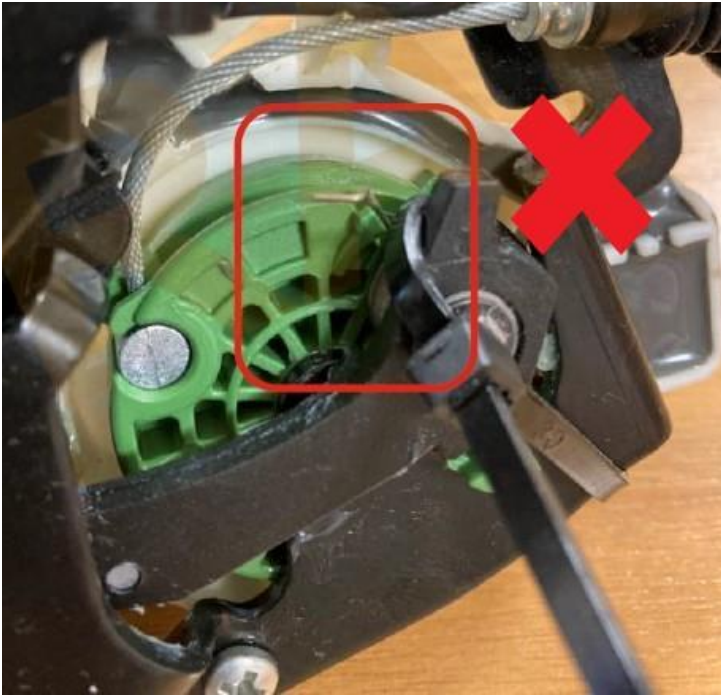
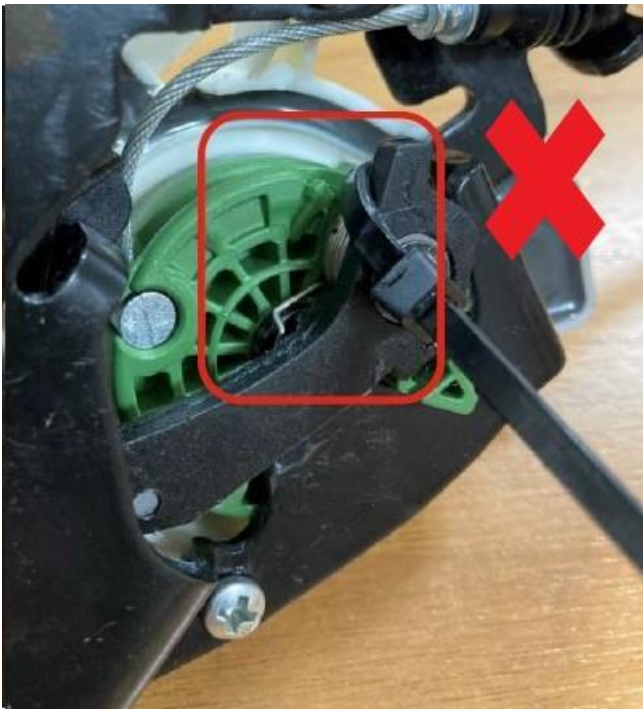
⚠ CAUTION
Take care when fitting the cable tie as the spool tensioning spring can be partially dislodged (Figure 9) or completely dislodged (Figure 10) in this scenario the spring should be relocated back to its original home position (refer back to Figure 8)

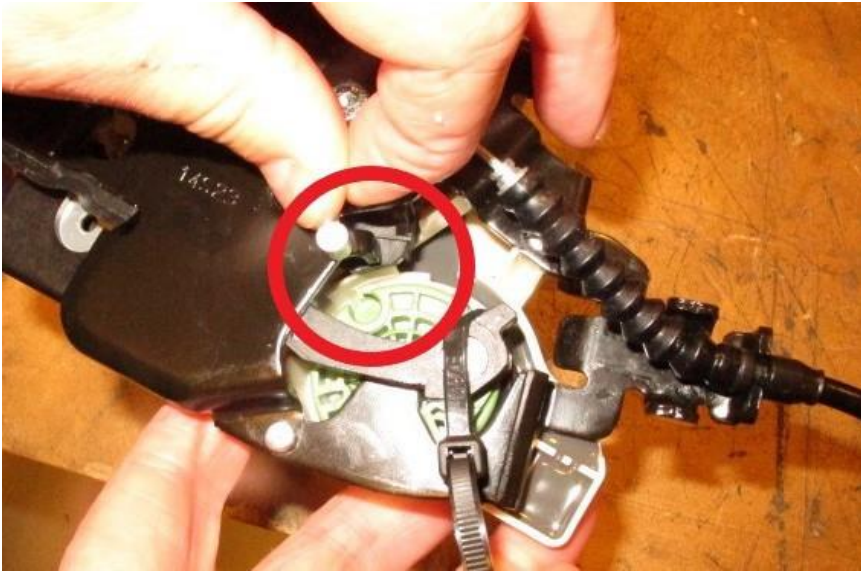
Figure 11

8) With care manoeuvre the cable barrel end out and away from the spool (Figure 11)

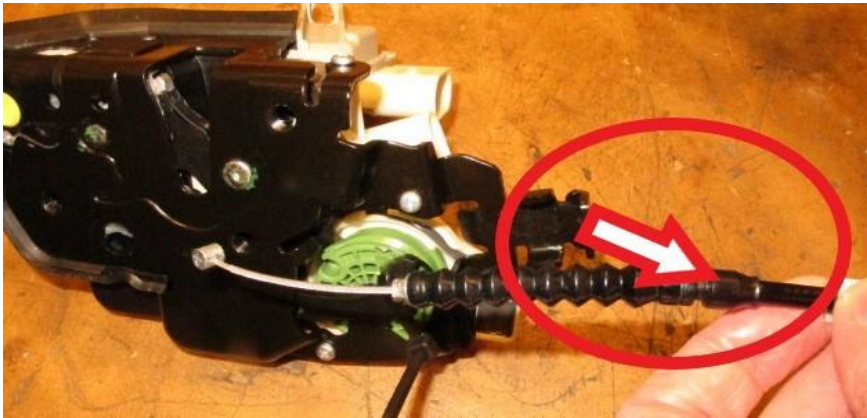
Figure 12

9) With care manoeuvre the outer cable housing out and away from the bracket (Figure 12)

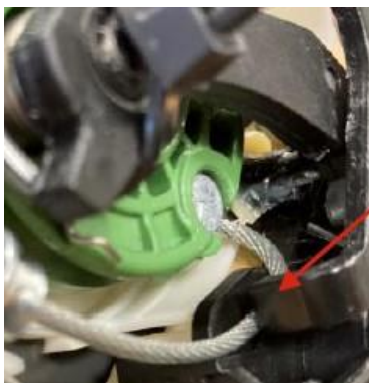
Figure 13

⚠ CAUTION
The cable can be easily bent / damaged during fitment into the spool, the cable could also be easily trapped under the bracket – Figures 13 shows an example of the cable trapped/damaged during fitment

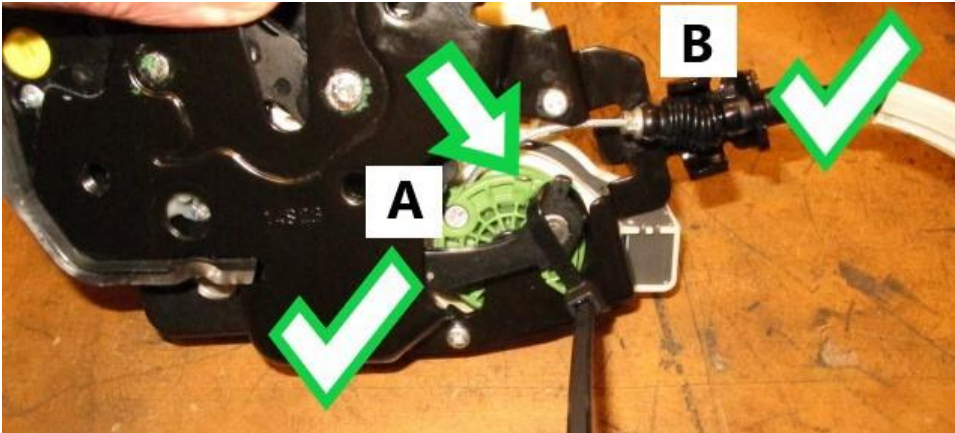
11) Referring to Figure 14 - Fit / locate the cable barrel end into the spool (A) ensuring the barrel end is fully located into the spool

- Guide the cable into the spool ensuring the cable is seated within the spool
- Push / fit the outer cable housing into the bracket (B)

- Confirm the tensioning spring is located correctly as shown (**ARROW**)

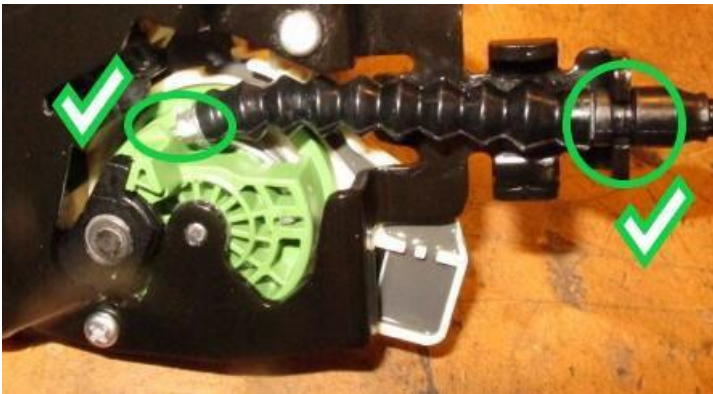
On completion the assembly should be as shown in Figure 15

- Check the cable has wound successfully onto the spool
- Check the boot and cable boss is not damaged / split or cut

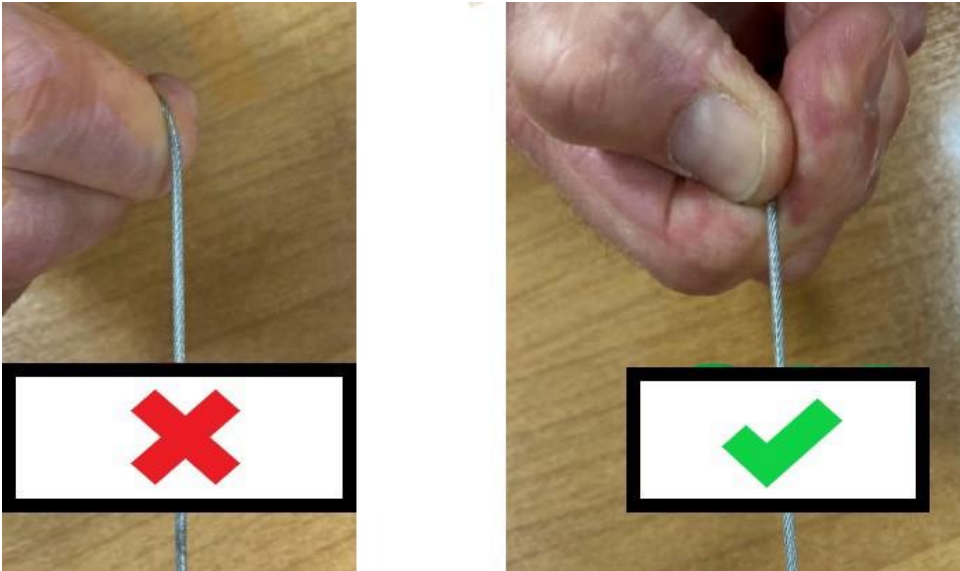
During the next part of the procedure the operative must operate (open / close the latch spool) - Do not bend the cable when conducting the operations, Figure 16 details the correct way to hold the cable without causing any damage to the cable

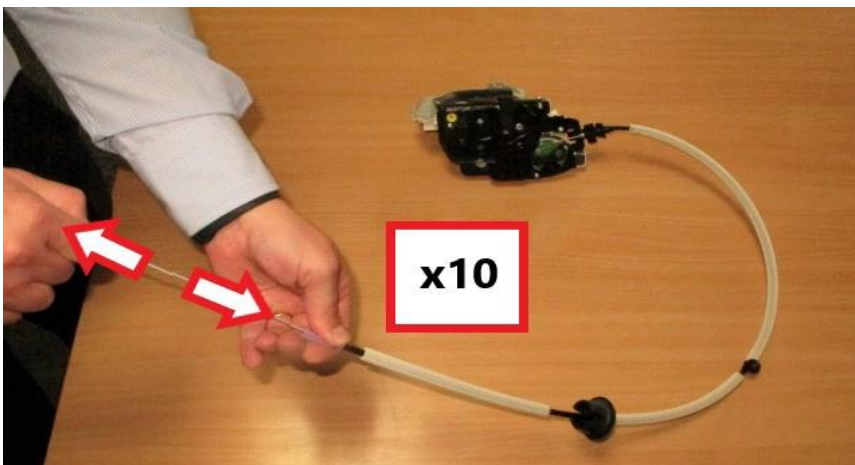
Figure 16

13) Referring to Figure 17 - Open and close the latch spool (x10) times whilst monitoring the operation of the spool / cable

⚠ CAUTION	
The operative must hold the cable exactly as shown ensuring the end fitting is held as shown in Figure 5

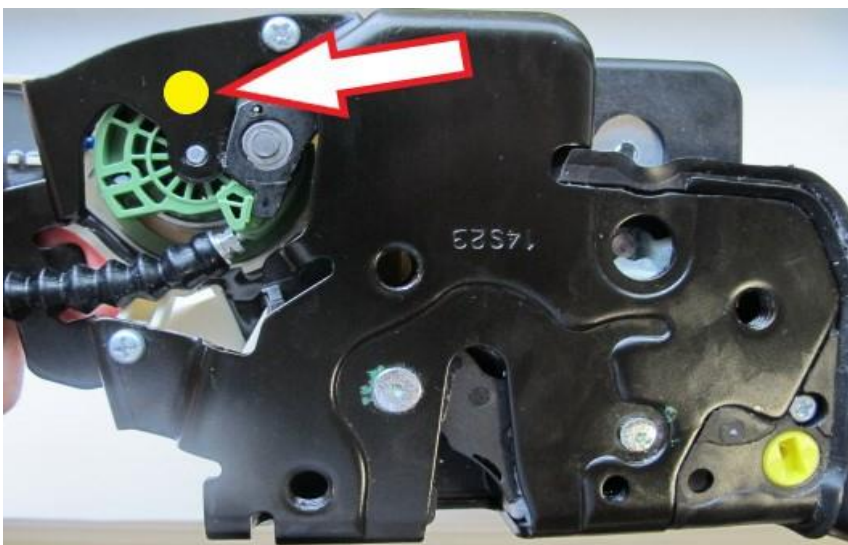
14) Should the spool/cable be operating to specification apply a yellow paint mark at the location shown in Figure 17 before refitting Note: The yellow paint mark confirms the cable has been replaced
