VTS Remote Services Fail due to False 3G

Vehicles Affected

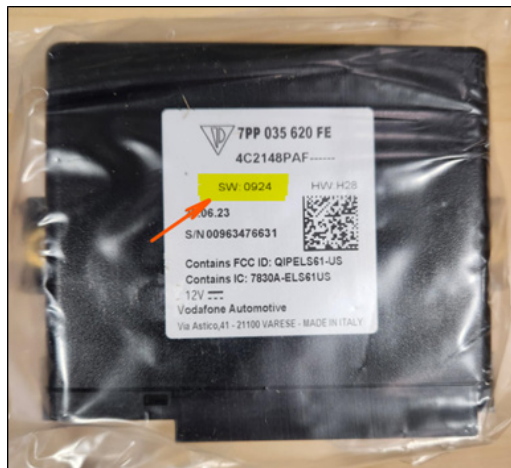
Figure 1

The workshop must replace the PCC/PVTS control unit to fix this condition. The desired part number is 958.035.620.J. The ECU label should show software version 0924. (See figure 1. This is a 'good' part.)

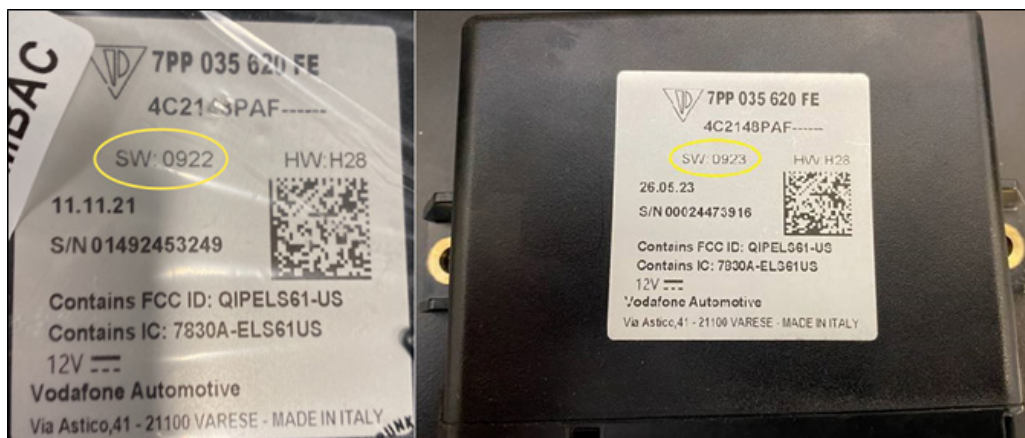
Figure 2

If you receive this part with a software version lower than 0924, please submit a Parts Claims and Returns PRMS ticket to your Area Parts Support Specialist for further instructions. (See figure 2 for 'bad' part examples.)
