9YA, 95B, 971 - Broken Valve Springs

Vehicles Affected

Models	Model Year	Model Type	VIN Range	Vehicle-Specific Equipment
Cayenne	As of 2021 up to 2022	All models (9YA)	N/A	N/A
Macan	As of 2021 up to 2022	S, GTS, Turbo (95B)	N/A	N/A
Panamera	As of 2021 up to 2022	All models (971)	N/A	N/A

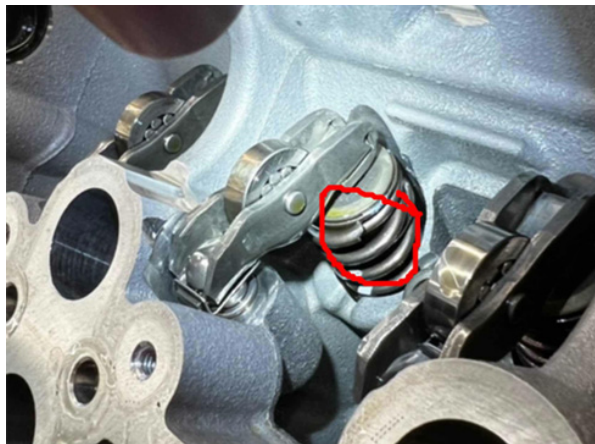
Customer complains of misfiring, vehicle may experience loss of power, and/or have a warning in the display indicating reduced power and enter limp or emergency drive mode. This condition applies to both V6 and V8 Engines.

The aforementioned faults/condition may be the result of a broken valve spring as shown in **Figure 1**. A manufactured batch of valve springs associated with the issue highlighted in this bulletin were quarantined by *Parts Withdrawal GR13D599 Valve Spring PAB109623/958109623 (published March 14, 2022)*. Any remaining stock of springs not quarantined or new parts received are therefore considered safe to use for installation.

In many cases, failures occur in less than 1000km (620 mls) of runtime, of which the majority are below 500 km (310 mls).

Figure 1 - Broken Valve Spring

In the event one or more valve springs are broken, then **ALL VALVE SPRINGS MUST BE REPLACED (INTAKE AND EXHAUST)**. Please perform the repairs in accordance with the respective workshop instructions.

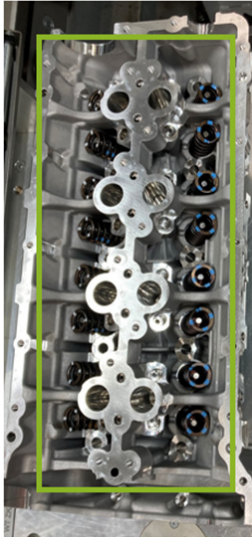
Figure 2 - Orientation

New springs must be replaced in the following orientation in V8 engines:

Exhaust: ALWAYS blue 90 deg (4x) apart on top of the spring, these markings must be facing up with the spring installed

Intake: ALWAYS white 120 deg (3x) apart on top, installed facing up

Springs in V6 engines will be replaced similarly with all white markings facing up when arranged in the cylinder head.
