SERVICE BULLETIN

APPLICABILITY: 2020-22MY Legacy and Outback Models **NUMBER:** 15-261-20R
SUBJECT: Reprogramming File Availability for Optimization of Gen 4 Denso CP1 Infotainment Systems **DATE:** 03/10/20
REVISED: 12/18/23

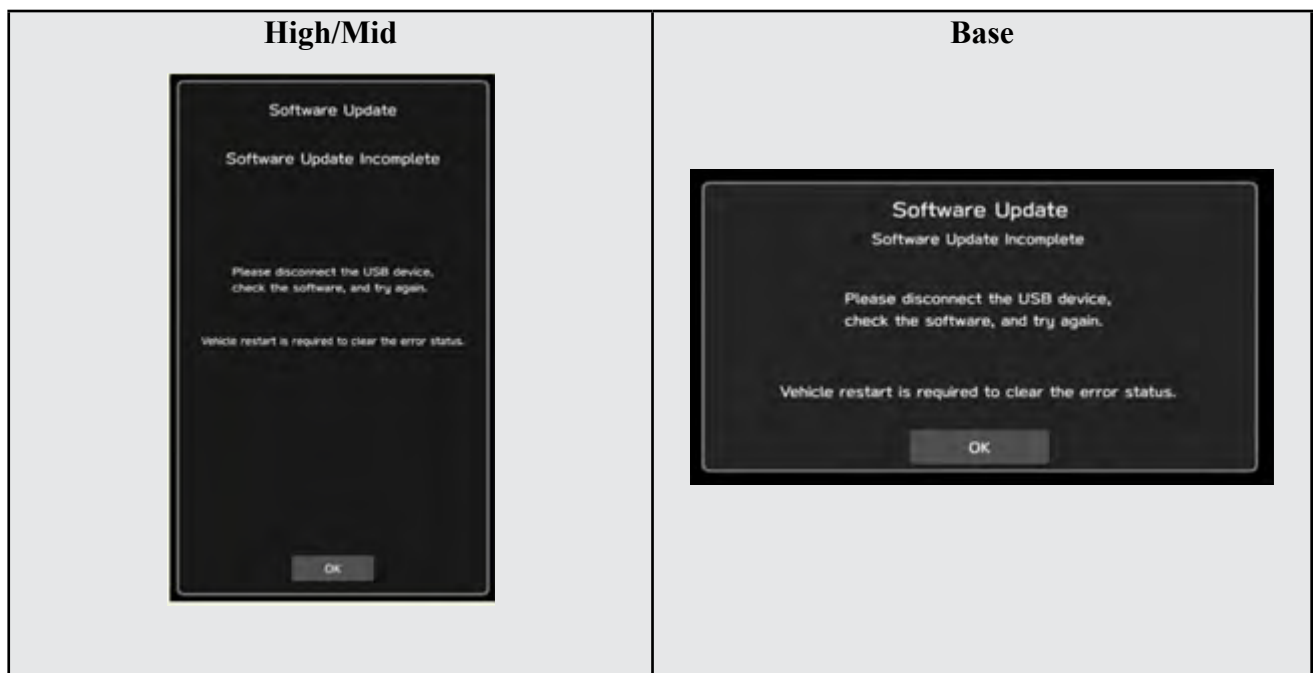
If you get the message Software Update Incomplete as shown below, please don't replace the hardware but retry updating the software according to the instructions in "Appendix B" on pg. 21.

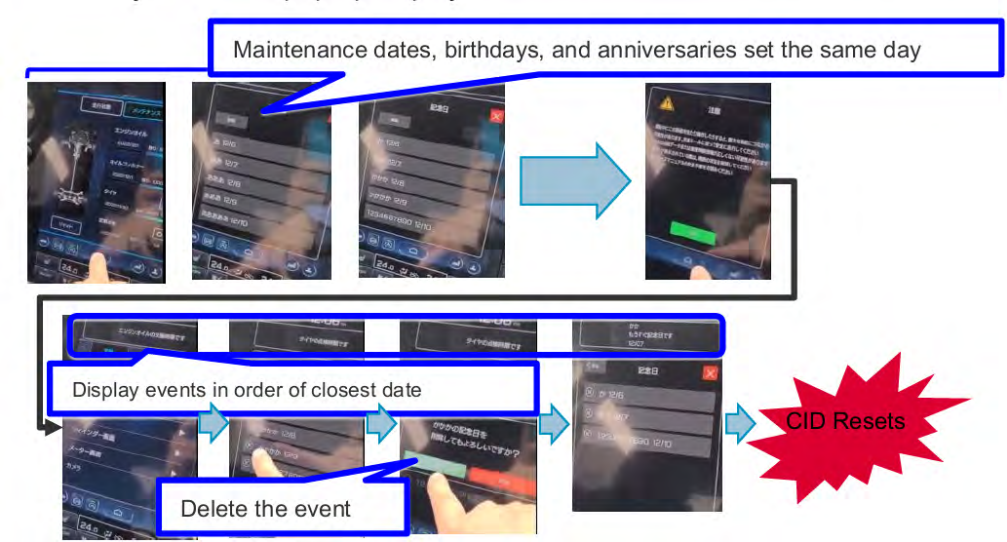
Number	Symptoms to be Improved:
<p>10</p>	<p>If a same date is set to maintenance date, birthday, and anniversary date, pop-ups will appear in sequence on the top of the CID after engine is started when the day comes. Under this condition, if an operation is performed to delete the maintenance date, birthday or anniversary date registration within a few seconds immediately before the pop-up display, the CID screen will reset.</p>

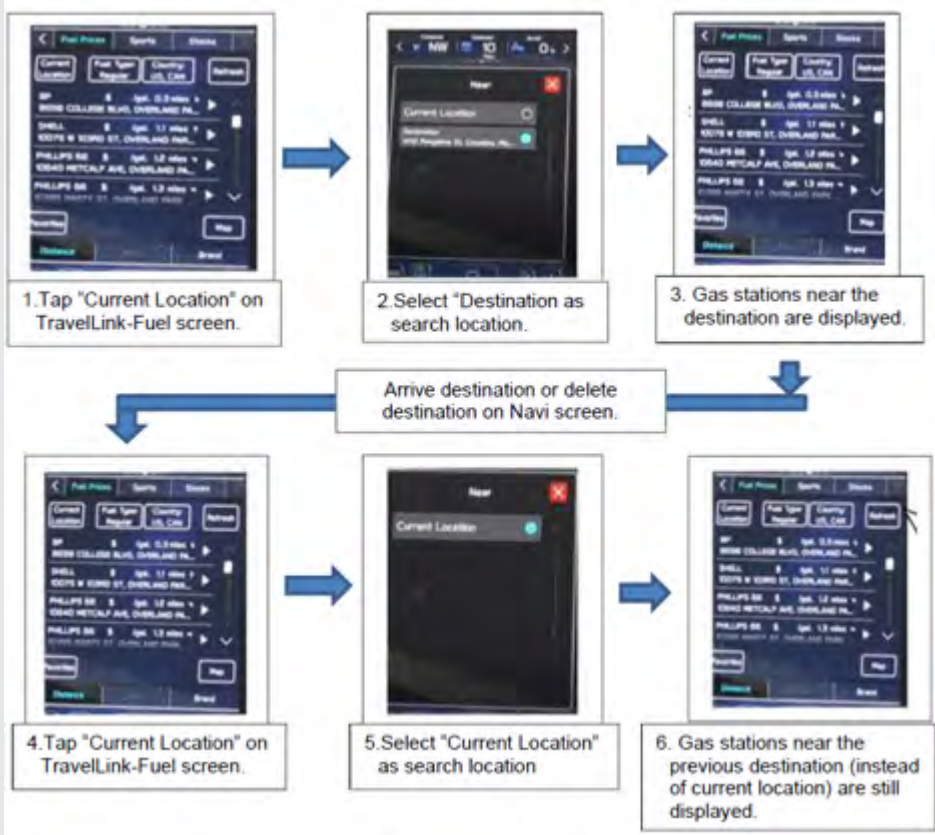
Number	Symptoms to be Improved:
30	<p>A wrong search location is used on TravelLink function. Example of the symptom.</p>

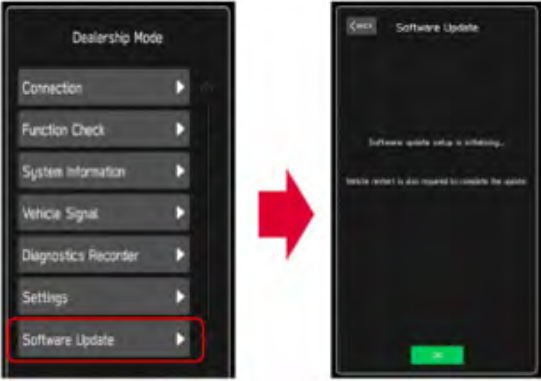
Number	Symptoms to be Improved:
<p>13</p>	<p>When “Software Update” is selected in the Dealership Mode, the following initialization process does not end more than 20 minutes. *</p>

<p>Note* In case this USB update failure occurs, retry updating according to the instructions in “Appendix A”</p>
<p>14</p>	<p>When the FOTA pop-up (new software availability notification) is displayed while the CarPlay is being used, the display comes back to CarPlay screen even if the customer tries to get into the FOTA screen.</p>

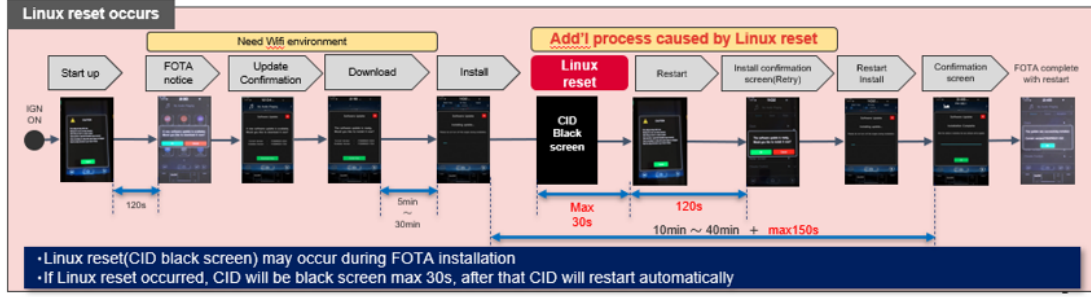
<p>However, in rare case, the CCU restarts itself* during installation.</p>

<p>Note* Even if this symptom occurs, after approximately 2 minutes, the system resumes, and the CID comes back to the below screen. Customer can then push the “Install Now” to proceed with the installation.</p>

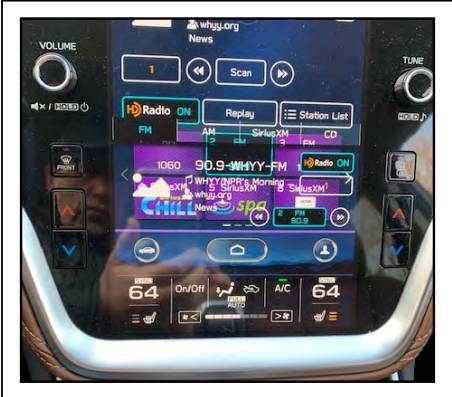
5	CarPlay stopped working after hanging up a hands-free phone call.
6	<p>CID shows multiple images simultaneously.</p>
