SERVICE BULLETIN

APPLICABILITY: 2023MY Outback & Legacy
2023MY Ascent

NUMBER: 15-311-23R

SUBJECT: FOTA (Firmware Over-The-Air) Reprogramming for DENSO Gen 4.5 Audio Navigation Infotainment Systems via DCM

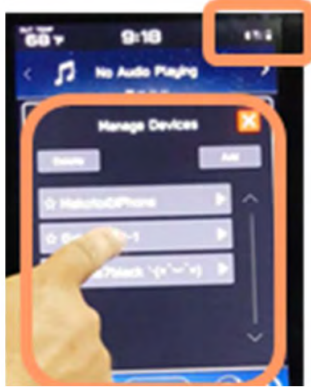
Symptoms Addressed By Update	
No	Conditions/Symptoms to be improved
5	<p>Bluetooth connection is disabled with a discrepancy in the display of status bar (showing Bluetooth devices being connected) and the “Manage Devices” screen (showing no Bluetooth devices being connected.)</p>

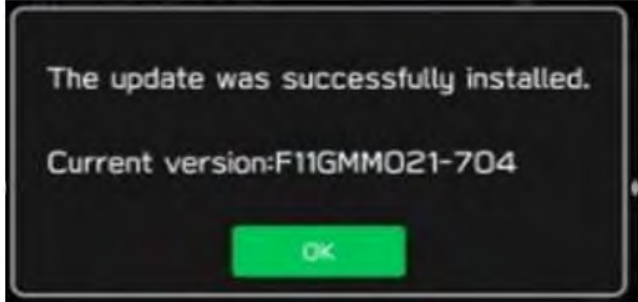
No	Conditions/Symptoms to be improved
13	<p>Popup of “The update was successfully installed” is not displayed after reboot (IG-OFF and ON) operation of FOTA (Firmware Over The Air) update.</p> <div style="text-align: center;">

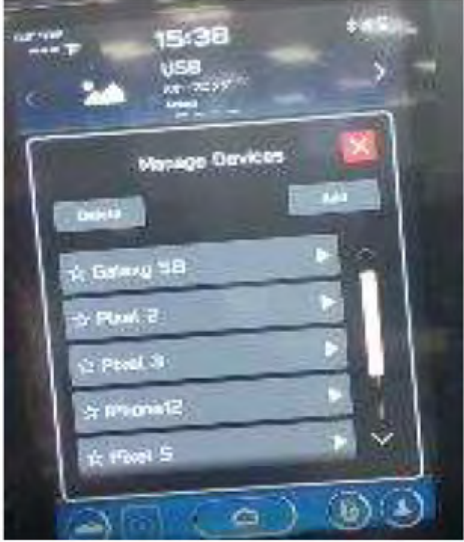
No	Conditions/Symptoms to be improved
21	<p>Status of Bluetooth on Manage Device screen is displayed as disconnect even though the Bluetooth Icon on top right of the screen is showing active.</p>

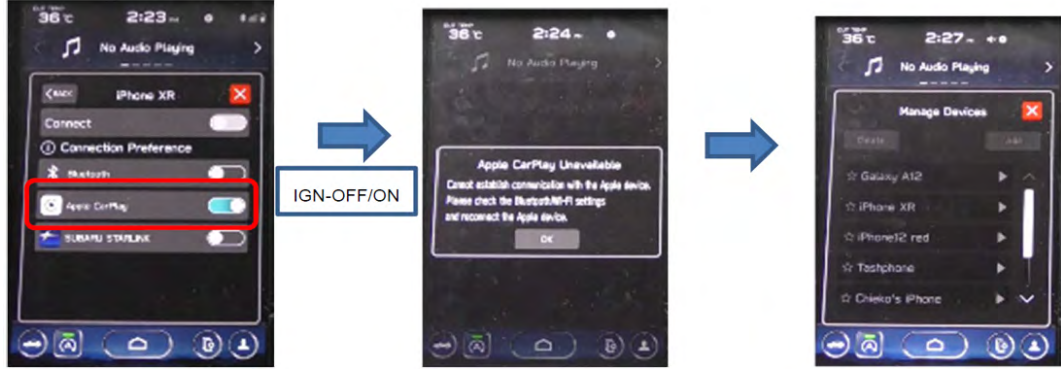
No	Conditions/Symptoms to be improved
25	<p>Manage Device Screen becomes dark and inoperative when Ignition Switch is turned Off and On while starting CarPlay by CID operation.</p>

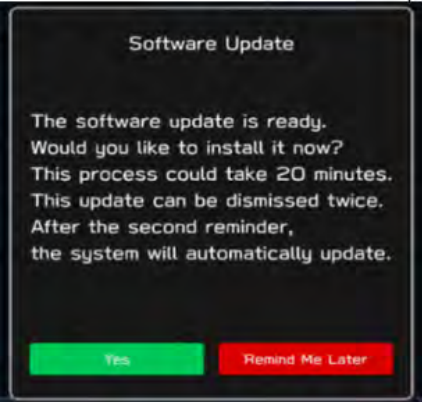
3-2		"The software installation failed. An error occurred during installation. Please contact your retailer." popup is shown while installing.	An exception error due to hardware malfunction	Installation will resume automatically 24hours later. If same error message again, please perform diagnostic of CCU or update CCU software via USB.
3-3		Selected <Remind Me Later>, but next time IG ON 3.a.i screen is not displayed.

DCM has lost connection to SUBARU server. After downloading was completed, DCM needs to connect with SUBARU server, before installing	Assure DCM has strong reception and reliable connection with the server, then turn ignition OFF and ON to repeat the test.
