SERVICE BULLETIN

APPLICABILITY: 23MY Outback/Legacy Models (including Wilderness models)
 23MY Ascent Models

NUMBER: 15-305-22R
DATE: 11/15/22
REVISED: 12/20/23

SUBJECT: Reprogramming File Availability for Optimization of Gen 4.5 Denso CP1.5 Infotainment Systems

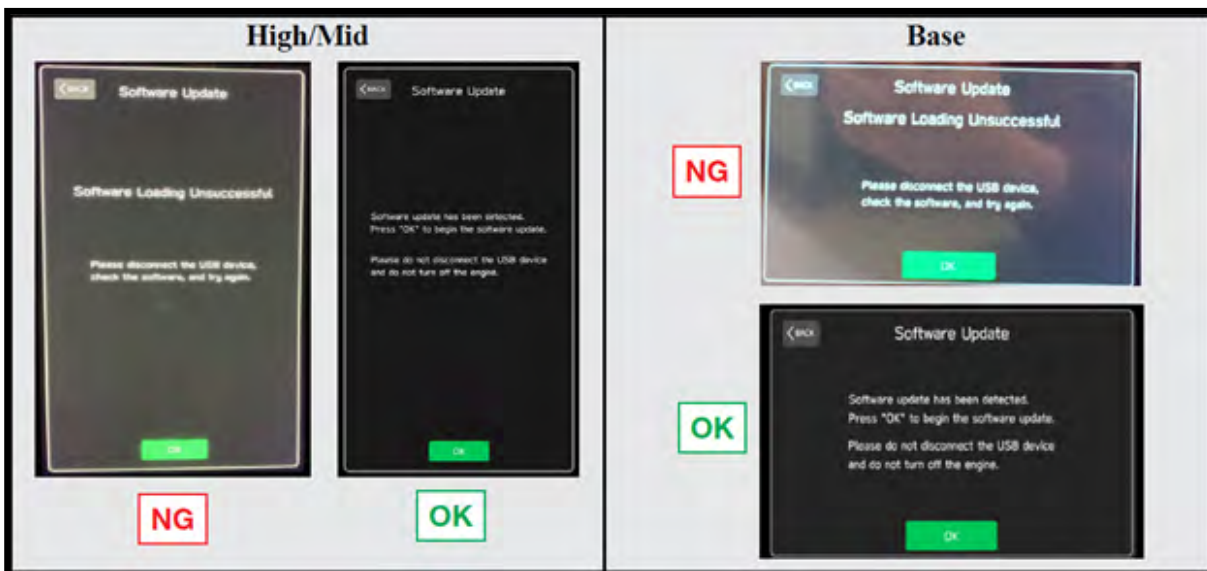
NOTE: If after plugging in the USB, the screen displays a **Software Loading Unsuccessful** message, confirm the USB device has been properly formatted and the software on the device matches the system being reprogrammed (example: Base software is being used to update a Base system) and retry.

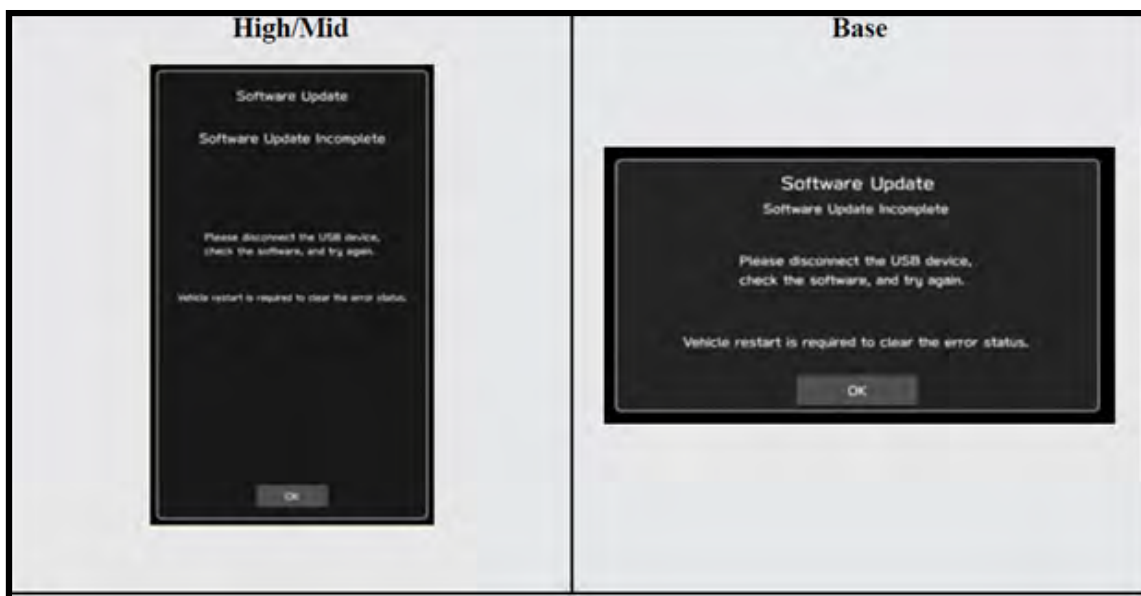
If you get the message **Software Update Incomplete** as shown below, please don't replace the hardware but retry updating the software according to the instructions in "**Appendix B**" on pg. 17.

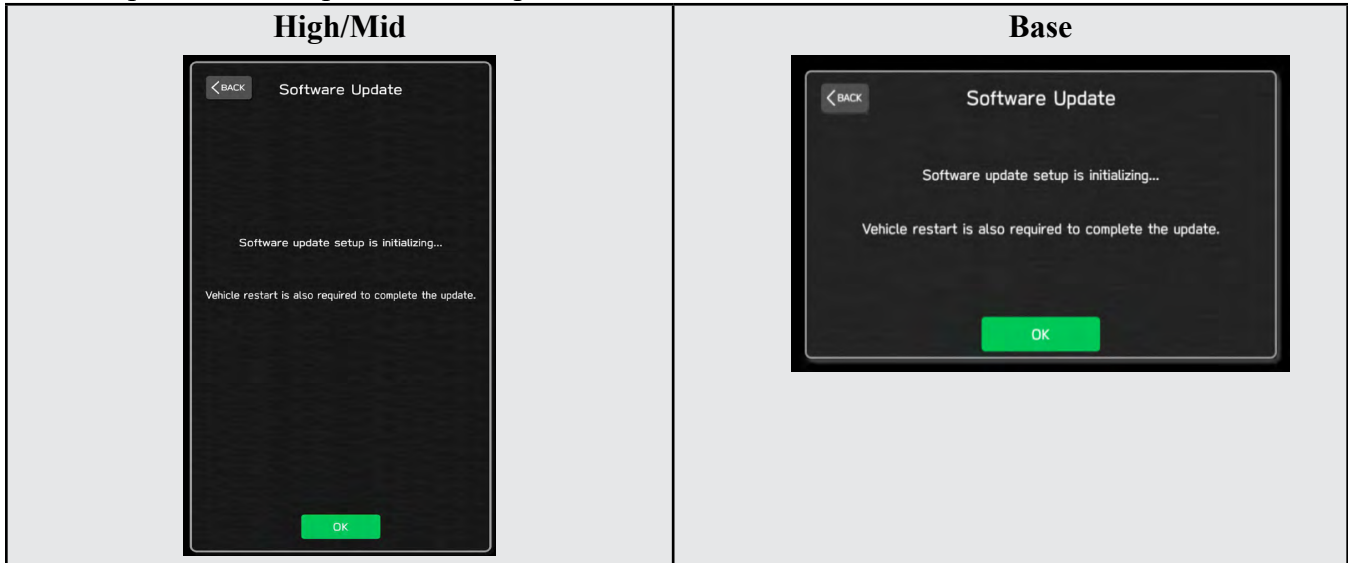
Follow this procedure in the RARE case of “Software update setup is initializing...” message is displayed:

- If the screen shown below appears, **WAIT** for approximately 30 minutes or as long as necessary (waiting for longer than 60 minutes might indicate system malfunction). In that case please perform recovery according to the instructions in “Appendix B ” to allow the Software update setup initialization process to complete.

IMPORTANT NOTE: If this procedure is required, contact Techline as additional action may be necessary.

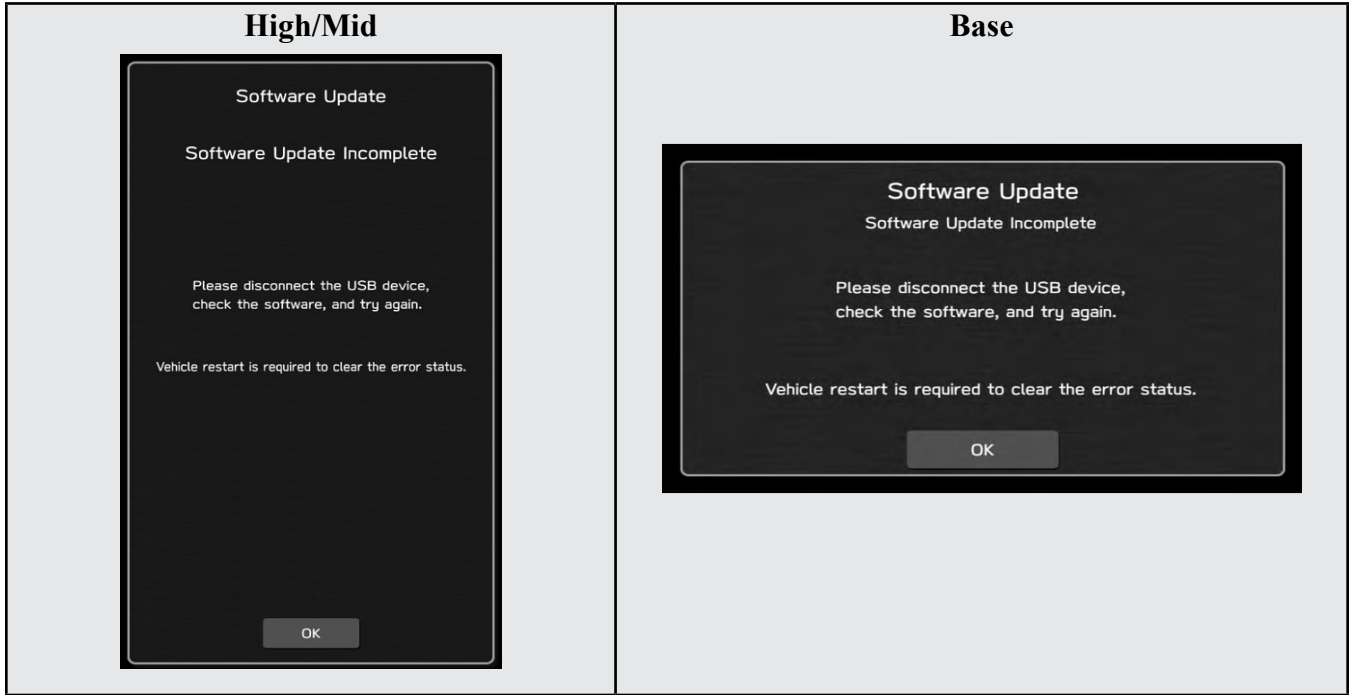
In case of retrying the software update after the first attempt of update fails.

- If the first attempt of update fails with the message below, follow the steps described below 1-2 to 1-8 before retrying the software update.

1-1. Select OK in the screen below

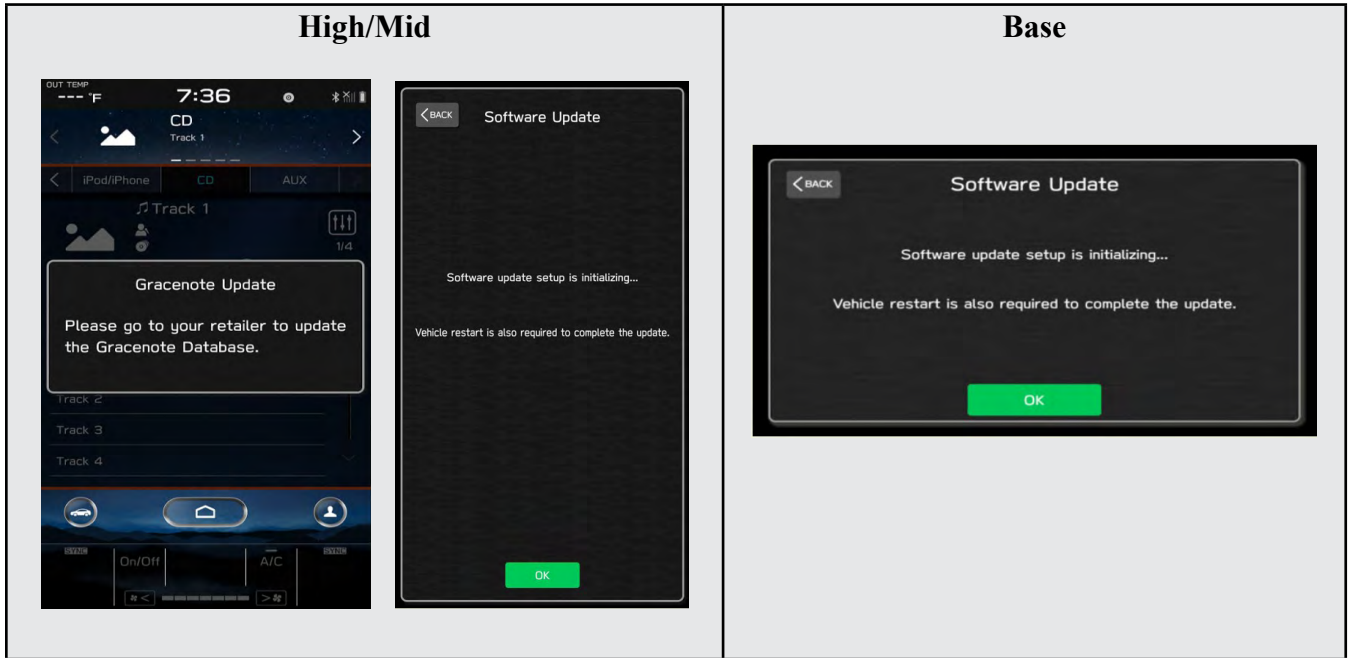
In case the Gracenote update popup screen appears or software initializing screen does not go away for more than 20 minutes, please perform steps 2-1 to 2-11.

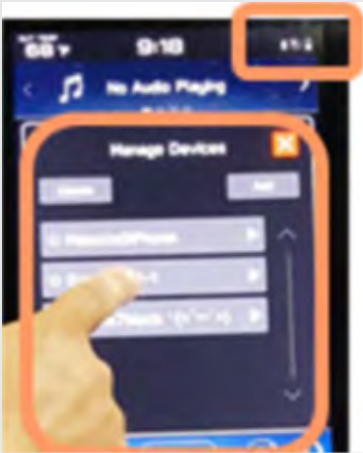
Number	Symptoms to be Improved:
1	CID goes black and does not accept any control.
2	Audio playing while CID shows black display
3	CID reboots.
4	“Manage Devices” is grayed out and cannot establish Bluetooth connection.
5	When the Bluetooth connection is cancelled manually on the mobile phone side during hands-free calling, the Bluetooth connection is disabled for that particular mobile phone. Even when it occurs, the connection can be reestablished by deleting the device in “Manage Devices” and register the device again by adding operation.
6	Bluetooth connection fails against the device that was paired before and “Manage Devices” is grayed out.
7	Bluetooth connection is disabled with a discrepancy in the display of status bar (showing Bluetooth devices being connected) and the “Manage Devices” screen (showing no Bluetooth devices being connected.) <div style="text-align: center;">

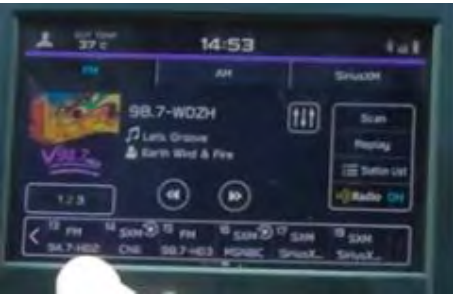
Number	Symptoms to be Improved:
12	<p>Sound is lost when changed to Subchannel 2 right after a preset HD radio channel has been selected.</p>

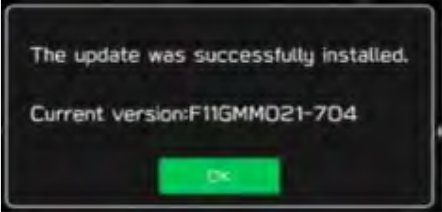
13	<p>After the destination is set on Navi screen, voice recognition command of “Find <POI category> along route” is made, search results are not given in order of distance.</p>
14	<p>When “Call” button is pressed in “Confirm Destination” screen of Navigation system (to call the destination site,) the call can be made but the screen does not transit to phone call screen.</p>
15	<p>Popup of “The update was successfully installed” is not displayed after reboot (IG-OFF and ON) operation of FOTA (Firmware Over The Air) update.</p>

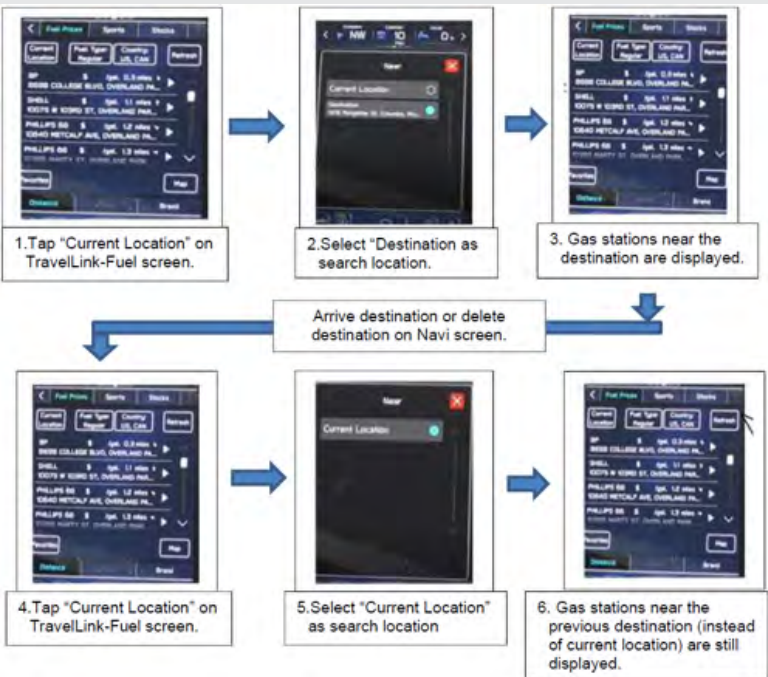
16	<p>When tapping preset “Team Channel” on SMX, a popup of different game is displayed. It can occur under the following sequence of operations:</p>
17	<p>A wrong search location is used on TravelLink function. Example of the symptom.</p>

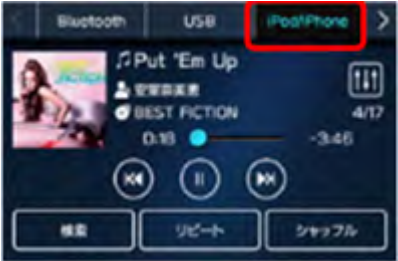
Number	Symptoms to be Improved:
1	<p>iPod/iPhone tab in Media screen cannot be selected, when connected by USB.</p> <p>The symptom occurs when the iPhone is connected to CP1.5 via Bluetooth in parallel to USB connection by error. (It is supposed to be connected either via Bluetooth or by USB.)</p>

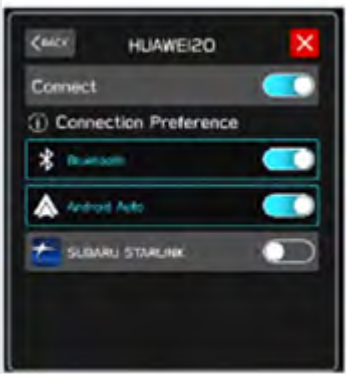
2	<p>On the "Manage Devices" screen Bluetooth cannot be selected as connection preference.</p>

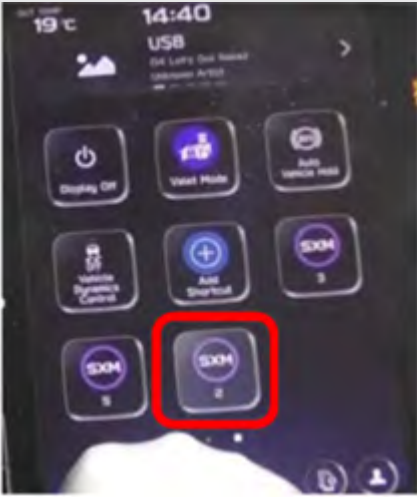
4	<p>Cannot pair new Bluetooth device or cannot connect paired Bluetooth device. This symptom possibly occurs after repeating IG OFF/ON operation while still pairing operation.</p>
5	<p>Cannot pair Bluetooth device, when Bluetooth device has long name including symbols.</p>
6	<p>SXM station shortcut created by the customer does not work when the SXM has not been used as audio source after the Ignition Switch was turned on in the ignition cycle.</p>

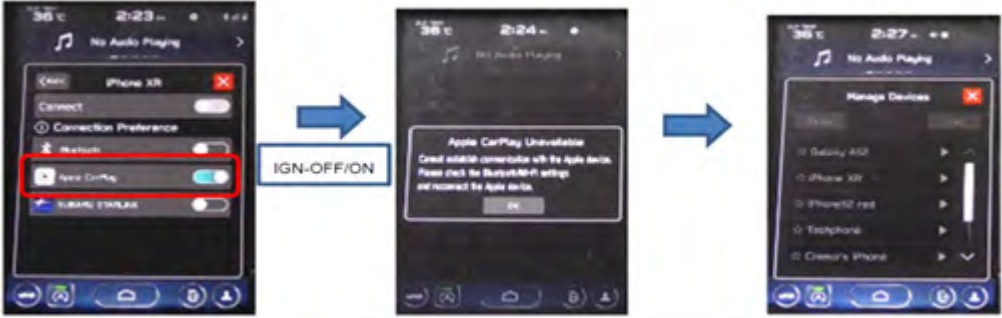
Number	Symptoms to be Improved:
7	<p>Manage Device Screen becomes dark and inoperative when Ignition Switch is turned Off and On while starting CarPlay by CID operation.</p>

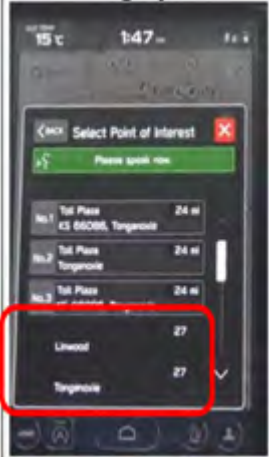
8	<p>Cannot connect to CarPlay via wireless connection. This symptom possibly occurs after the Ignition Switch was turned Off and On abruptly.</p>
9	<p>POI Search Result shows only city names and distances (without unit) when voice recognition POI search with Category name like “Find toll gate” is used.</p>

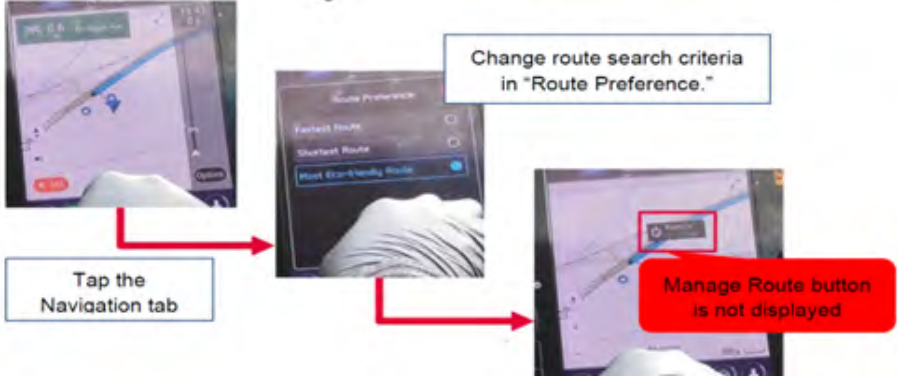
10	<p>Navigation restarts itself, when the letters are rashly entered or deleted using keyboard function to search destination.</p>
11	<p>“Manage Route” button is not displayed when touching the route line on Navigation system, when the route search criteria got changed in the Route Preference Screen after a route had been searched.</p>

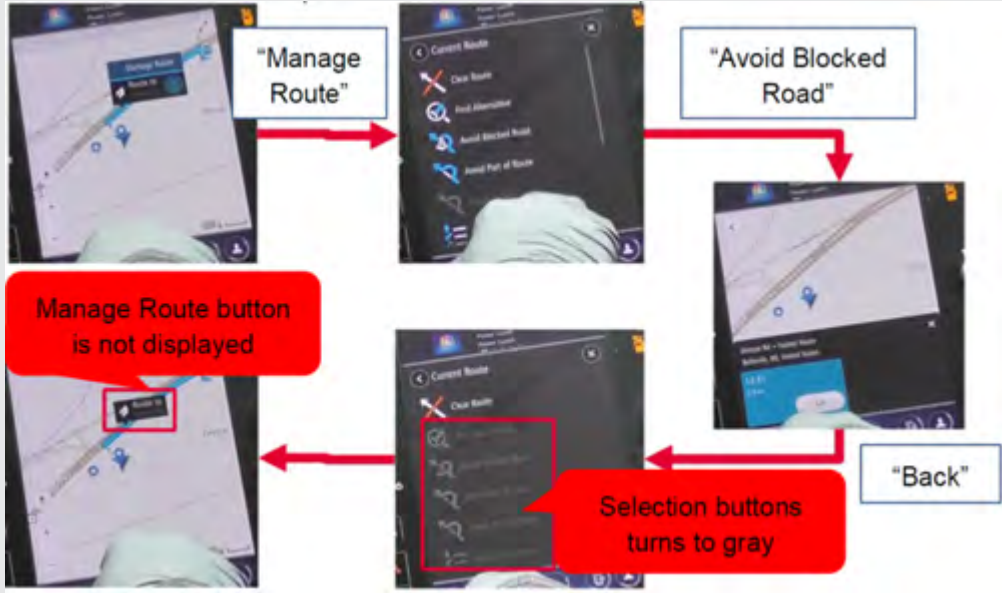
Number	Symptoms to be Improved:
12	<p>“Manage Route” button is not displayed and buttons on the Current Route Screen become unselectable (turns to grayish fill) when the Navigation system is operated in the sequence of “Manage Route” > “Avoid Blocked Road” (in the Current Route Screen) > “Back.”</p>
