Technical Service Bulletin

91 Parking assistance provides false warnings

91 23 06 2024323/10 December 21, 2023. Supersedes Technical Service Bulletin Group 91 number 22-75 dated February 7, 2022 for reasons listed below.

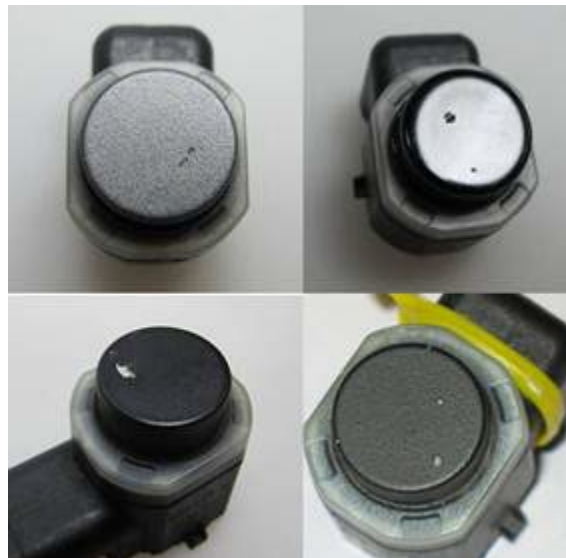
3. Check parking sensors (Figure 3) for obvious issues:
 - Mechanical damage (stone chips, scratches).
 - Dirt, ice, foreign bodies, and/or foil adhered to the sensor.
 - Damage to the bumpers that may indicate an accident (or paint indicating a previous incident).

Figure 3. Stone chips causing sensor failure.

Exterior damage to the vehicle, including stone chips and scratches, is not covered by Audi Warranty. When painting sensors, the special painting instructions for parking sensors in the paint repair manual must be observed.

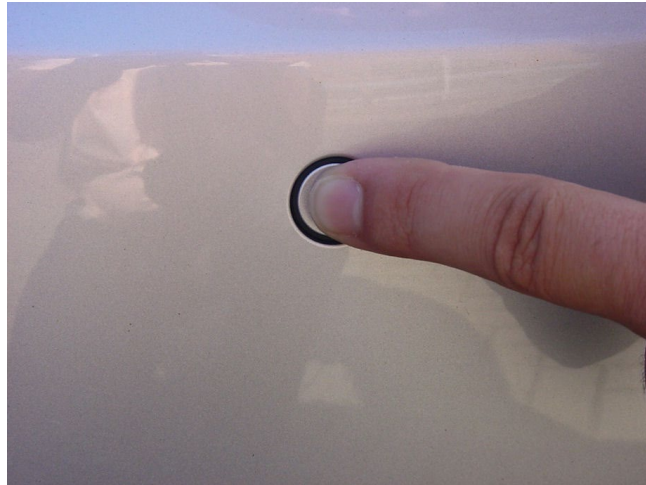
Figure 4. A pressure check on a parking aid sensor.

4. Pressure check for a tight fit and correct attachment of the parking sensors (Figure 4). If the sensor is not snug or feels loose, remove the bumper and reinstall the sensor.

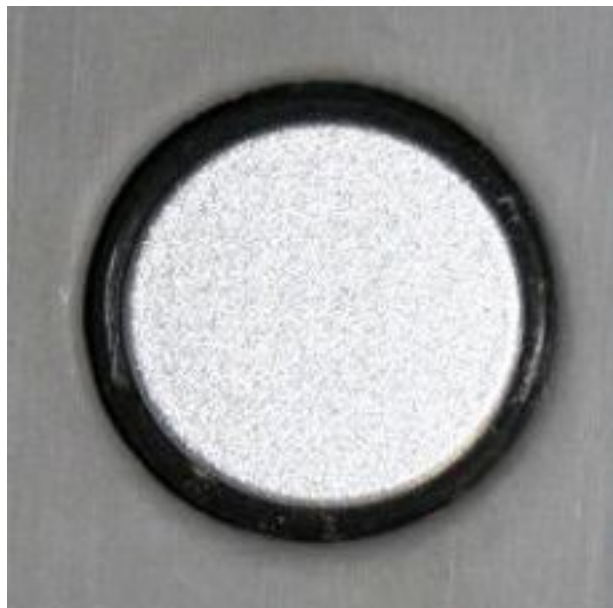
Figure 5. A correctly seated decoupling ring.

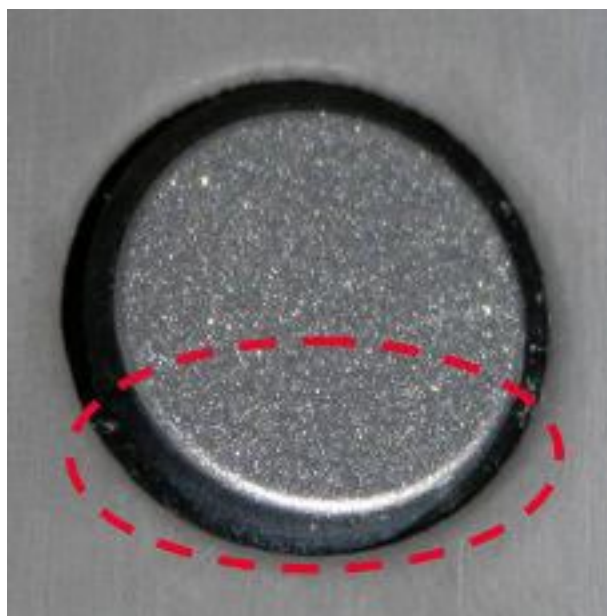
Figure 6. An incorrectly seated decoupling ring (bulging).

5. Check that the decoupling ring is correctly seated (Figures 5 - 7). If the ring is folded or bulging, remove the bumper and reinstall the sensor.

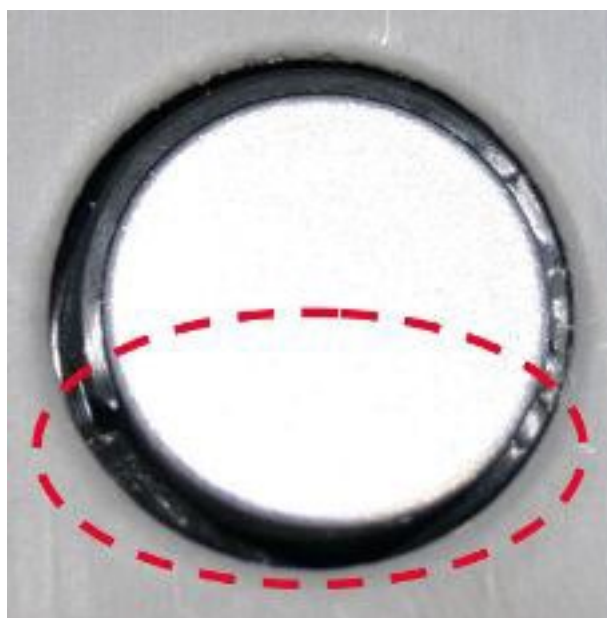
Figure 7. An incorrectly seated decoupling ring (folded).

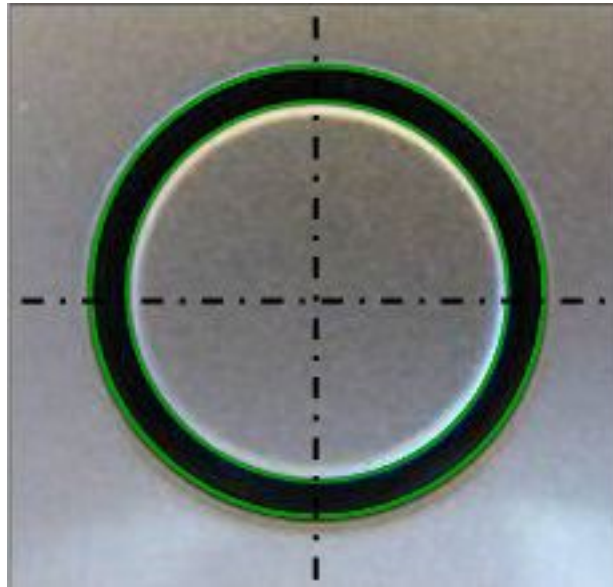
Figure 8. A correctly centered parking aid sensor.

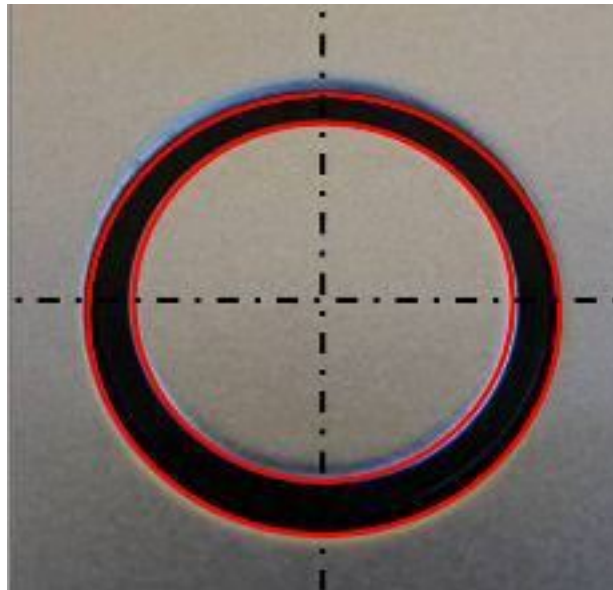
Figure 9. An off-center parking aid sensor.

6. Verify that the sensor is centered inside of the mounting hole (Figures 8 - 9). If the sensor is mounted off-center, remove the bumper and reinstall the sensor.

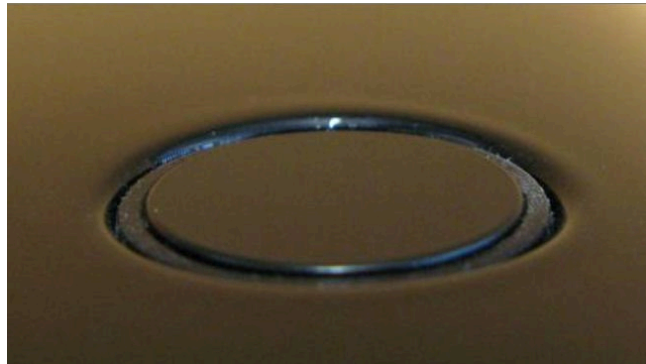
Figure 10. A correctly installed parking aid sensor.

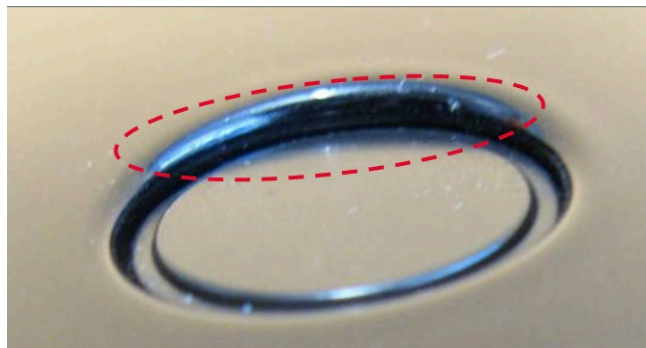
Figure 11. A recessed parking aid sensor.

7. Ensure the sensor sits flush with the bumper (Figures 10 - 11). If the sensor is recessed or bulging, remove the bumper and reinstall the sensor.

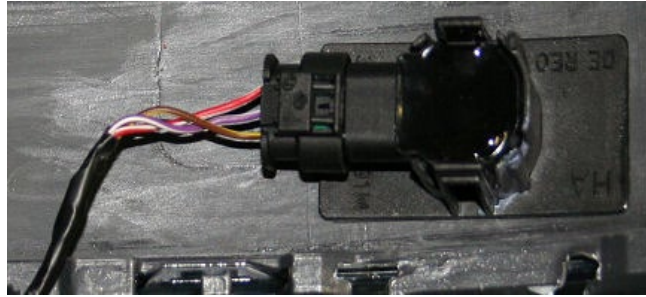
Figure 12. A correctly installed cable with sufficient length.

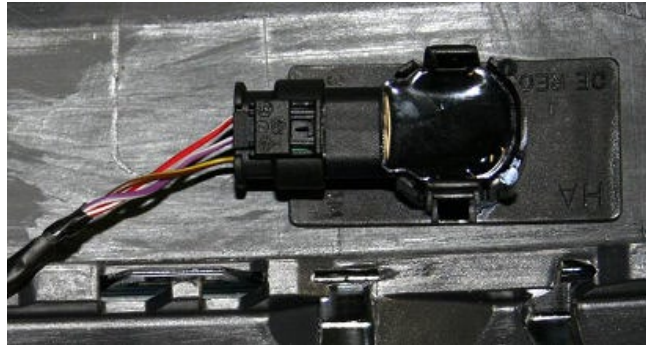
9. Check the cables in the bumper for damage and sufficient length (Figures 12 - 13). Cables that are too short can cause damage to the harness.

Figure 13. A sensor cable with insufficient length.

- If the cable is damaged, repair the cable using VAS Repair Kit 1978.
- If the cable is too tight, correct the routing by moving the support clip so the cable is no longer under tension.

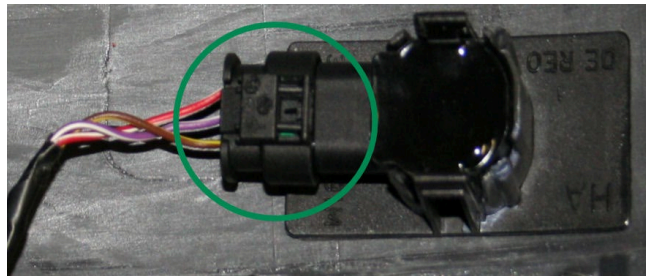
Figure 14. A correctly installed parking aid sensor connector.

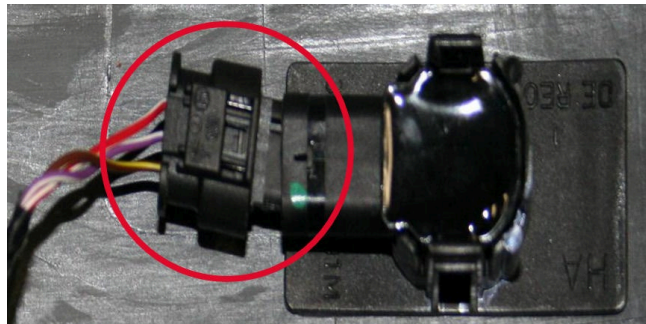
Figure 15. A parking aid sensor connector that is not seated correctly.

- 10 Check the connectors on the parking sensors and the socket box for correct installation (Figures 14 - 15). If the connectors are not installed properly, reinstall.
