Technical Service Bulletin

27 48V vehicle electrical system warning, DTC U046900 stored in the ECM

27 23 64 2058831/11 December 22, 2023. Supersedes Technical Service Bulletin Group 27 number 23-63 dated December 13, 2023 for reasons listed below.

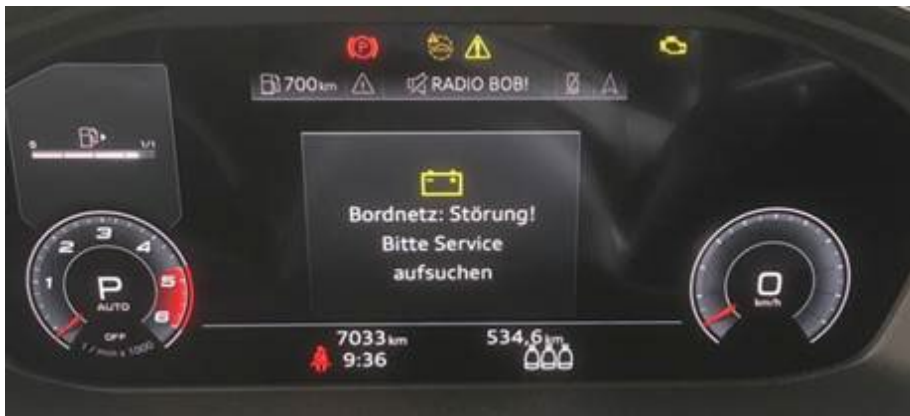
- The message “Electrical system: Malfunction. See owner’s manual” is displayed on the instrument cluster (Figure 1).
- A yellow or red battery warning symbol is displayed on the instrument cluster.

Figure 1. Cluster Warning Message.

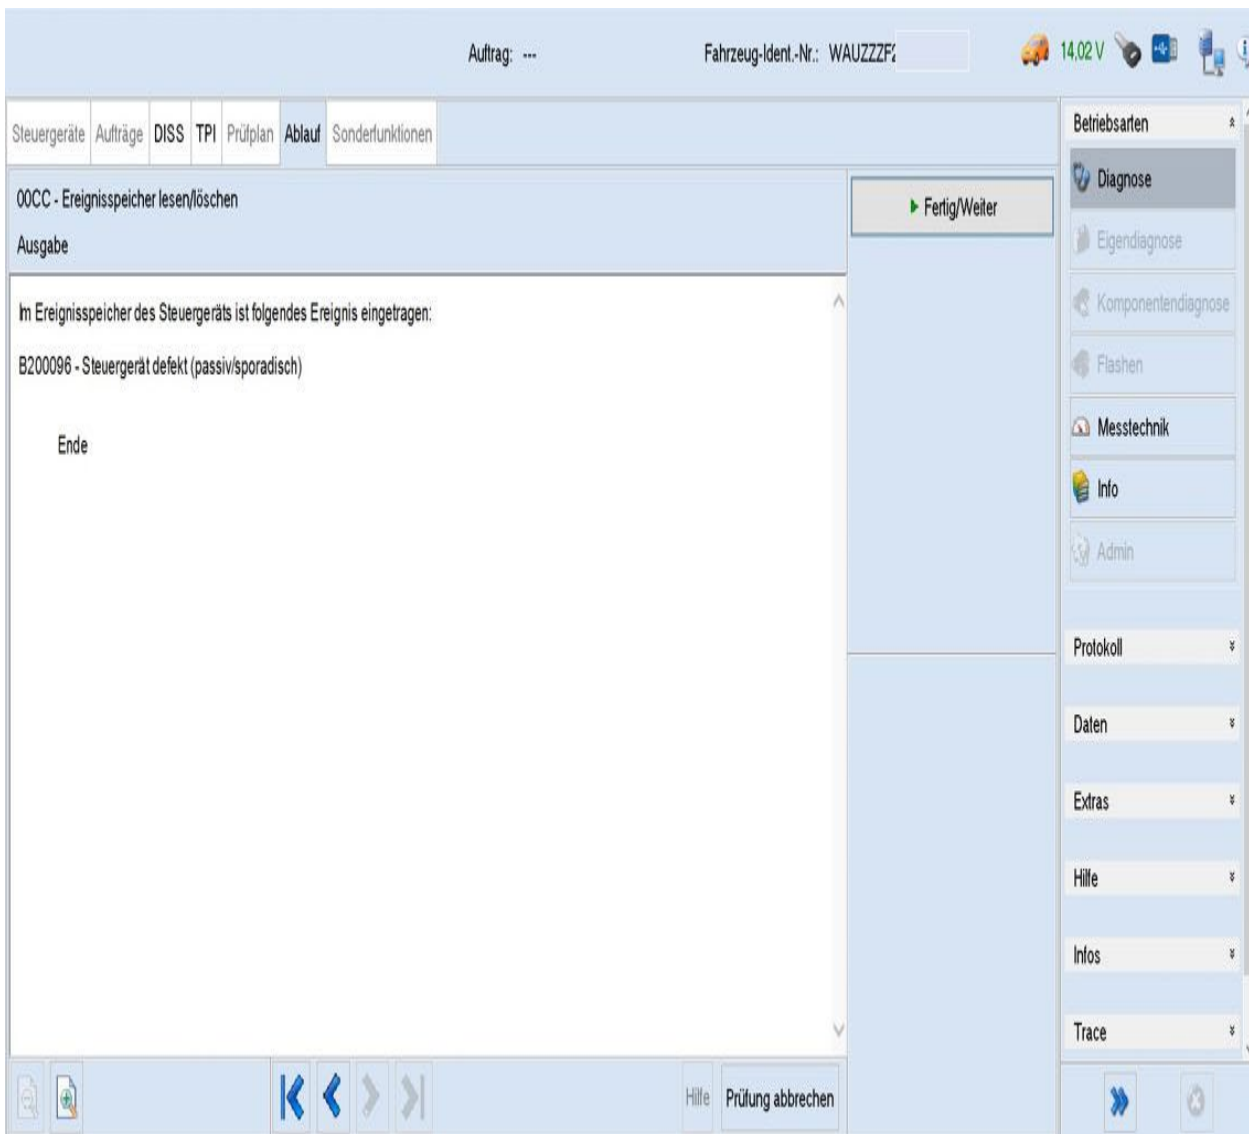
- **B200096** – Faulty control module (Figure 2).

Figure 2. ODIS tester screen.

If the following event memory entry is shown in ODIS, replace the starter-alternator according to ETKA and reevaluate the concern:
