**PRODUCT CAMPAIGN BULLETIN**

**APPLICABILITY:** 2005-2006 model year Baja  
 2009-2012 model year Legacy  
 2009-2012 model year Outback  
 2009-2012 model year Forester  
 2006-2012 model year Tribeca  
 2006-2011 model year Impreza (including WRX and STI)  
 2012 model year WRX and STI

**NUMBERS:** TKA-17R  
 TKB-17R  
 TKC-17R

**SUBJECT:** Takata Front Passenger Airbag Inflator Replacement

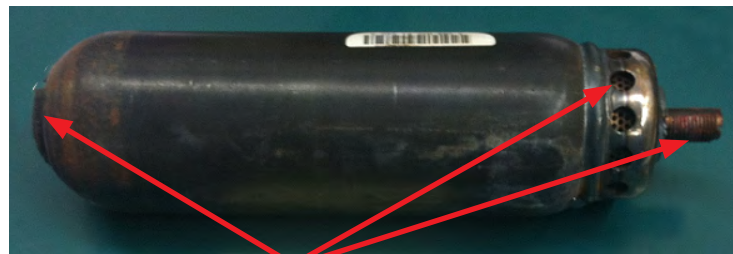
**The shape, holes, and copper-colored stud indicate this not a Genuine Subaru inflator.**

- **Do not proceed with this repair if your inspection reveals a non-Genuine Subaru airbag module has been installed in the vehicle.** Follow the instructions described in the “Counterfeit Airbag Information” Dealer Advisory Bulletin.

- Document the presence of the aftermarket or counterfeit device on the repair order and with photos. Report this information immediately on a Quality Monitoring Report (QMR). **IMPORTANT:** When entering a related QMR, use failure code **ULF** and **NOT** the campaign fail code.

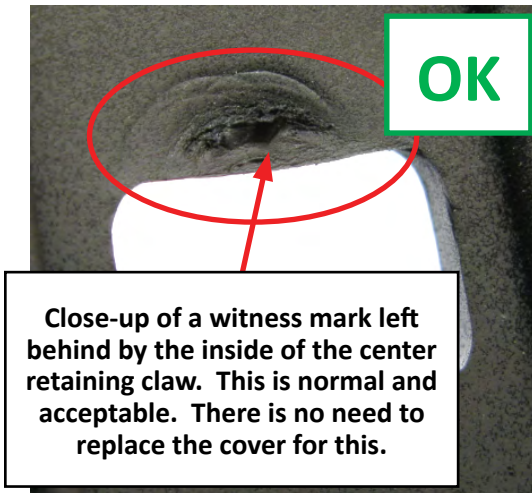
Close-up of a witness mark left behind by the inside of the center retaining claw. This is normal and acceptable. There is no need to replace the cover for this.

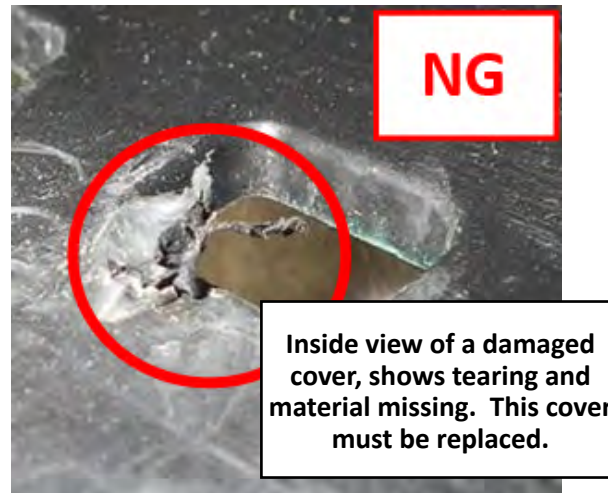
Inside view of a damaged cover, shows tearing and material missing. This cover must be replaced.

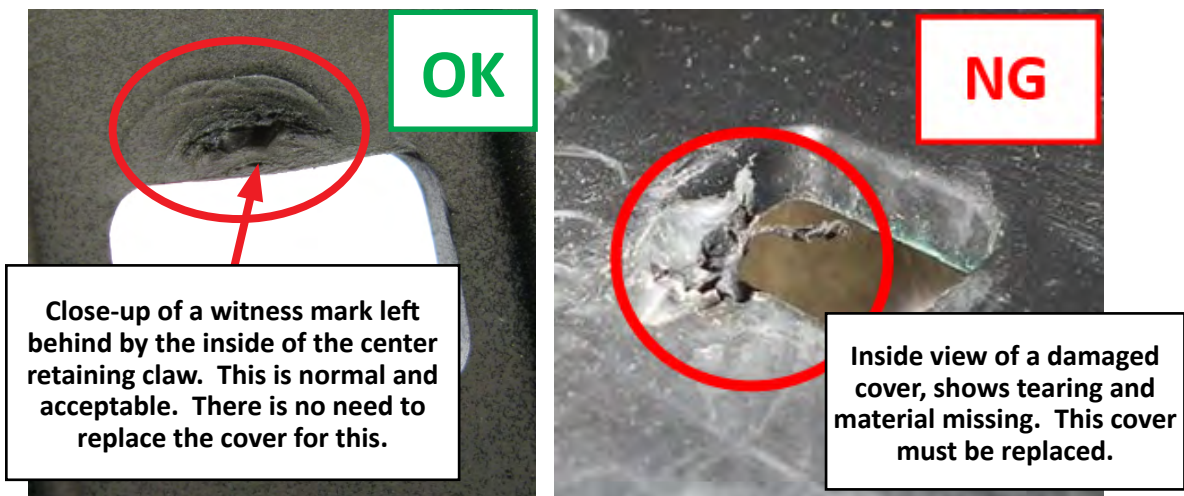
Close-up of a witness mark left behind by the inside of the center retaining claw. This is normal and acceptable. There is no need to replace the cover for this.

- Inspect the claw openings on the outside and inside of the cover for damage. If any found to look like the NG example photo below, the cover must be replaced.
