Coolant Warning Light Lights Up: Supposed Coolant Loss on the Coolant Pump (167/23)

Vehicle Type: **Macan S (95B) / Macan GTS (95B) / Macan Turbo (95B)**

Model Year: **As of 2019**

Concerns: **Coolant pump**

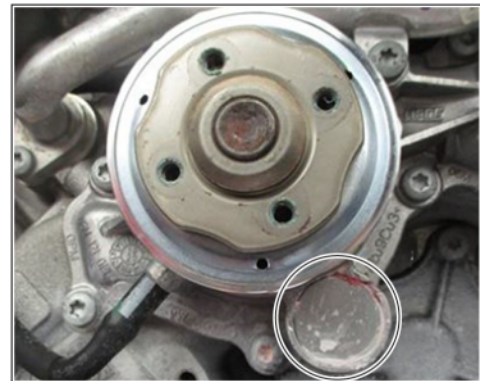
The visual inspection can show that small traces of coolant are detected at the weep hole of the coolant pump.
Due to lubrication/cooling of the lip seal on the coolant pump, up to **3 ml coolant per 100 operating hours** can escape. Coolant outlet to this extent can be considered normal and does not constitute grounds for complaint. ⇒ *Traces of coolant on coolant pump*

Traces of coolant on coolant pump

Action: Check cooling system for leaks and replace any affected components.

Assessment		Action
(✓)	No further coolant leak can be detected at the affected location.	Continue observing, a part replacement is not required. End of remedial action.
(x)	New coolant leak can be detected at the affected location.	Replace component causing damage.
