Coolant Warning Light Lights Up: Supposed Coolant Loss on the Coolant Pump (167/23)

Vehicle Type: **Panamera (971) / Panamera 4 (971) / Panamera 4S (971) / Panamera 4 E-Hybrid (971) / Panamera 4S E-Hybrid (971)**

Concerns: **Coolant pump**

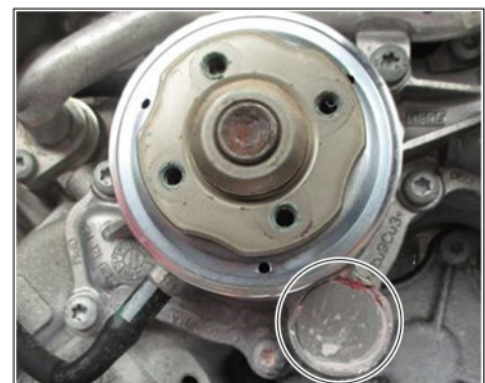
The visual inspection can show that small traces of coolant are detected at the weep hole of the coolant pump.
Due to lubrication/cooling of the lip seal on the coolant pump, up to **3 ml coolant per 100 operating hours** can escape. Coolant outlet to this extent can be considered normal and does not constitute grounds for complaint. ⇒ *Traces of coolant on coolant pump*

Traces of coolant on coolant pump

Action: Check cooling system for leaks and replace any affected components.

Assessment		Action
(✓)	No further coolant leak can be detected at the affected location.	Continue observing, a part replacement is not required. End of remedial action.
(x)	New coolant leak can be detected at the affected location.	Replace component causing damage.
