TECHNICAL SERVICE BULLETIN Second Row Seat Back Does Not Fold Down Or Recline

23-2396 04 December

Ford 2018-2024 Expedition Lincoln 2018-2024 Navigator

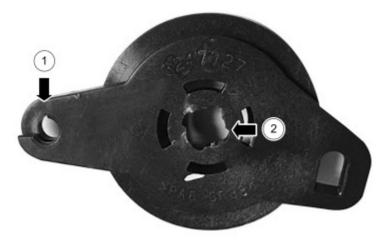
Figure 1

Issue: Some 2018-2024 Navigator and Expedition vehicles may exhibit a concern where the second row seat back does not fold down or recline when the recline handle is pulled upward or the second row single seat easy entry seat fold switch is pressed. This concern may occur with vehicles equipped with two or three second row seats. This may be due to a broken recliner release lever. To correct this concern, replace the recliner release lever.

Possible locations for damage on the recline release lever. (Figure 1)

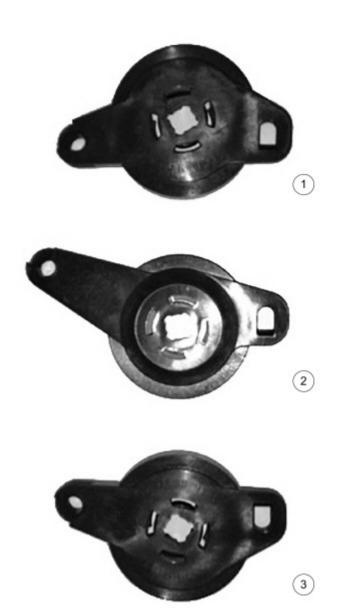
Figure 2

There are three different recline release levers based on the seat repair. (Figure 2)

Item	Description
1	Right seat release lever
2	Middle seat release lever
3	Left seat release lever

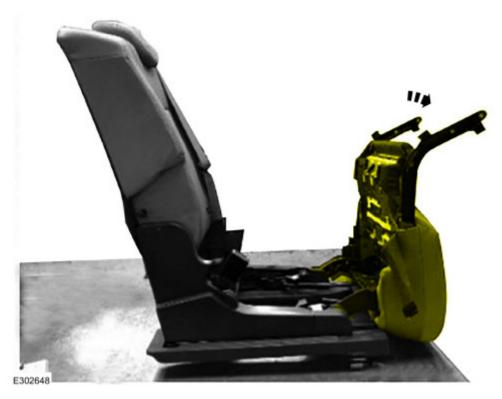
Figure 8

NOTE: Avoid sliding the seat on the seat track front to back while the seat cushion is flipped forward or damage may result to the neighboring seat trim and material. (Figure 8)

(2). Carefully, without damaging the neighboring seat material, flip the seat cushion forward.

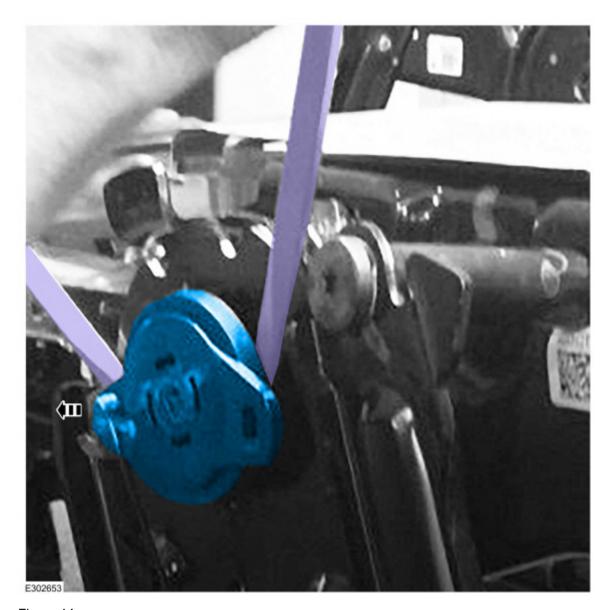
Figure 13

NOTE: When prying on the backside of the recline release lever, be careful not to remove the inner mounting ring. If the inner mounting ring is removed, seat assembly replacement is required. (Figures 13-14)

(2). Once both the spring and release cable are free of the recline release lever, gently pry on the backside of the recline release lever to remove it.

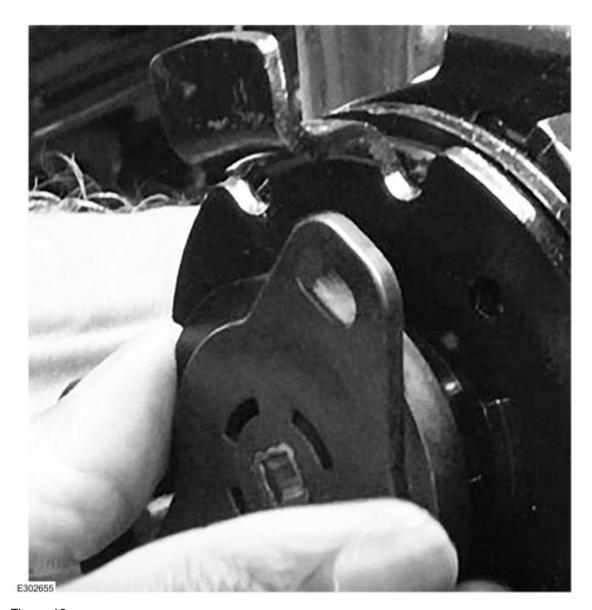
NOTE: The square tube that holds the recline release lever in place may need to be pulled out to seat the new part. Do not pull the tube more than a few millimeters as this tube runs the entire length of the chair. Pulling out too far unseats the opposite side of the chair and requires replacing the seat assembly. (Figures 15-16)

(1). Install the new recline release lever by pressing the new part into place.
