Subject: TELEMATICS COMMUNICATION UNIT (TCU) REPLACEMENT / ACTIVATION PROCEDURE	Service Alert No.: SA-025/23
	Last Issued : 12/05/2023

2019-2024 Mazda3	2021-2024 CX-5	2022-2023 MX-30	2024 CX-90
2020-2024 CX-30	2021-2023 CX-9	2023-2024 CX-50

When the Telematics Control Unit (TCU) replacement is necessary due to a failure, use MDARS to activate the new TCU after replacement.

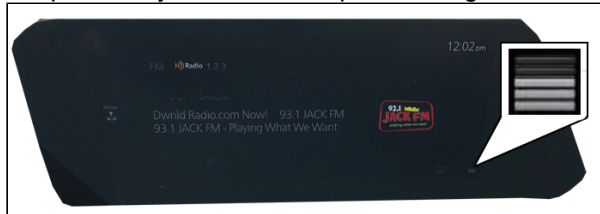
If customer was previously enrolled, reception strength icon will show normal

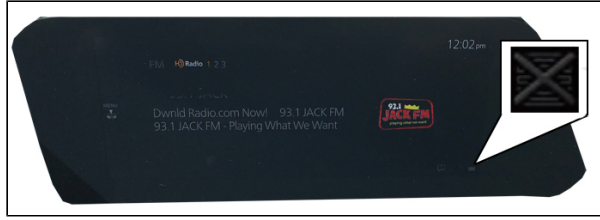
If customer was not previously enrolled, reception strength icon will show "X", this is a normal Deactivation Mode function.

Customer/Dealer can activate CV services anytime via MyMazda app (there just might be a slight delay in making the backend connection since it was temporarily deactivated).

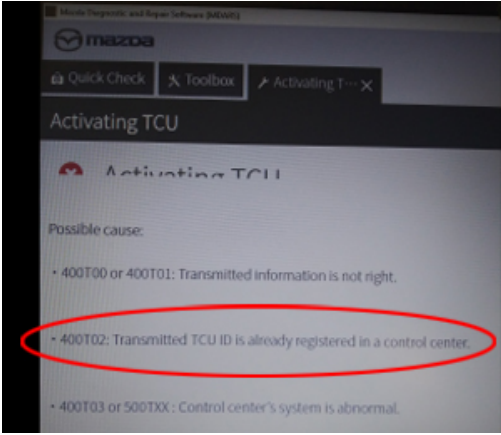
ERROR:05	Error code 400t02

- If DTC U2050:55-TCU (Activation of remote control not implemented) is stored, go to TSB [09-013/20 - DTC U2050:55 STORED AFTER REPLACING OR REPROGRAMMING TCU](#).
- If the TCU was not replaced and MDARS shows error code 400t02 and/or ERROR:05, TCU activation was previously completed. Ignore these errors as TCU activation is not required.
