GENUINE MOTOR PARTS AND MOTOR ACCESSORIES BULLETIN

PAB1146

PAB1146: 68193-95 BULB WEDGE, FENDER TIP LAMP

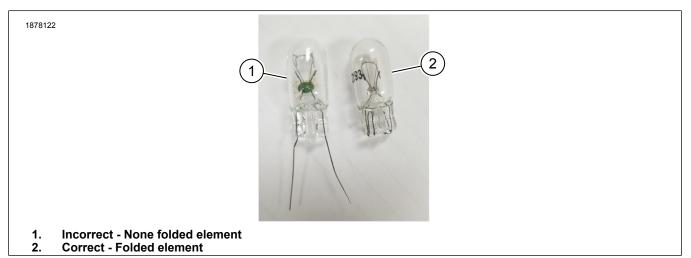
Figure 1. Incorrect vs Correct Bulb

Harley-Davidson has found an issue with the wire terminals on the light bulb (Part No. 68193-95) not being folded and molded back into the housing. The bulb style has been corrected by working with our supplier.

Shipments of the incorrect bulb (1) started in March 2022 and ended in August 2023 with the following packages dates March 25, 2022 and October 24, 2022. Inspect your inventory of this part and dispose of the defective stock. Submit a warranty claim for reimbursement. Refer to Credit Procedure.
