IMC Customer Concern Intermittent or Permanent Loss of Audio

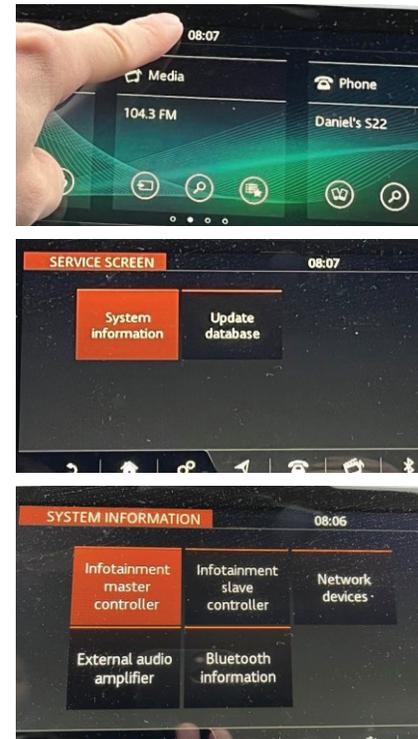
1. Using Touch Screen press and hold left of clock until Service Screen is displayed
2. From the Service Screen, select the Service Information tab to access the System Information screen
3. Then select Infotainment Master Controller tab to review the software currently reporting in the IMC
