EXHAUST TAILPIPE CORROSION – 5.0L AJ133-8 CYLINDER ONLY

Defender

- 20–24MY Defender

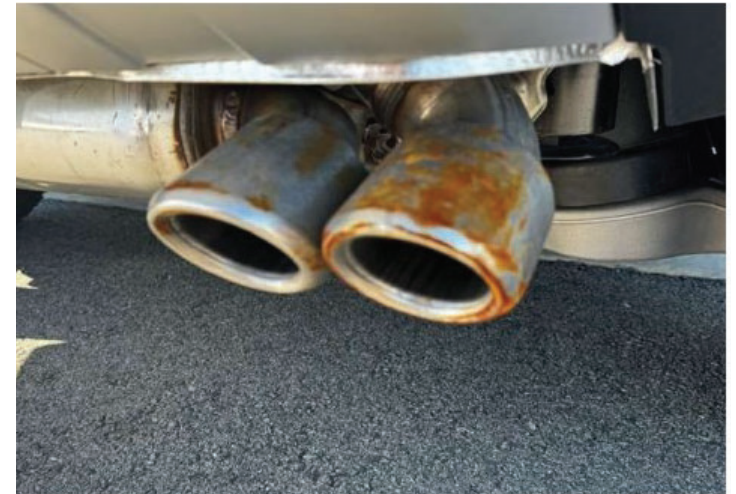
- JLR Retailers have reported visible corrosion around the outlet of the exhaust tailpipe prior to PDI

- Please find attached an example image showing light corrosion.
- Where mild corrosion is visible on the exhaust tail pipe, clear away the corrosion using a non-metallic scouring pad or suitable mild cutting paste.
- SRO 99010105,.2
