© Jaguar Land Rover North America, LLC

501-02

Excessive Wind Noise

MODEL:	MODEL YEAR:	VIN:	ASSEMBLY PLANT:
Range Rover (LK)	2022 Onwards	000293 Onwards	Solihull
Range Rover Sport (L1)	2023 Onwards	100000 Onwards	Solihull

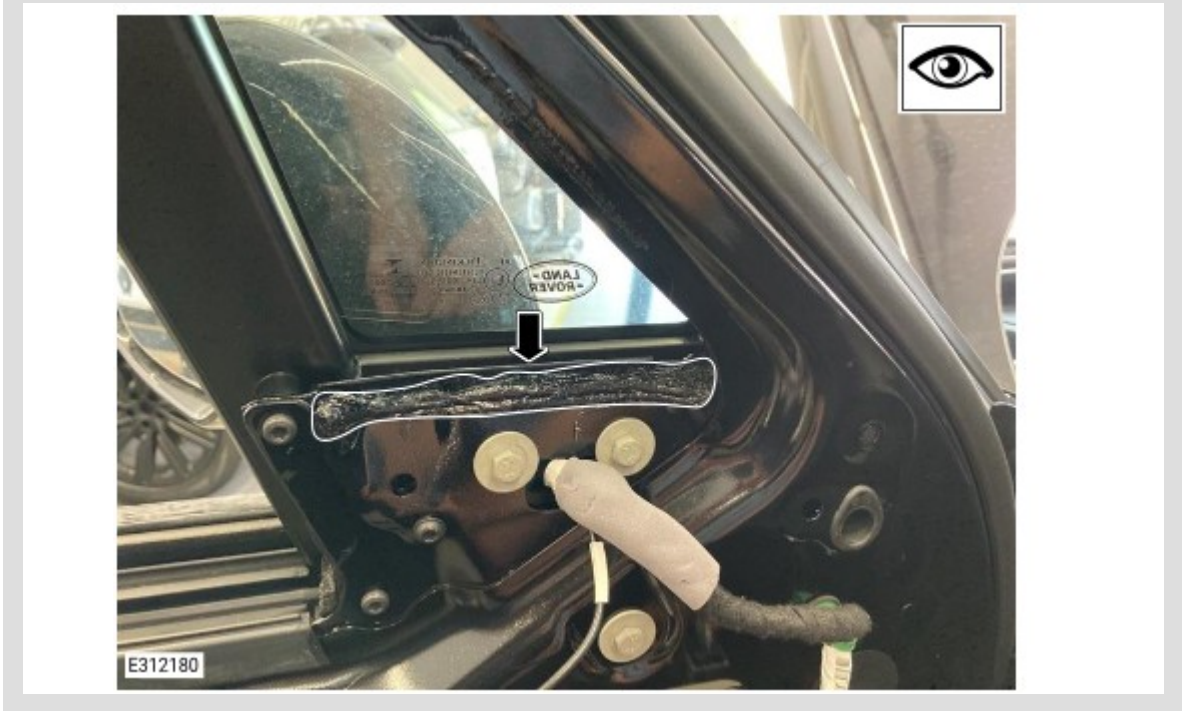
REWORK 2

Inspect the NVH material already applied in the area shown.

- Apply 3M™ Scotch-Weld 5313 (or an equivalent suitable black butyl strip) to fill any cavities which may be present in the area shown.
- Use a finger or thumb to firm down the butyl.

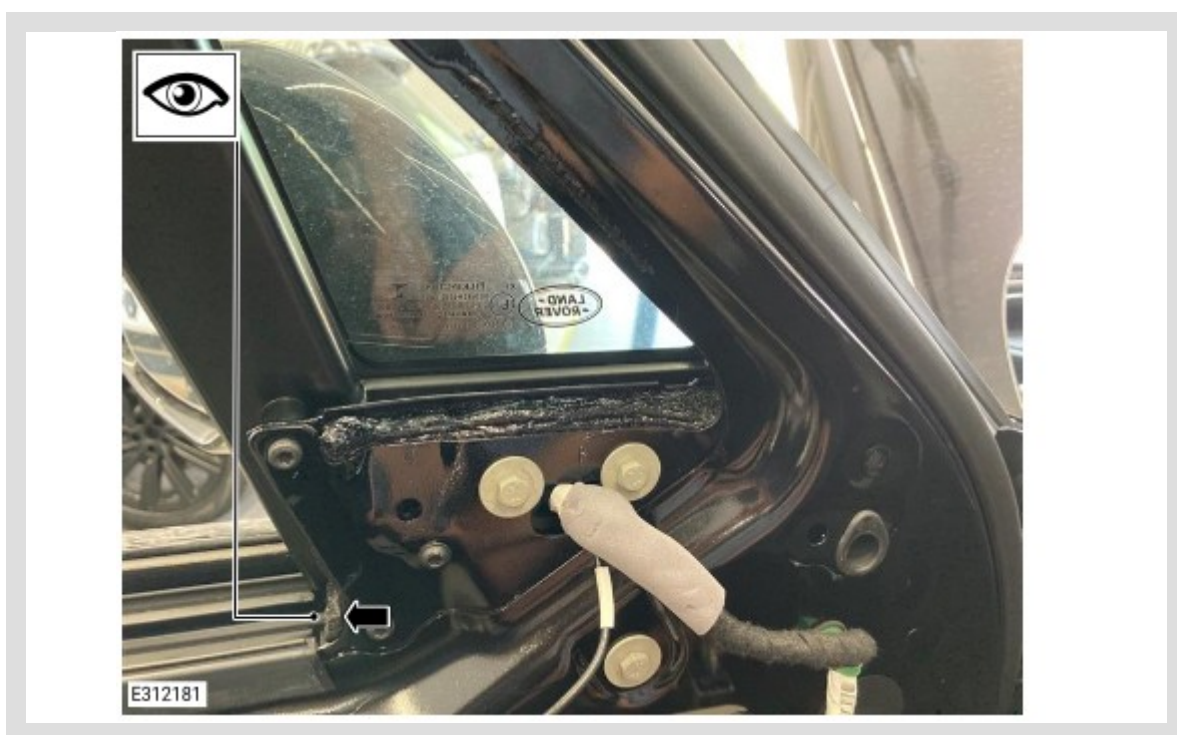
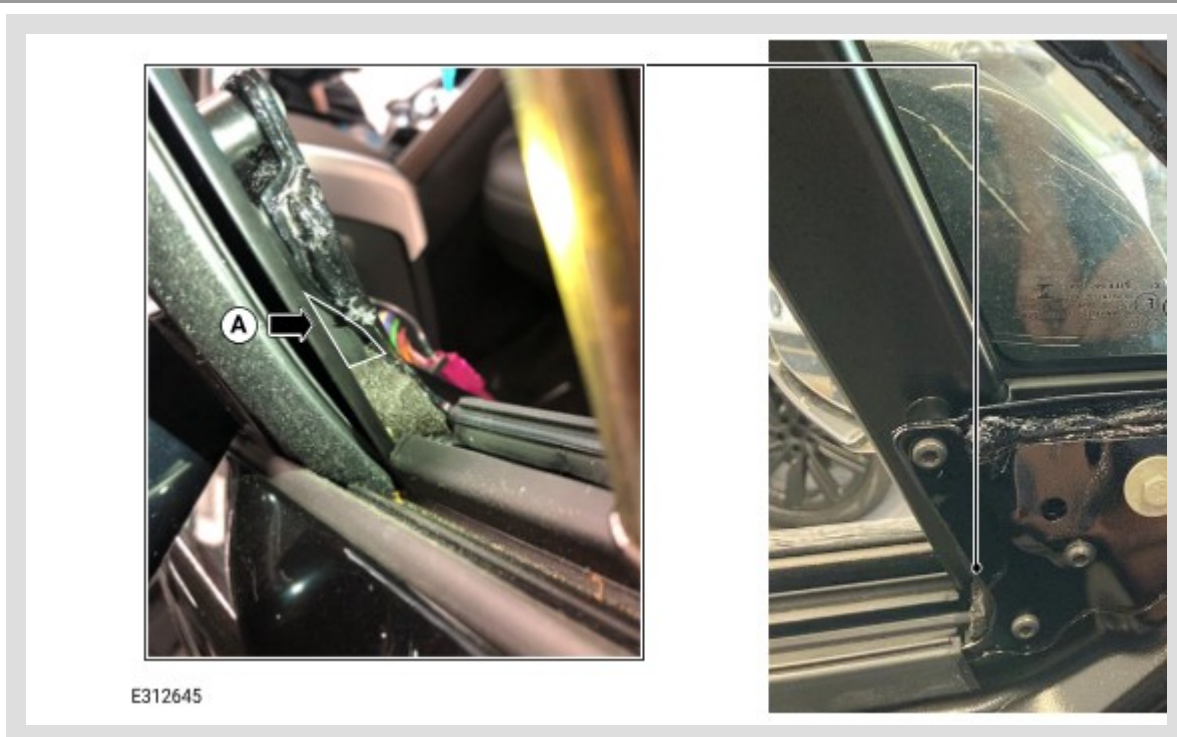
REWORK 5

Locate the NVH material already applied in the area shown.

Apply 3M™ Scotch-Weld 5313 (or an equivalent suitable black butyl strip) to fill the small cavity marked 'A' in the illustration, directly above the NVH material already applied.
