UPDATE PRIOR TO SALE NOTICE

Global Service Action
Number: N837 UPS5123-2

Structural Adhesive Concern	Publication No.: N837 UPS5123-2
	Model: Range Rover (LK)
	Model Year: 2024
	Model: Range Rover Sport (L1)
	Model Year: 2024
	Date of Issue: 15 December 2023
	Expiry Date: 15 December 2024

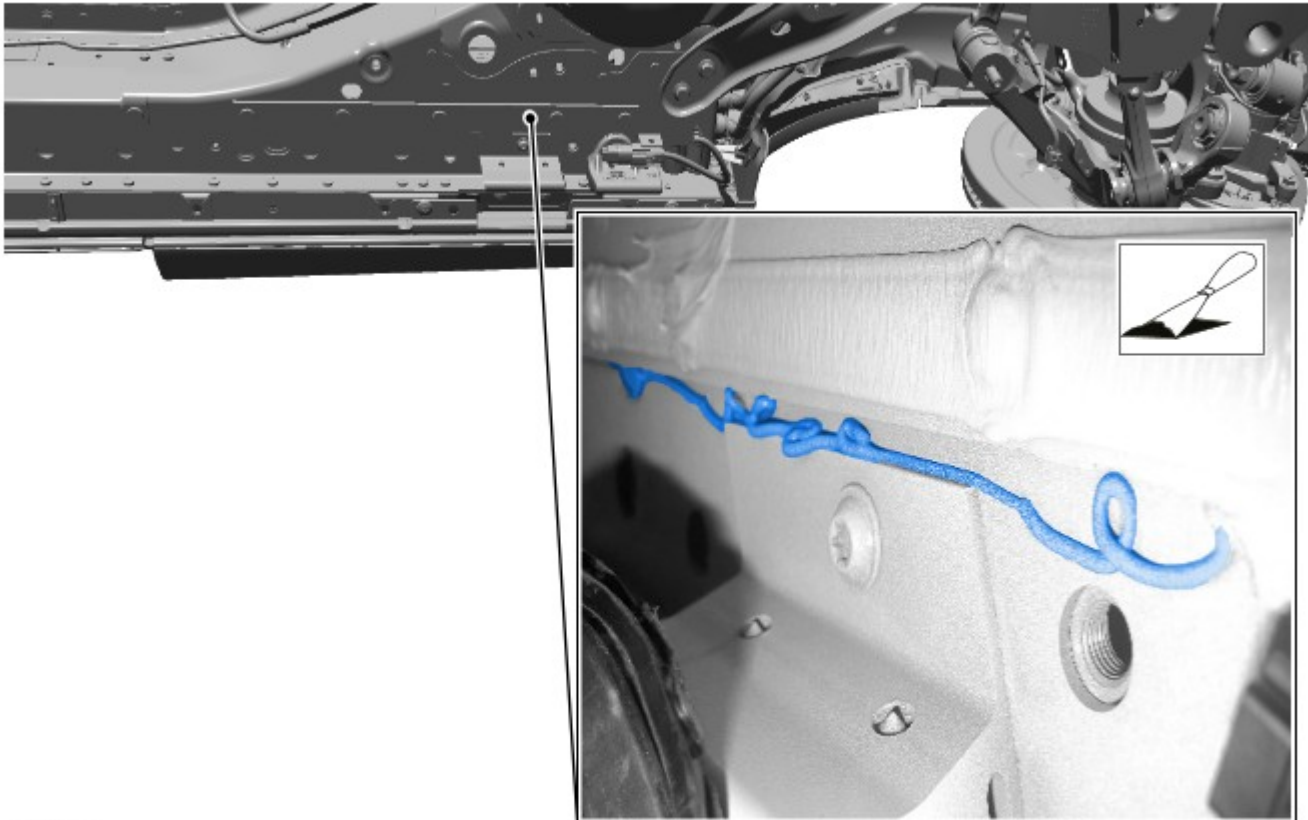
E351566

3. Using a suitable tool, remove the incorrectly applied sealant.
