# Service Bulletin

Bulletin No.: PIT5295A

**Subject:** Unable To Install a CD Or DVD (Slot Misalignment)

**Models:** 2015 Cadillac Escalade Models  
2015 Chevrolet Suburban, Tahoe  
2015 GMC Yukon Models

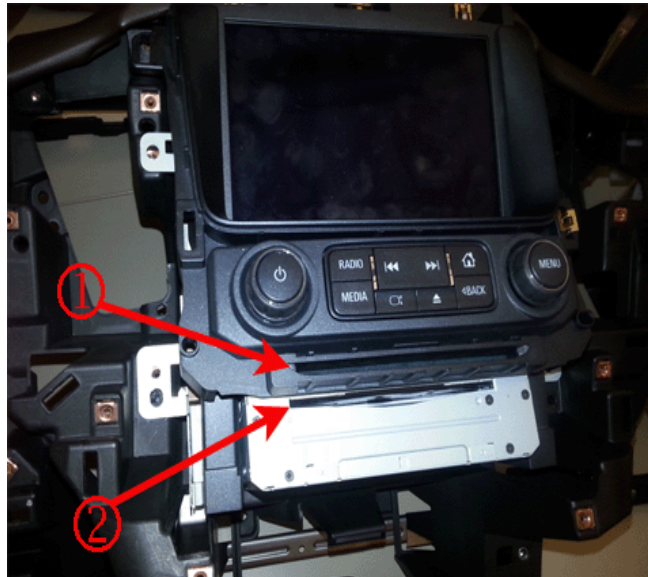
3921692

Some owners may comment that they are unable to install a CD or DVD in the player. This concern could be caused by the Integrated Center Stack or ICS (1) not being properly installed, causing a misalignment with the slot in the multimedia player (2), as shown below.

To correct this concern, remove the ICS and multimedia player. Reinstall the multimedia player ensuring the rear locating pin and front two common locating pins are properly engaged. Next, reinstall the ICS ensuring its rear locating pin and front two common locating pins (3) are properly engaged.

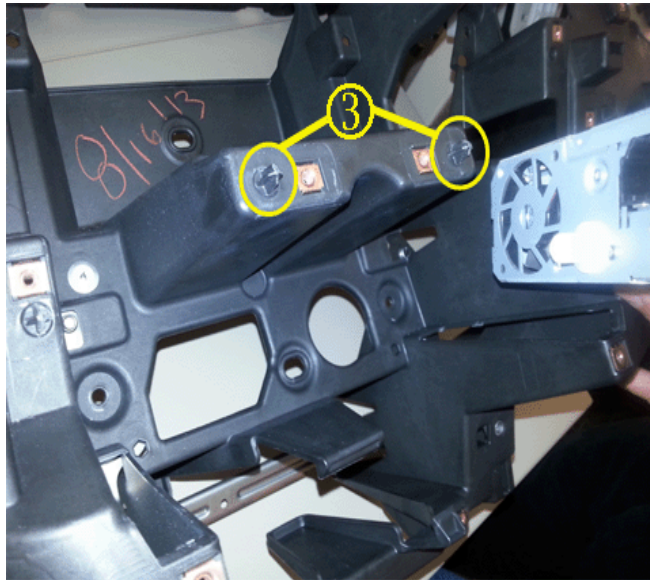
3921696

The ICS and multimedia player use two common locating pins (3), as shown below. When the ICS is installed, the two common locating pins (3) may not properly engage into the holes in the back of the ICS, causing the condition.
