REFERENCE:	TSB: 23-094-23 GROUP: 23 - Body	Date:	September 12, 2023	REVISION:	-
VEHICLES AFFECTED:	2023 (JT) Jeep Gladiator This bulletin applies to vehicles built on and after March 07, 2023 (MDH 0307XX) on and before March 07, 2023 (MDH 0307XX).			MARKET APPLICABILITY: <input checked="" type="checkbox"/> NA <input type="checkbox"/> MEA <input type="checkbox"/> SA <input checked="" type="checkbox"/> IAP <input checked="" type="checkbox"/> EE <input type="checkbox"/> CH	
CUSTOMER SYMPTOM:	Interior water leak at back glass (backlite) and hardtop, allowing water to leak into the vehicle at the lower passenger side corner Fig. 1 .				
CAUSE:	Manufacturing issue.

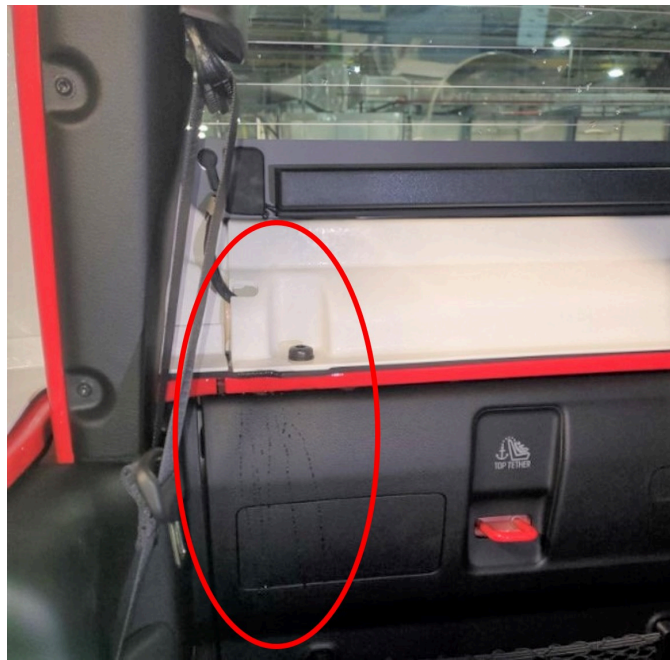
Fig. 1
Water Leak At Backlite

- Using a hose, pour water over the outside right upper corner of the backlite continuously for five minutes.
- Was a water leak detected on the inside backlite lower corner [Fig. 1](#)?
 - YES>>> Proceed to [Step 1](#) of the Repair Procedure.
 - NO>>> Normal diagnosis should be performed. Use the Inspection LOP (23-30-32-98) to close the active RSU.

- Replace the backlite. Refer to the detailed service procedures listed in DealerConnect>Service Library under: 23 - Body / Stationary Glass / Backlite / Removal and Installation. Ensure the interior is dry before returning the vehicle to the customer.
