From: [Redacted]
Sent: Friday, December 1, 2023 4:29 PM
To: [Redacted]
Cc: [Redacted]
Subject: P/N 5261439 - Fuel Hose Leaks Level 5
Attachments: Fuel Hose Leak_5261439_ One Pager_ Paccar.pptx
Importance: High

12/1/2023: Fuel Hose leak P/N : 5261439

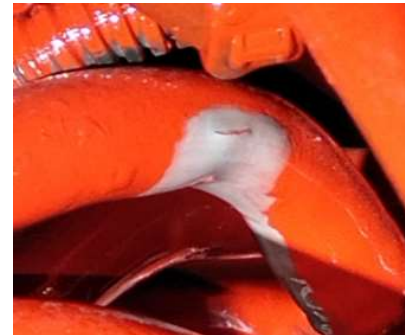
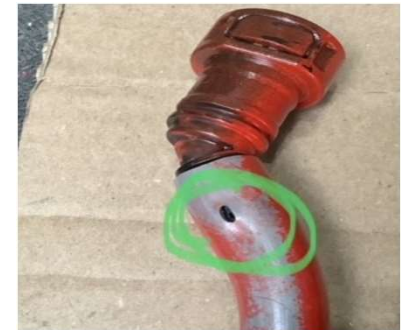
- Engines failing at multiple customers for level 5 fuel leaks on P/N 5261439.
- Leaks are observed during startup or at Dyno.
- 2 failures observed at Paccar St. Therese, 6 failures observed at DTNA Santiago.
- Slits observed on the fuel hoses for all the failures observed.

- Based on the parts returned for the BIS failures, it was observed that the leak path was created from inside to the outside of the fuel hose by fluid pressure.
- Supplier has performed a study using Pressure testing at 230 PSI to understand the conforming batch of fuel hose.
- Based on BIS issues notified until now, a suspect list has been generated for ESNs which use suspected parts from the supplier.
- Inhouse RMEP containment being carried out for engines by replacing the suspected parts from Supplier.
- Fuel hoses from the suspect batch have been shipped back to the Supplier for further testing and evaluation. (1762 engines suspect)

- Met Lab has sectioned a failed, returned part and discovered damage is internal from supplier's process. This creates a weak area internally, causing hose to rupture.

- Communicate to the OEMs impacted along with account managers in the loop.
- Generate Work instructions and provide to the onsite techs for performing the containments.
- Provide replacement parts to the On- Site techs for replacement.
- Get the parts back to RMEP upon replacing them.
