TECHNICAL SERVICE BULLETIN

Classification: TF16-002E	Reference: ITB17-001E	Date: December 13, 2023
------------------------------	--------------------------	----------------------------

FLUID LEAK CAUSED BY TRANSFER ASSEMBLY RIGHT SIDE DRIVE SHAFT OIL SEAL

- APPLIED VEHICLES:** 2019-2024 QX50 (J55)
2022-2024 QX55 (FJ55)
2014-2020 QX60 (L50)
2014-2017 QX60 Hybrid (L50H)
- APPLIED DRIVELINES:** AWD only

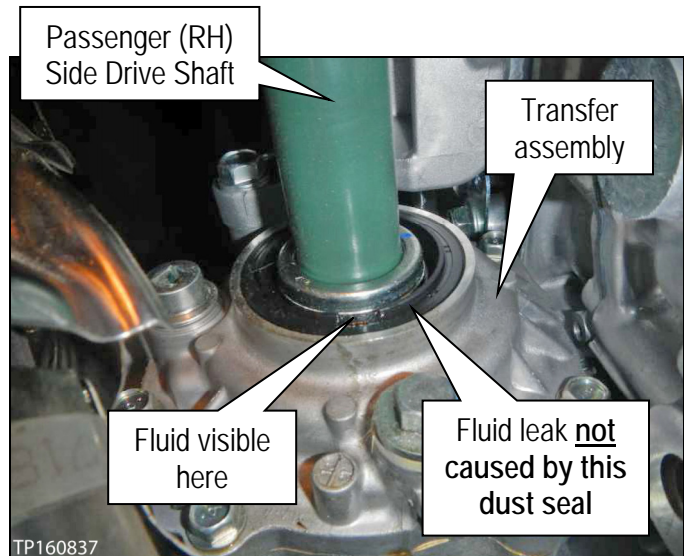
Figure 1

If fluid is leaking from the front passenger (RH) side of the transfer assembly, refer to the information in this bulletin.

- The fluid leak is NOT caused by the dust seal shown in Figure 1.
- This repair does NOT require transfer assembly removal from the vehicle.

1. **DO NOT REPLACE** the transfer assembly.
2. Replace the drive shaft oil seal and the dust seal.
 - Refer to ITB21-023 for drive shaft oil seal and dust seal replacement.
