TECHNICAL SERVICE BULLETIN

Classification: TF16-001F	Reference: NTB17-003F	Date: December 13, 2023
------------------------------	--------------------------	----------------------------

FLUID LEAK CAUSED BY TRANSFER ASSEMBLY RIGHT SIDE DRIVE SHAFT OIL SEAL

APPLIED VEHICLES:	2019-2024 Altima (L34)	2014-2020 Rogue (T32)
	2015-2024 Murano (Z52)	2021-2023 Rogue (T33)
	2016 Murano Hybrid (Z52H)	2017-2019 Rogue Hybrid (T32H)
	2013-2020 Pathfinder (R52)	2017-2022 Rogue Sport (J11)
	2014 Pathfinder Hybrid (R52H)

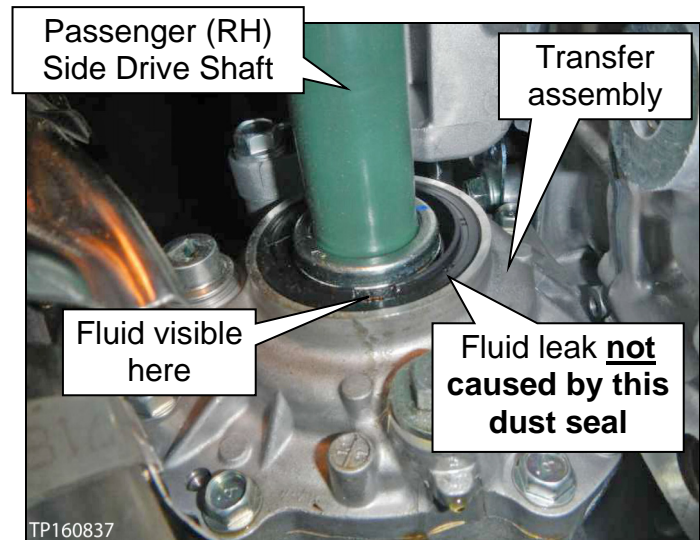
Figure 1

If fluid is leaking from the front passenger (RH) side of the transfer assembly, refer to the information in this bulletin.

- The fluid leak is NOT caused by the dust seal shown in Figure 1.
- This repair does NOT require transfer assembly removal from the vehicle.

1. **DO NOT REPLACE** the transfer assembly.
2. Replace the drive shaft oil seal and the dust seal.
 - Refer to NTB21-094 for drive shaft oil seal and dust seal replacement.

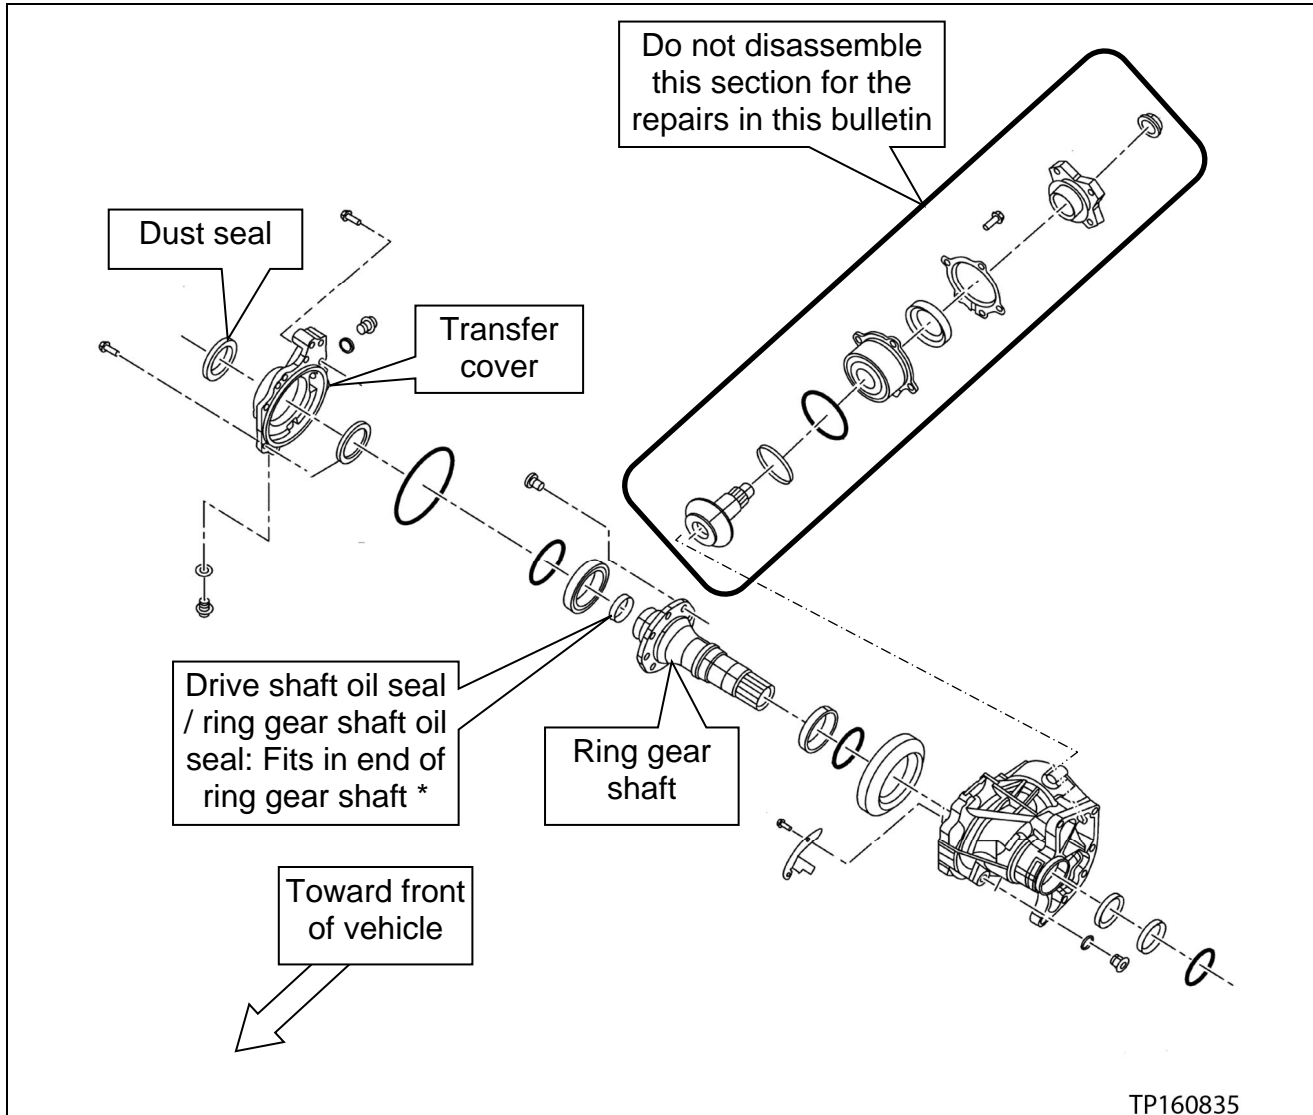
Figure 6

* The seal causing the leak is called "Drive shaft oil seal" in the ESM for all applied models except Rogue, Rogue Hybrid, Rogue Sport, and Altima. For these vehicles, it is called "Ring gear shaft oil seal".

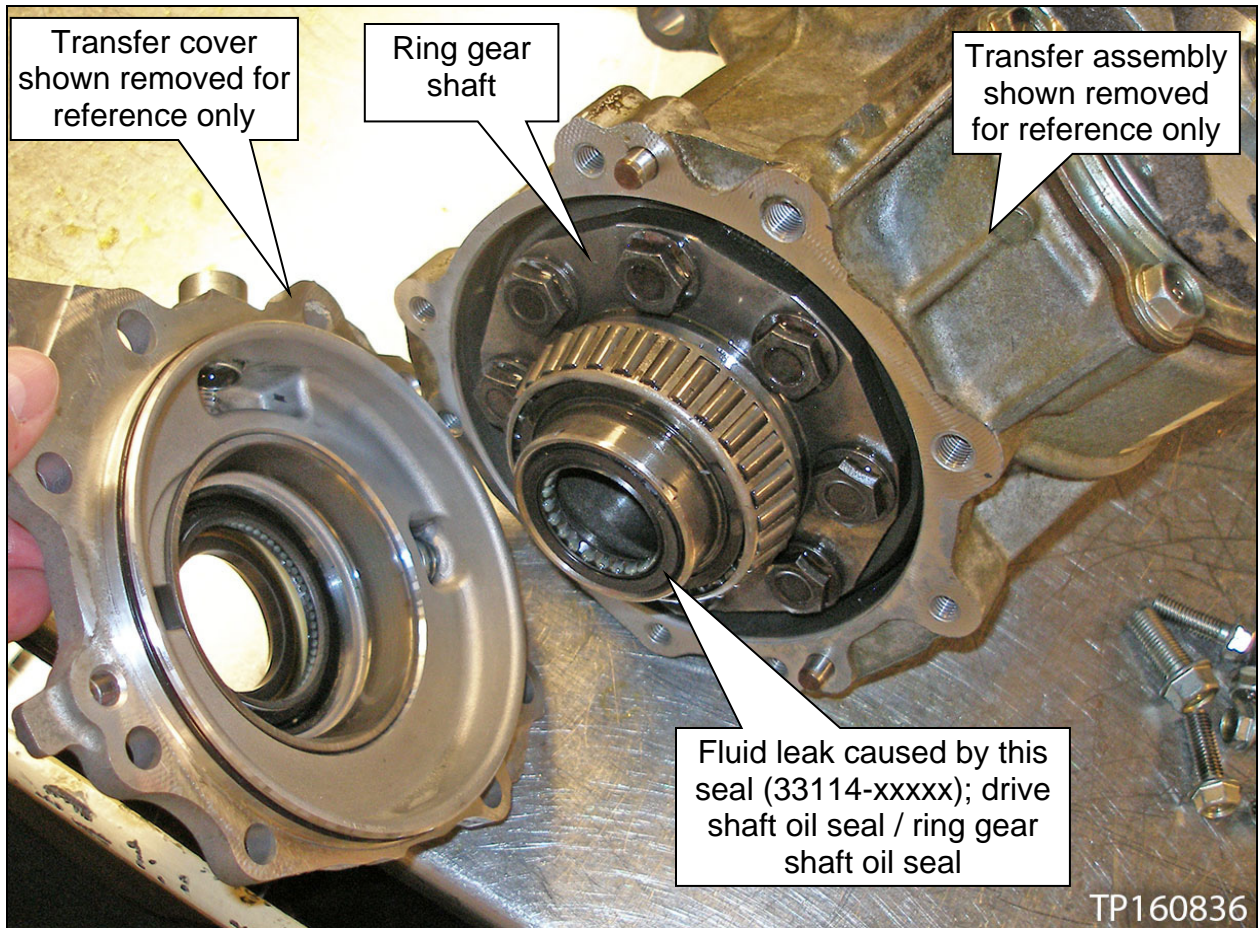
- This repair does NOT require transfer assembly removal from the vehicle.
- This repair does NOT require transfer cover removal from the transfer assembly.
- Figure 7 shows the transfer assembly removed from the vehicle and the transfer cover removed from the transfer assembly for reference only.

To avoid damage to the transfer assembly and new seals, use an appropriate seal installer and seal protector during the repair.
