Technical product information

Topic	Headlamp control unit replacement and/or turn signal control unit replacement
Market area	Australia E04 Bentley rest Asia and Australia (6E04),China 723 Volkswagen (Anhui) Automotive CO (6723),China 796 VW Import Comp. Ltd (Vico), Beijing (6796),Germany E02 Bentley rest Europe (6E02),Japan E03 Bentley Japan (6E03),Korea, (South) E08 Bentley South Korea (6E08),United Arab Emirates E06 Bentley Middle East and Africa (6E06),United Kingdom E01 Bentley UK (6E01),United States E05 Bentley USA and rest America (6E05)
Brand	Bentley
Transaction No.	2071933/1
Level	EH
Status	Approval
Release date

Bentayga Series and New Flying Spur Series

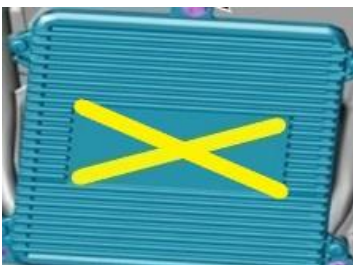
Figure 1

! NOTICE
 The headlamp control unit can only be replaced a **MAXIMUM** of **TWO** times (per headlamp) If there are two yellow paint marks on the control units (Figure 1) or the vehicles repair history shows the control units have been replaced **TWICE**, a new headlamp assembly is required
