Technical product information

| Topic | Charging starts and stops when using a high voltage charging unit - DTC P33E800 is evident within 00C6 |

Bentayga Hybrid

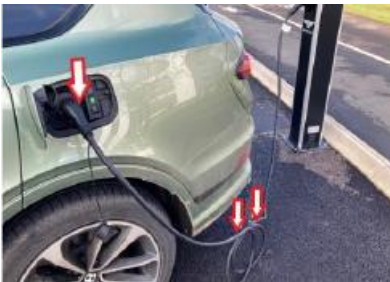
Referring to Figure 1 - Whilst charging the high voltage battery when using a high voltage charging unit (with the vehicle in an unlocked condition) the charge socket locking pin retracts. The unsupported weight of the cable results in the cable relaxing within the charge socket, the charging issue is then evident once the vehicle is locked, this is due to the locating pin being unable to lock into place resulting in the charging process being interrupted

In the event the issue is as described within the Customer statement/Workshop findings section, refer to the instructions within the Measure section of this TPI
