Technical product information

Topic	Front seat adjustment switch broken / damaged - Warranty replacement guidelines
Market area	Australia E04 Bentley rest Asia and Australia (6E04),China 796 VW Import Comp. Ltd (Vico), Beijing (6796),Germany E02 Bentley rest Europe (6E02),Japan E03 Bentley Japan (6E03),Korea, (South) E08 Bentley South Korea (6E08),United Arab Emirates E06 Bentley Middle East and Africa (6E06),United Kingdom E01 Bentley UK (6E01),United States E05 Bentley USA and rest America (6E05)
Brand	Bentley
Transaction No.	2072330/1
Level	EH
Status	Approval
Release date

New Continental GT / GTC and New Flying Spur

Front seat adjustment switch is broken / damaged

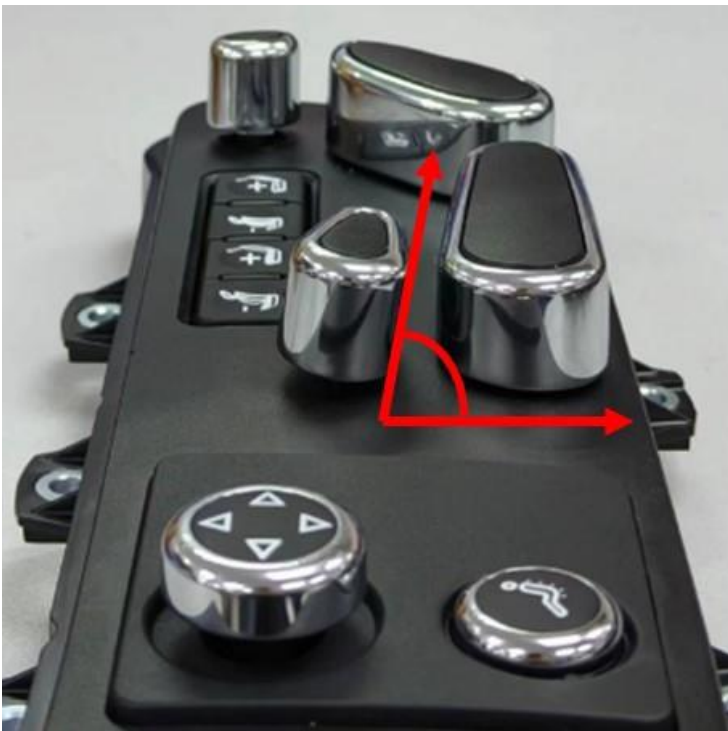
Referring to Figure 1 - The seat cushion switch is out of position, this damage was caused by misuse / force (Figure 1)

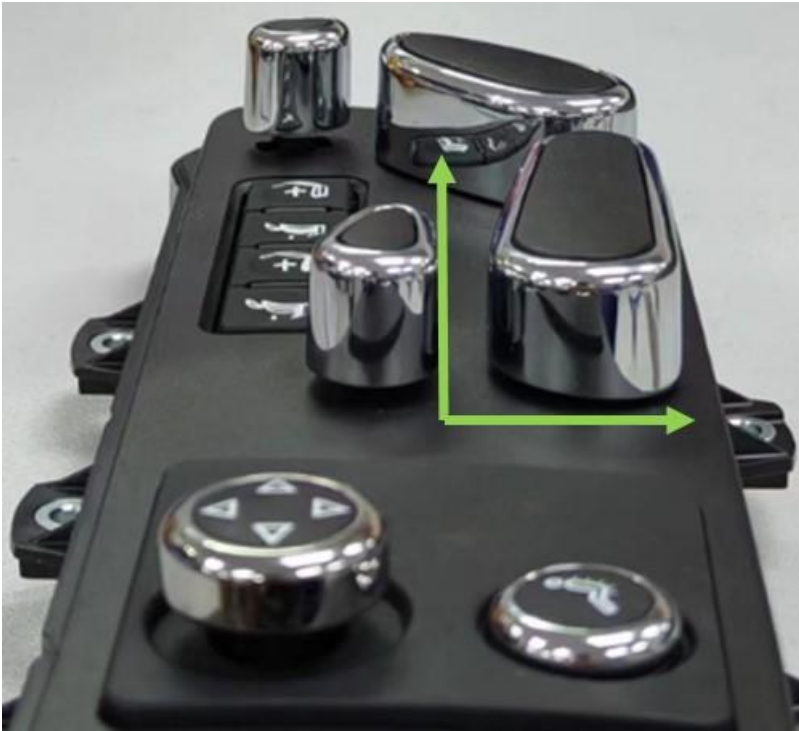
Figure 2 shows the switch in the correct position (No damage)

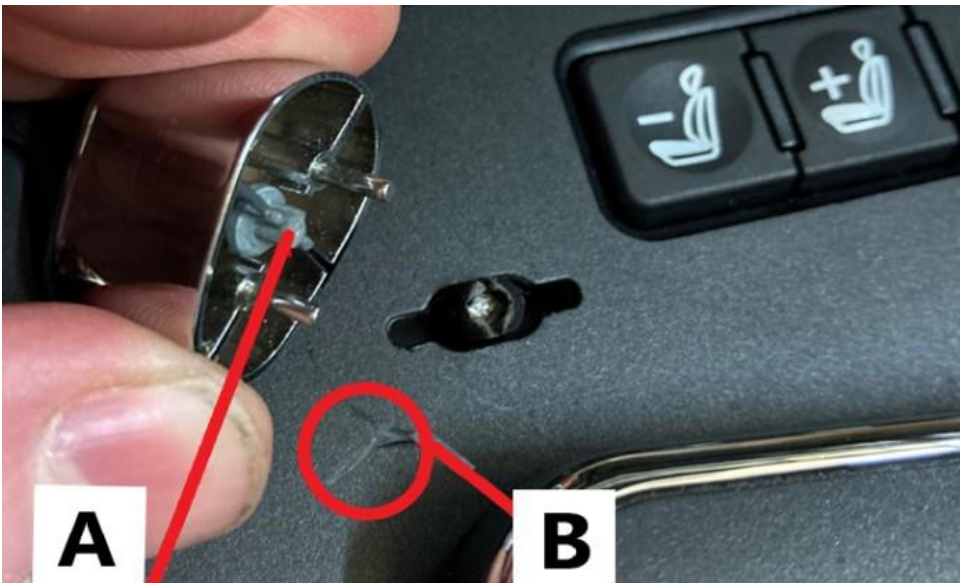
Referring to Figure 3 - The leg support cushion switch is broken (Point A)

Damage is also evident on the switch pack outer cover (Point B) due to excess force being applied to the switch
