# Technical product information

<b>Topic</b>	Infotainment screen turns red sporadically
<b>Market area</b>	Australia E04 Bentley rest Asia and Australia (6E04),China 723 Volkswagen (Anhui) Automotive CO (6723),China 796 VW Import Comp. Ltd (Vico), Beijing (6796),Germany E02 Bentley rest Europe (6E02),Japan E03 Bentley Japan (6E03),Korea, (South) E08 Bentley South Korea (6E08),United Arab Emirates E06 Bentley Middle East and Africa (6E06),United Kingdom E01 Bentley UK (6E01),United States E05 Bentley USA and rest America (6E05)
<b>Brand</b>	Bentley
<b>Transaction No.</b>	2055846/9
<b>Level</b>	EH
<b>Status</b>	Approval
<b>Release date</b>

Infotainment screen turns red sporadically

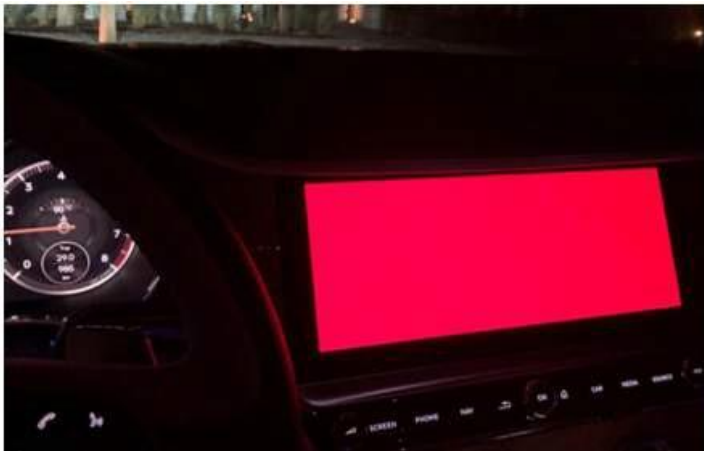
Figure 1

Infotainment screen 'Goes Red Fully or partially' within the MMI Screen (Figure 1)

#### Reset the Infotainment system as follows:

- Press and hold the volume rotary switch (Figure 2) for 10 seconds
