## Technical product information

<b>Topic</b>	Rotating display/screen - Fault diagnosis - Mechanical malfunction DTC B140107 is evident within 005F
<b>Market area</b>	Australia E04 Bentley rest Asia and Australia (6E04),China 723 Volkswagen (Anhui) Automotive CO (6723),China 796 VW Import Comp. Ltd (Vico), Beijing (6796),Germany E02 Bentley rest Europe (6E02),Japan E03 Bentley Japan (6E03),Korea, (South) E08 Bentley South Korea (6E08),United Arab Emirates E06 Bentley Middle East and Africa (6E06),United Kingdom E01 Bentley UK (6E01),United States E05 Bentley USA and rest America (6E05)
<b>Brand</b>	Bentley
<b>Transaction No.</b>	2067955/4
<b>Level</b>	EH
<b>Status</b>	Approval
<b>Release date</b>

- Bentley Rotational Display (BRD) operational issues
- Mechanical malfunction DTC B140107 evident within 005F

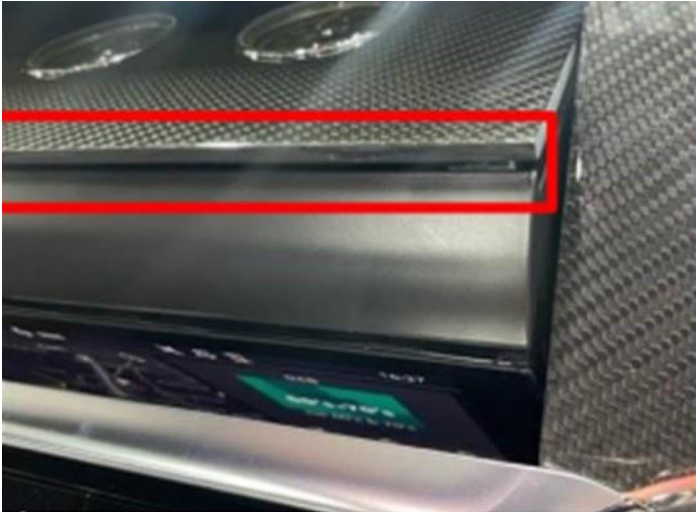
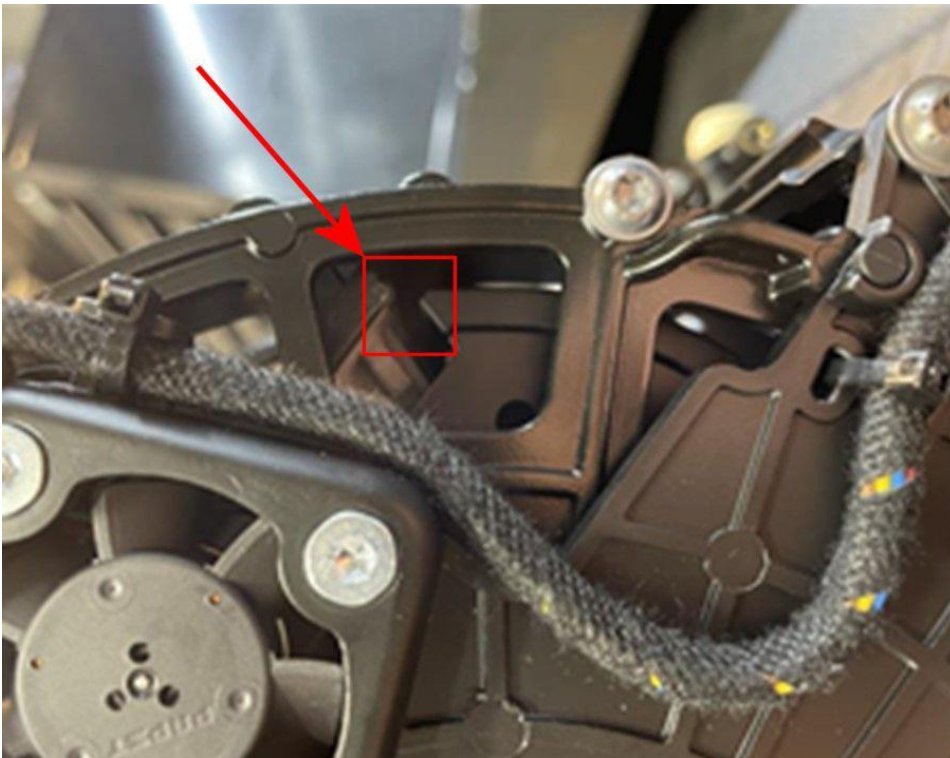
4) Figures 1 and 2 show an example of the display clocks and/or dials fascia unclipped)

Please note: The BRD must be removed (Rep.Gr 91) to allow visual inspection of the panel at the back of the BRD for signs of unclipping (Figure 2)

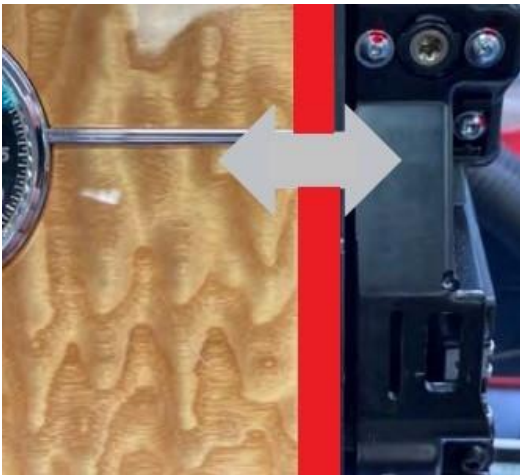
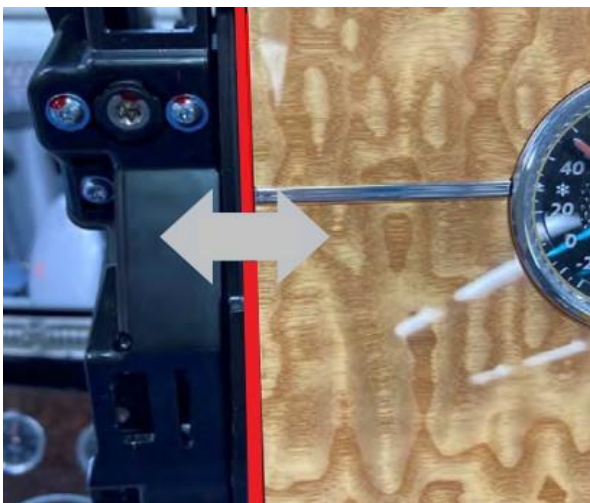
- **HINT: Referring to Figures 4 and 5, if there is a large gap on one side of the fascia panel and a small gap on the opposing side or a report of clashing with driver fascia or clunking the operative should check to confirm the bearings of the unit have not displaced as shown in Figure 6**

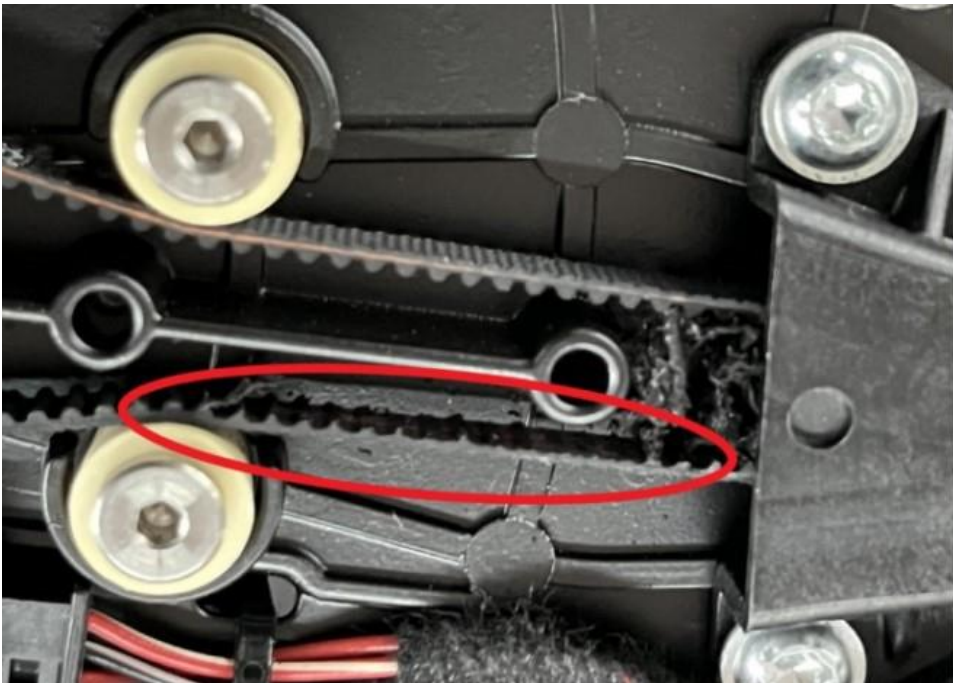
Figure 7

Figure 6  
8) Belt drive check (Figure 7)
