Service Bulletin

Bulletin No.: 23-NA-122

Subject: Engine Oil Leak

Brand:	Model:	Model Year:		VIN:		Engine:	Transmission:
		from	to	from	to		
Buick	Encore GX	2020	2024	—	—	1.2L Turbo (RPO LIH)	—
	Envista	2024					
Chevrolet	Trax	2024					
	Trailblazer (VIN M)	2021

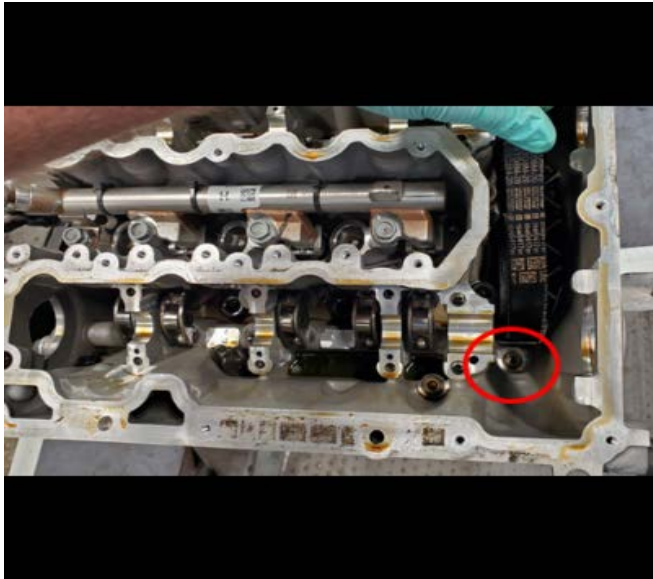
6373158

Note: Camshaft removed for clarity.

1. Remove the exhaust camshaft sprocket and position aside. Refer to *Camshaft Exhaust Sprocket Replacement* in the Service Manual.
2. Remove the cylinder head bolt.

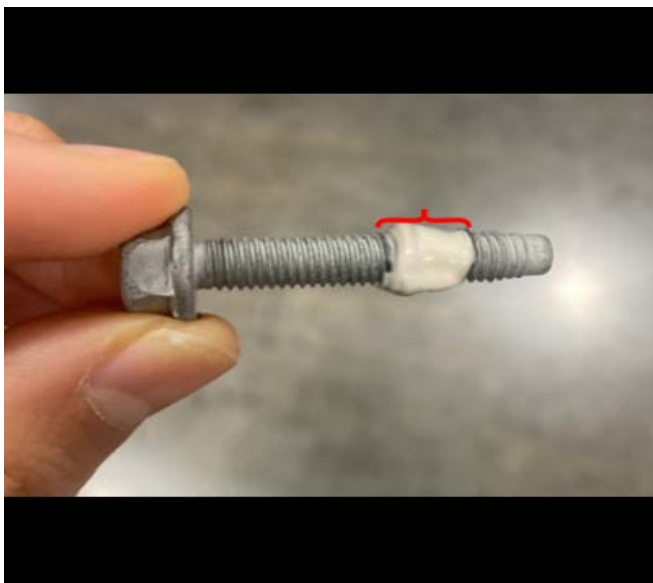
6373161

Important: Do Not apply Loctite© to the end of the bolt. Damage to the engine block may occur.

3. Apply 565 Loctite© to a new cylinder head bolt as indicated in the graphic above.
4. Install the bolt into the cylinder head and torque to 14.5 N•m (10.7 lb ft). Refer to *Fastener Specifications* in the Service Manual.
5. Install the exhaust camshaft sprocket. Refer to *Camshaft Exhaust Sprocket Replacement* in the Service Manual.
