Service Bulletin

Subject: Radio Software Version Y171 – Multiple Updates

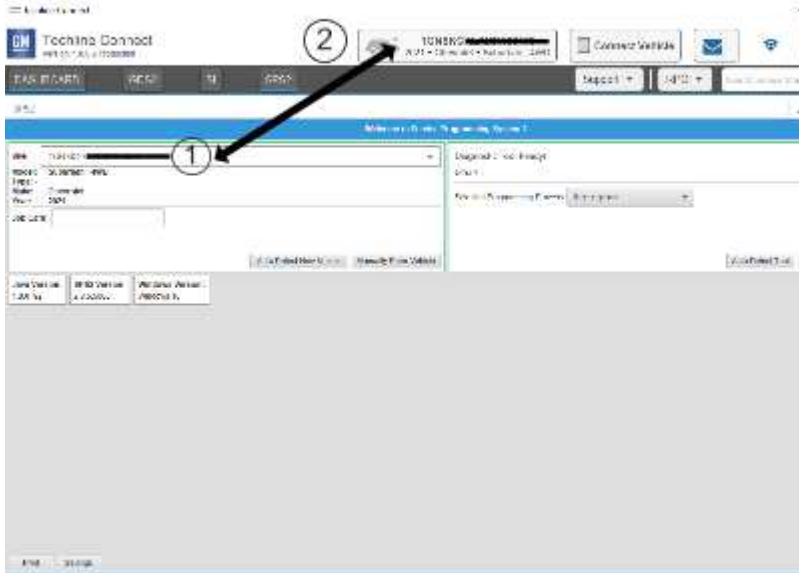
Caution: Be sure the VIN selected in the drop down menu (1) is the same as the vehicle connected (2) before beginning programming.

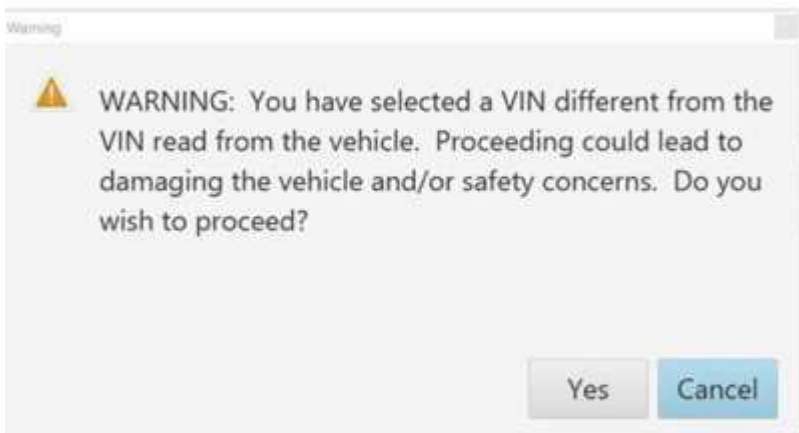
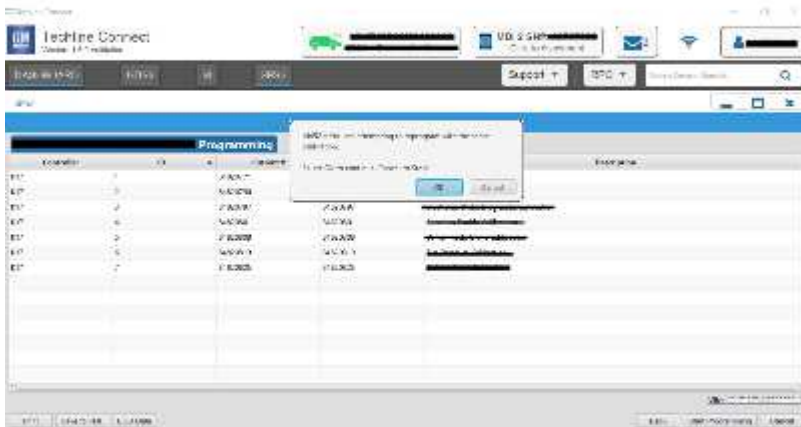
Important: If the vehicle VIN DOES NOT match, the message below will be shown

- If the VIN that shows up in the TLC top center window after correctly reading the VIN from the vehicle does not match the VIN plate of the vehicle, manually type in the VIN characters from the vehicle VIN plate into the TLC top center window and use these for programming or reprogramming the subject module with the correct vehicle VIN and software and/or calibrations.

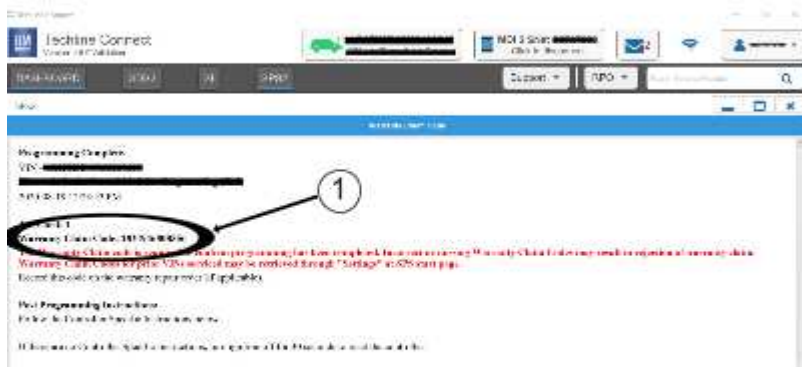
Note: The screenshot above is an example of module programming and may not be indicative of the specific module that is being programmed. Module selection and VIN information have been blacked out.

Important: To avoid warranty transaction rejections, you MUST record the warranty claim code provided on the Warranty Claim Code (WCC) screen

shown above on the job card. Refer to callout 1 above for the location of the WCC on the screen.
