Subject: Missing the V Series Instrument Panel Graphics on Vehicle Startup

Brand:	Model:	Model Year:		VIN:		Engine:	Transmission:
		from	to	from	to		
Cadillac	Escalade Models (Premium Only)	2024	2024

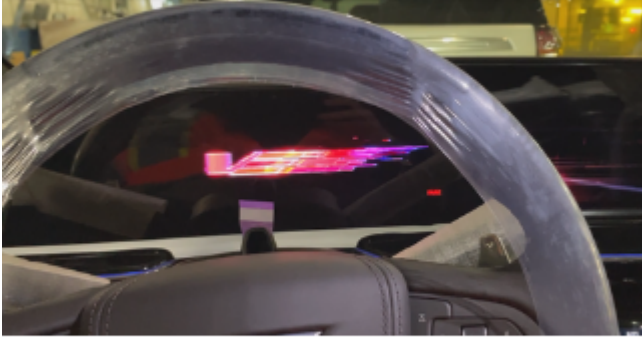
<p>6505913</p> <p>Some customers may comment that their vehicle is missing the V Series graphic displayed on the instrument panel during vehicle startup.</p>
Cause	This may be caused by a software anomaly.
Correction	If you encounter a vehicle with any of the above conditions, reprogram the Instrument Cluster Control Module (IPC) with the latest available software.
