STAR ONLINE PUBLICATION

Case Number: S2323000081

Symptom/Vehicle Issue: Buzz Squeak Rattle (BSR) From Rear Seat Area.

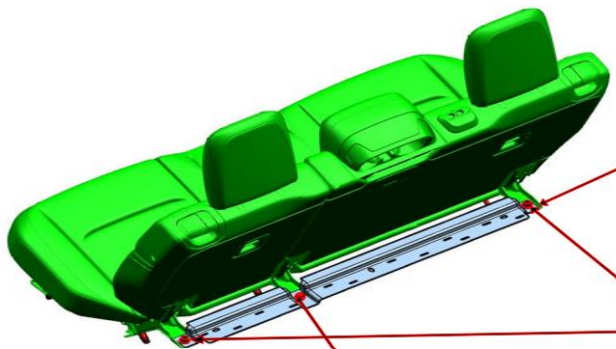
Customer Complaint/Technician Observation: BSR coming from rear seat assembly when driving vehicle or operating seat folding functions.

Discussion: The second-row seat may be under tension causing noises. To resolve this the seat fasteners must be removed, and the seat assembly reinstalled with fasteners tightened in order. Torque all the outboard fasteners first (outboard leg and rear screws) and then remaining inboard screws to avoid causing a bind condition at the latches or hinge points. Then test drive to verify the customer concern is now resolved. Also refer to Service Library 23 - Body / Seats, Second Row / SEAT, Second Row / Removal and Installation for more information.
