REFERENCE:	TSB: 10-001-23 REV. A GROUP 10 - Restraints	Date:	November 9, 2023	REVISION:	10-001-23
VEHICLES AFFECTED:	2015 - 2022 (B1) Jeep Renegade 2015 - 2018 (BU) Jeep Renegade 2019 - 2022 (BV) Jeep Renegade 2019 - 2022 (FD) Fiat 500X 2015 - 2018 (FB) Fiat 500X	MARKET APPLICABILITY: <input type="checkbox"/> NA <input checked="" type="checkbox"/> MEA <input type="checkbox"/> SA <input checked="" type="checkbox"/> IAP <input checked="" type="checkbox"/> EE <input type="checkbox"/> CH			
CUSTOMER SYMPTOM:	Customers may experience a Malfunction Indicator Lamp (MIL) illumination. Upon further investigation the technician may find one or more of the following Diagnostic Trouble Codes (DTCs) has been set: <ul style="list-style-type: none"> • B0050-1D - Driver Front Buckle Switch - Out of Range (Active or Stored). • B0050-13 - Driver Front Buckle Switch - Circuit open (Active or Stored). 				
CAUSE:	Micro vibrations between buckle and seat wiring connectors causing male and female terminal corrosion Fig. 1.

This bulletin supersedes Technical Service Bulletin (TSB) 10-001-23, date of issue August 25, 2023, which should be removed from your files. All revisions are highlighted with ****as

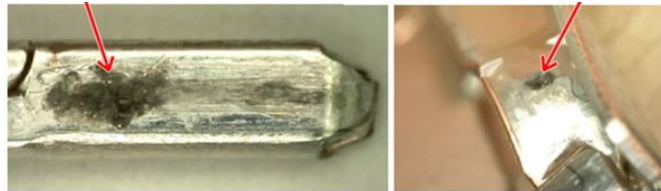
Fig. 1
Terminal Corrosion

This bulletin involves replacing the inline seat connector.

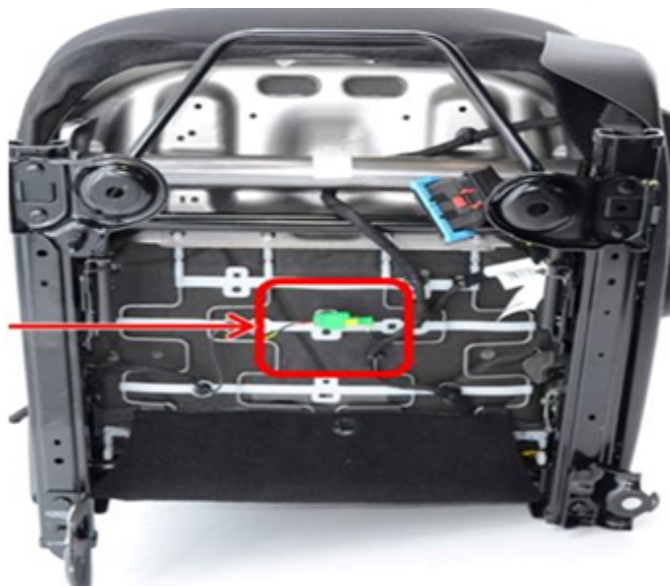
**Fig. 2**

Seat Belt Buckle In Line Connector Location

3. Remove the old seat belt buckle connector.
4. Splice in the new in line connector. Refer to the detailed service procedures available in DealerConnect>Service Library under: Service Info> 10 - Restraints / Standard Procedure Supplemental Restraint System Wiring Repairs.
