GROUP	MODEL
Subsequent Repair Action	2019MY Optima (JFa), Sorento (UMa), and Sportage (QL)
NUMBER	DATE
PI1805Y/Z	January 2024

### ENGINE REPLACEMENT INSTRUCTIONS FOR DTC P1326 (PI1805Y/Z)

This bulletin provides information related to the Technical Service Bulletin previously published in (PI1805) titled "Knock Sensor Detection System - ECU Logic Improvement" for certain 2019MY Optima (JFa), Sorento (UMa) and Sportage (QL) vehicles equipped with a 2.4L GDI or 2.0L T-GDI engine (Refer to page 9 for production dates). Specifically, this bulletin provides instructions on which procedures to follow if, after installation of the KSDS, any one of the subject vehicles below return to the dealer with Diagnostic Trouble Code (DTC) P1326 (Knock Signal Range/Performance).

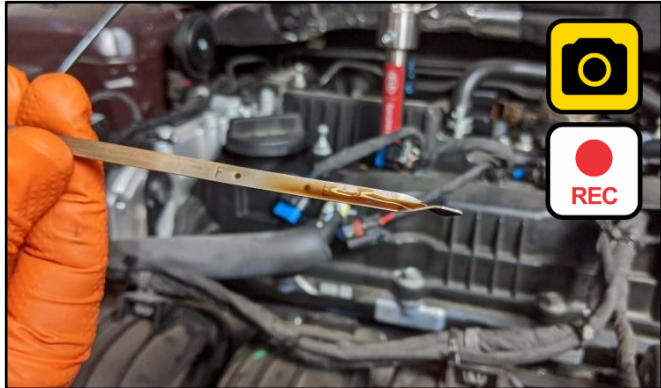
1. Start video showing vehicle and move in towards the dash VIN tag.
2. Measure and record oil dip stick level.
3. Note oil dip stick reading on the RO.
4. Take a picture of the oil reading on dipstick.
5. Inspect the inner/bottom of the oil cap and inside oil filler opening.

**Record/Note findings:** Oil sludge, varnish, burnt oil smell condition(s) found.

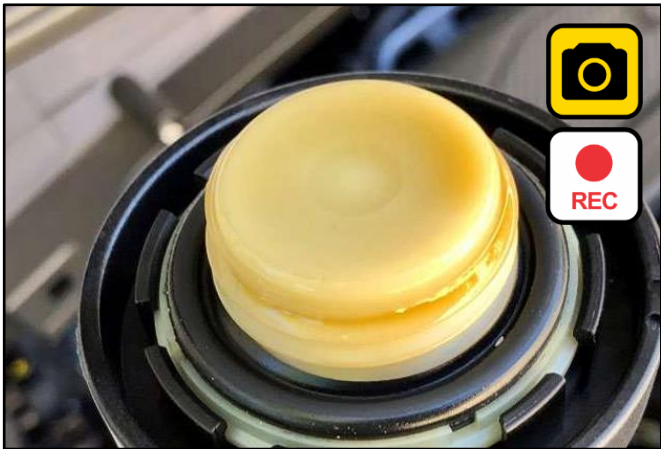
6. Inspect the inner/bottom of the oil cap and inside oil filler opening.

**Record/Note findings:** Oil sludge, varnish, burnt oil smell condition(s) found.

**If oil lacquering, oil sludge or oil varnish is present, then the engine is therefore suspect to maintenance neglect. Review of the vehicle's maintenance history is required.**
